Defect Listing

Pipe Segment Refere... B4-1_B-20	City Oliver springs	Street Butler St	Material Concrete Pipe (non-...	Location C... Light High...	Sewer Use Sanitary
Upstream MH B4-1	Total Length 207.3	Year Laid	Shape Circular	Location Details	
DS Manhole B-20	Length surveyed 207.3	Year Renewed	Height 8	Width 8	Pipe Joint... 4

SPR 4	MPR 26	PO Number 4397-03	Customer GRW
SPRI 4	MPRI 2	Work Order 4397-02	Purpose Pre-Rehabilitation Survey
QSR 4100	QMR 2A00		
OPR 30	Surveyed By Charlie Gordon	Direction Downstream	Date 20150904
OPRI 2.1	Certificate Number U-615-07000491	Pre-Cleaning Jetting	Time 12:34
	Date Cleaned 20150904	End Time 12:47	Weather Dry
			Additional Info

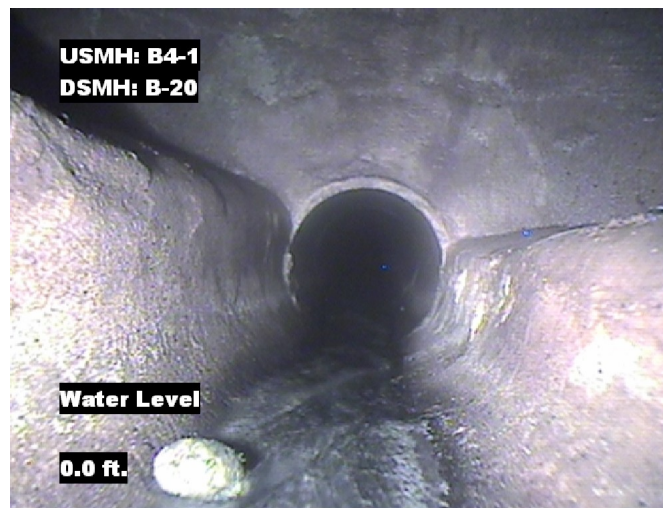
Distance: 0.0 ft. Grade: 0
Condition: Water Level
Remarks: N/A

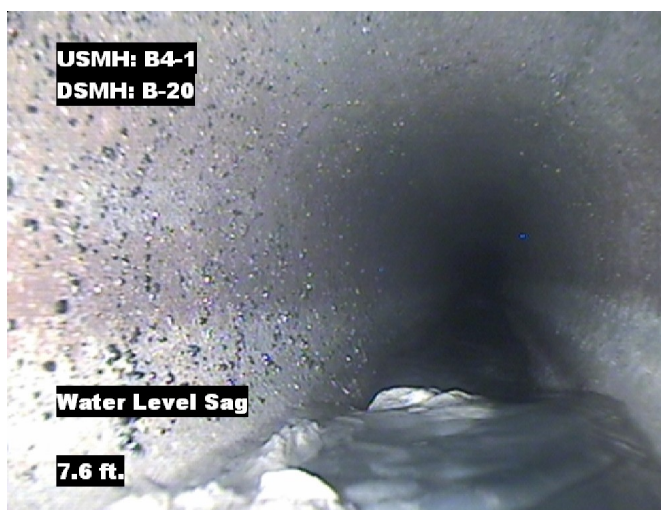
Distance: 7.6 ft. Grade: 2
Condition: Water Level Sag
Remarks: N/A

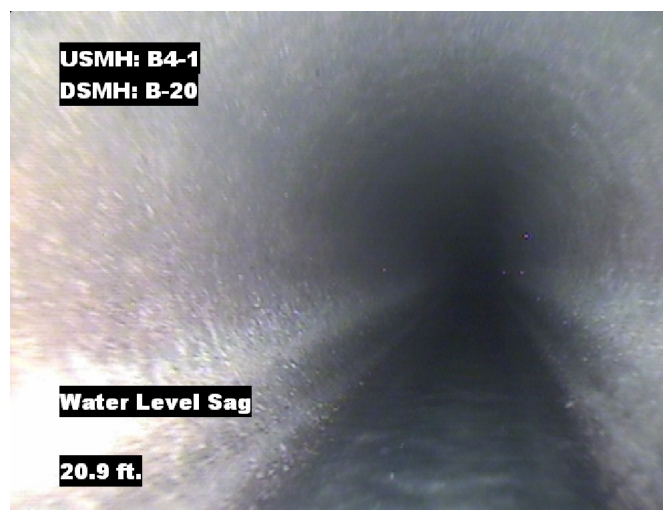
Distance: 20.4 ft. Grade: 2
Condition: Water Level Sag
Remarks: N/A

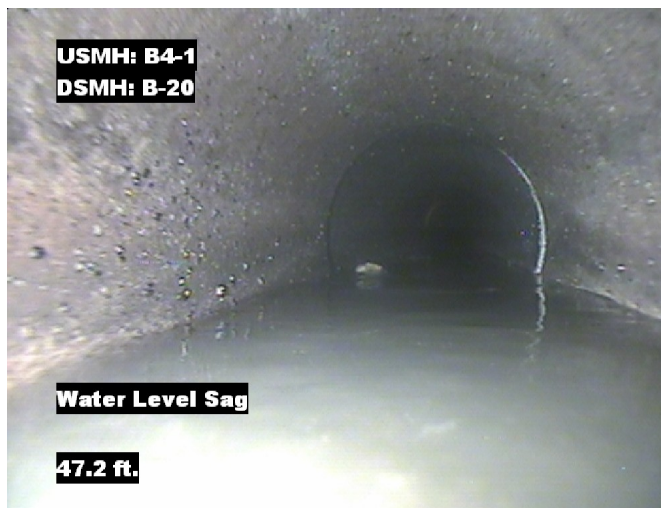
Distance: 47.1 ft. Grade: 2
Condition: Water Level Sag
Remarks: N/A

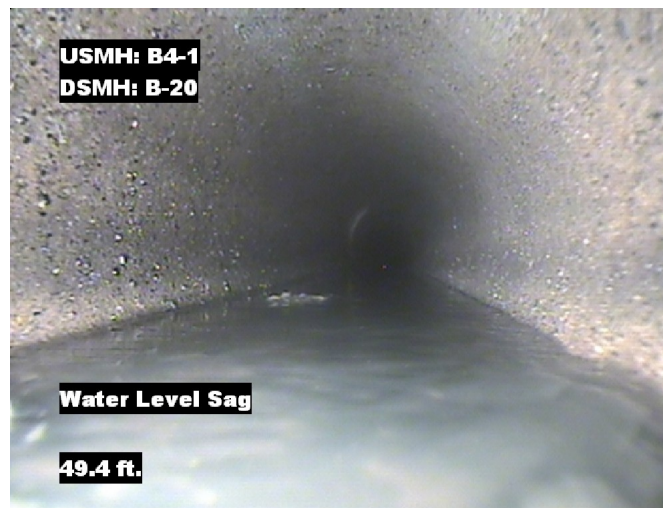
Distance: 49.4 ft. Grade: 2
Condition: Water Level Sag
Remarks: N/A

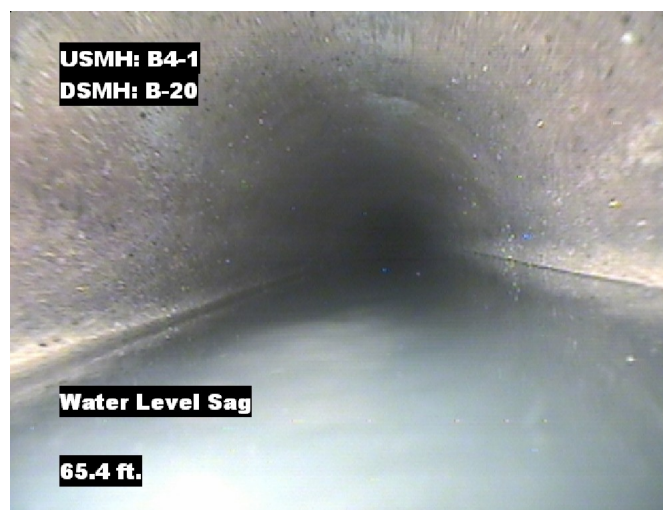
Distance: 65.4 ft. Grade: 2
Condition: Water Level Sag
Remarks: N/A

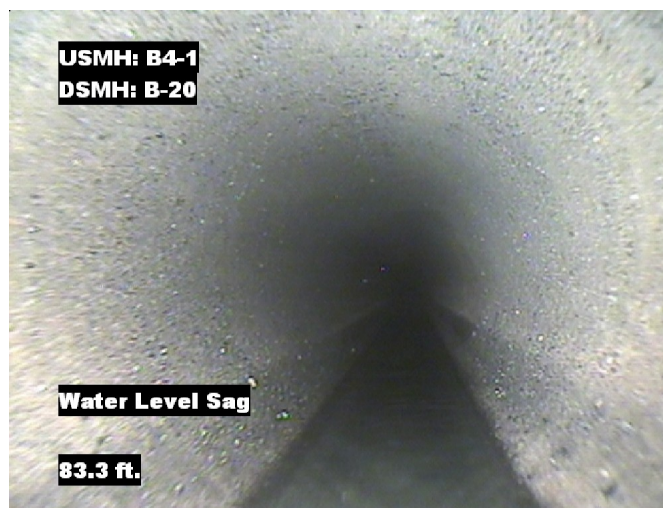
Distance: 83.2 ft. Grade: 2
Condition: Water Level Sag
Remarks: N/A

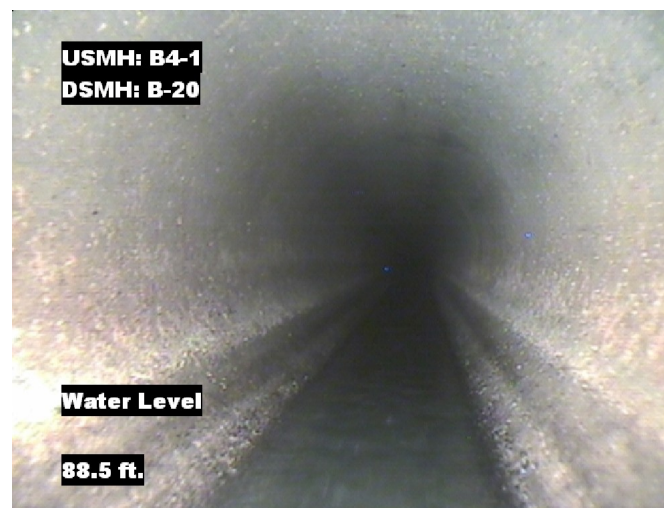
Distance: 88.5 ft. Grade: 0
Condition: Water Level
Remarks: N/A

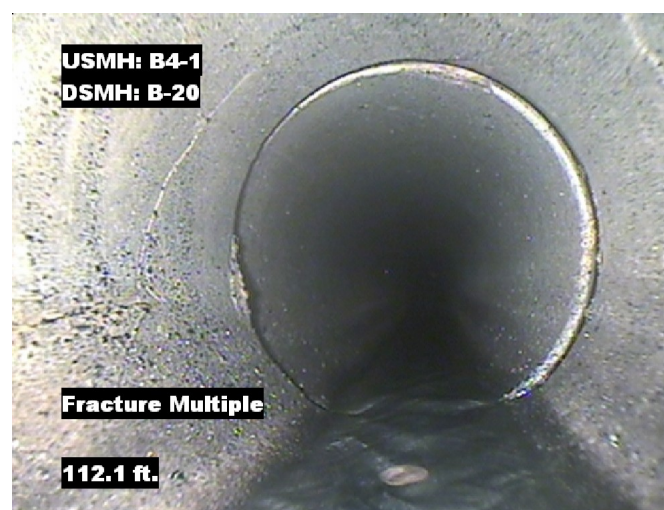
Distance: 112.1 ft. Grade: 4
Condition: Fracture Multiple
Remarks: N/A

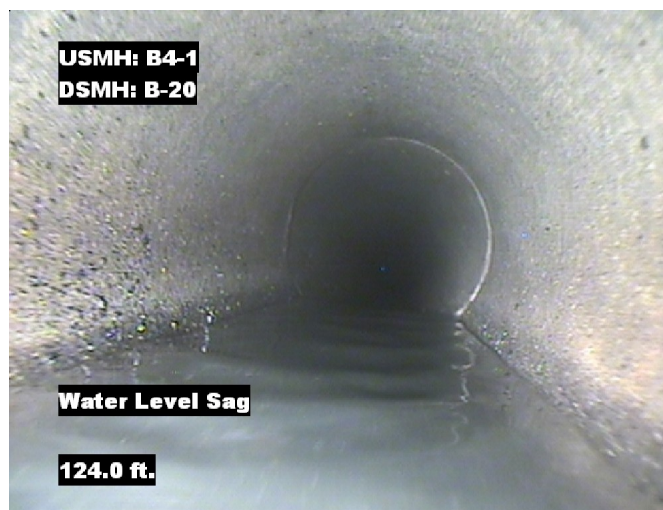
Distance: 124.0 ft. Grade: 2
Condition: Water Level Sag
Remarks: N/A

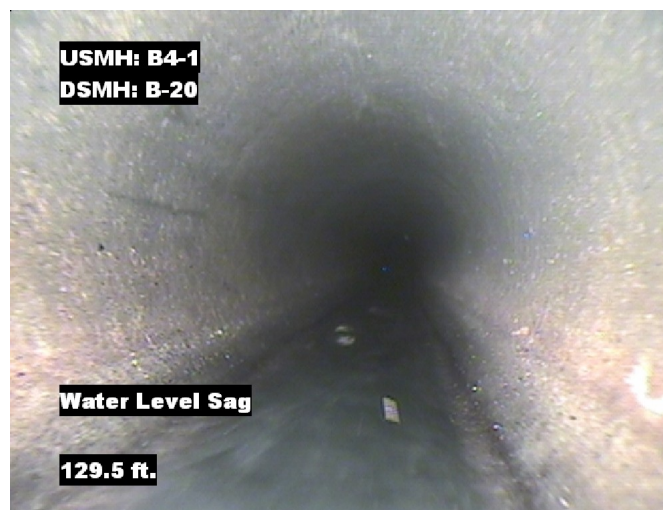
Distance: 129.5 ft. Grade: 2
Condition: Water Level Sag
Remarks: N/A

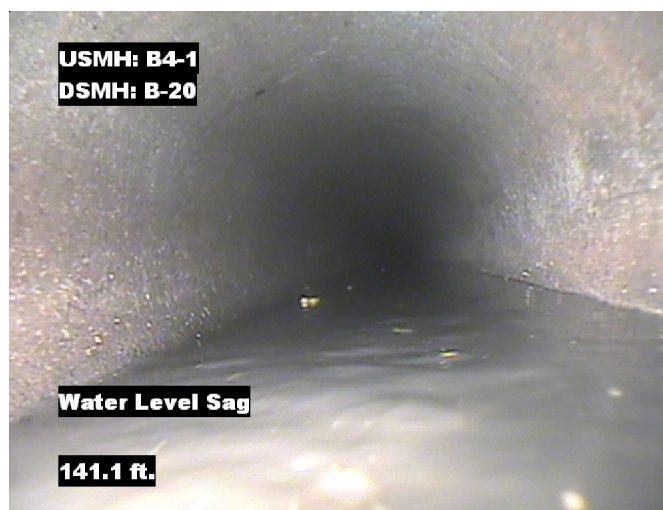
Distance: 141.1 ft. Grade: 2
Condition: Water Level Sag
Remarks: N/A

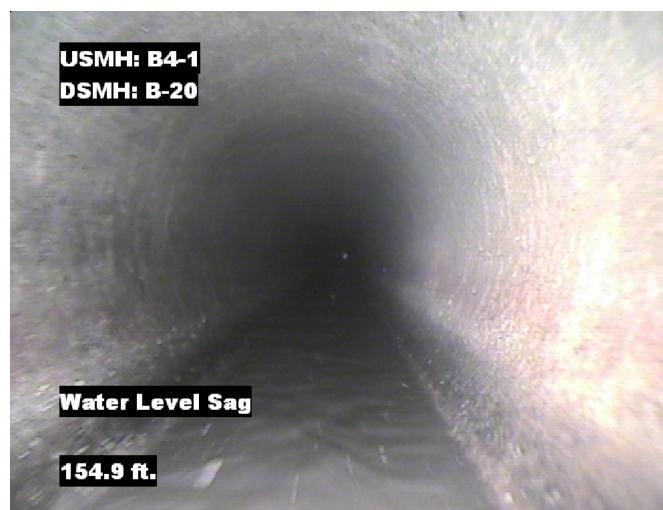
Distance: 154.9 ft. Grade: 2
Condition: Water Level Sag
Remarks: N/A

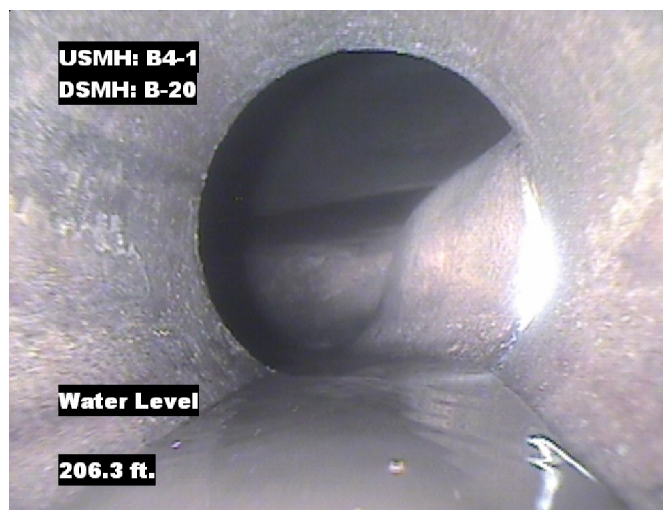
Distance: 206.3 ft. Grade: 0
Condition: Water Level
Remarks: N/A
