## Defect Listing

Pipe Segment Refere... <b>B4-2 B4-1</b>	City <b>Oliver Springs</b>	Street <b>Butler St</b>	Material <b>Concrete Pipe (non-...</b>	Location C... <b>Light High...</b>	Sewer Use <b>Sanitary</b>
Upstream MH <b>B4-2</b>	Total Length <b>343.1</b>	Year Laid	Shape <b>Circular</b>	Location Details	
DS Manhole <b>B4-1</b>	Length surveyed <b>343.1</b>	Year Renewed	Height <b>8</b>	Width <b>8</b>	Pipe Joint... <b>4</b>

SPR <b>7</b>	MPR <b>2</b>	PO Number <b>4397-03</b>	Customer <b>GRW</b>
SPRI <b>3.5</b>	MPRI <b>2</b>	Work Order <b>4397-02</b>	Purpose <b>Pre-Rehabilitation Survey</b>
QSR <b>5121</b>	QMR <b>2100</b>		
OPR <b>9</b>	Surveyed By <b>Charlie Gordon</b>	Direction <b>Downstream</b>	Date <b>20150904</b>
OPRI <b>3</b>	Certificate Number <b>U-615-07000491</b>	Pre-Cleaning <b>Jetting</b>	Time <b>12:06</b>
	Date Cleaned <b>20150904</b>	End Time <b>12:30</b>	Weather <b>Dry</b>
		Additional Info

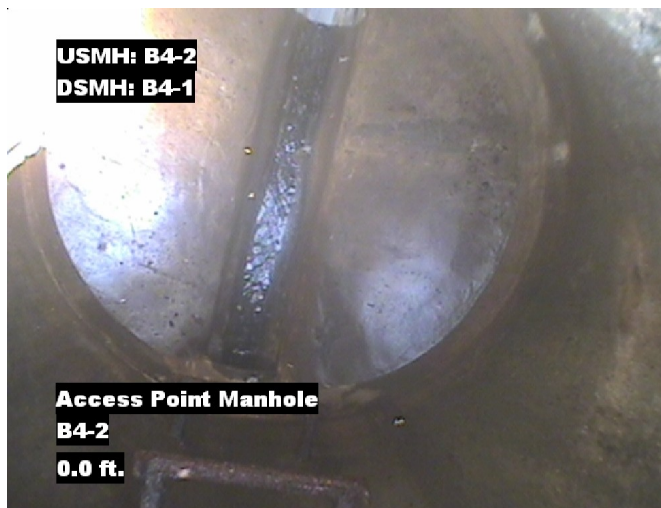
Distance: 0.0 ft. Grade: 0  
Condition: Access Point Manhole  
Remarks: B4-2

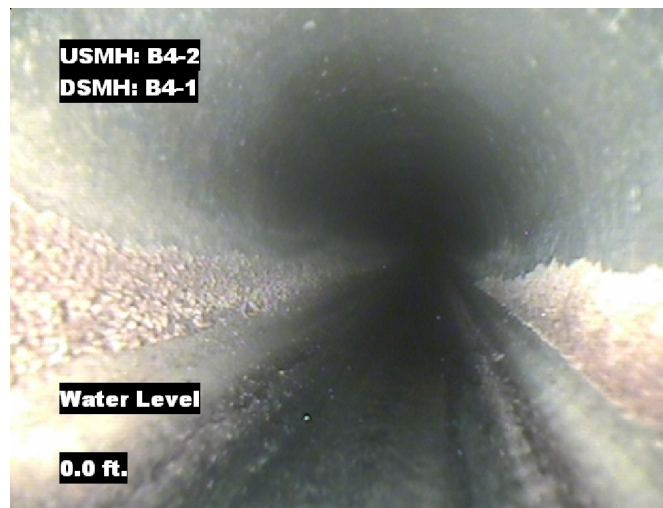
Distance: 0.0 ft. Grade: 0  
Condition: Water Level  
Remarks: N/A

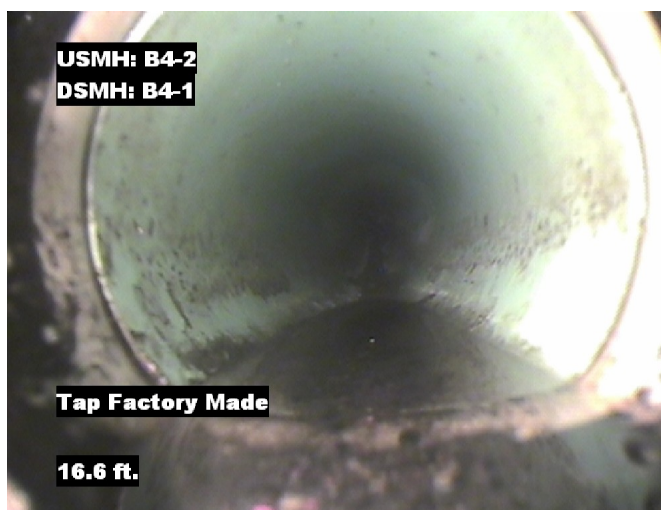
Distance: 16.6 ft. Grade: 0  
Condition: Tap Factory Made  
Remarks: N/A

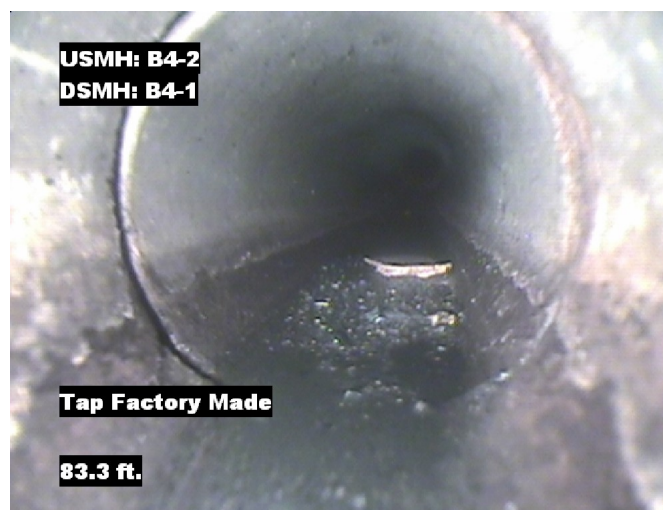
Distance: 83.3 ft. Grade: 0  
Condition: Tap Factory Made  
Remarks: N/A

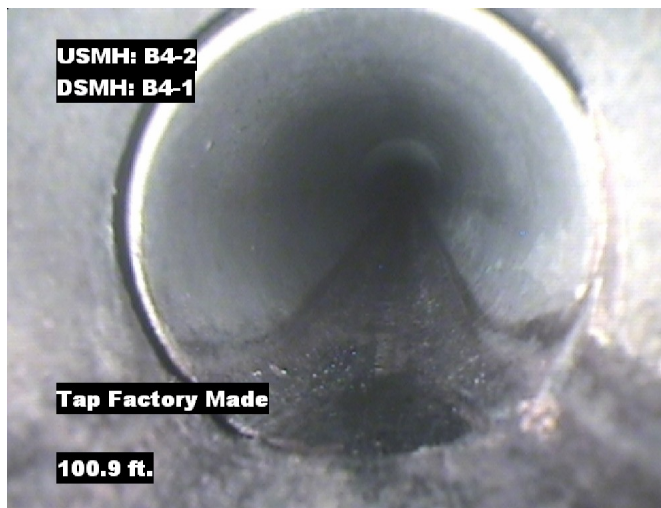
Distance: 100.9 ft. Grade: 0  
Condition: Tap Factory Made  
Remarks: N/A

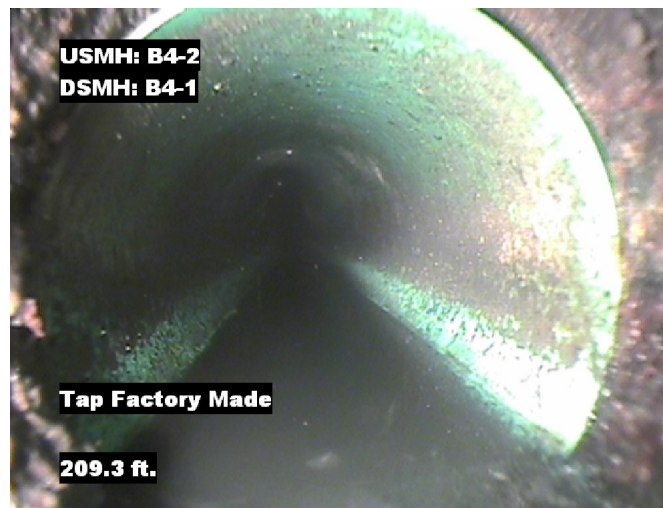
Distance: 209.3 ft. Grade: 0  
Condition: Tap Factory Made  
Remarks: N/A

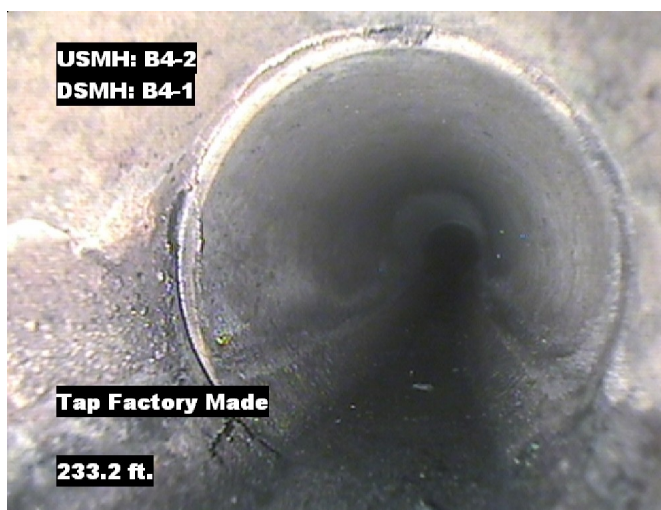
Distance: 233.2 ft. Grade: 0  
Condition: Tap Factory Made  
Remarks: N/A

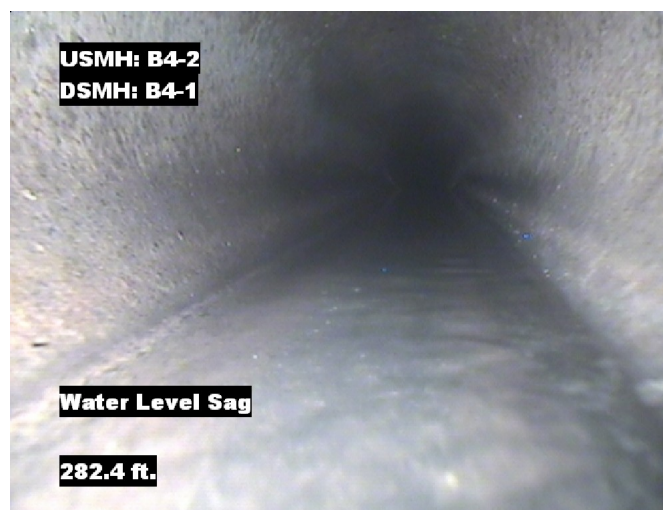
Distance: 282.4 ft. Grade: 2  
Condition: Water Level Sag  
Remarks: N/A

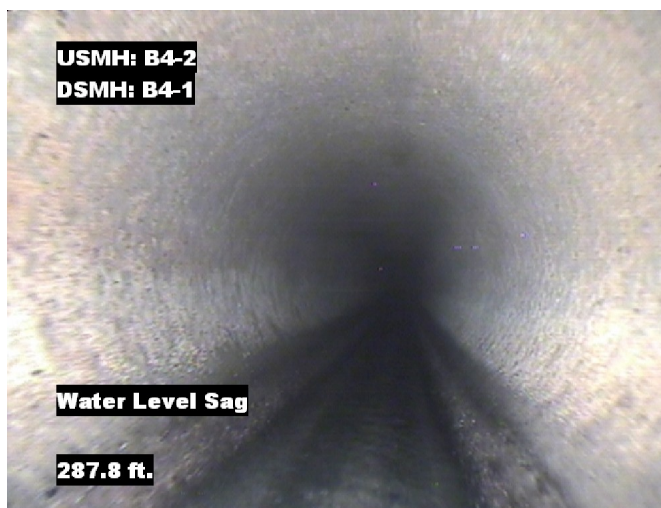
Distance: 287.7 ft. Grade: 2  
Condition: Water Level Sag  
Remarks: N/A

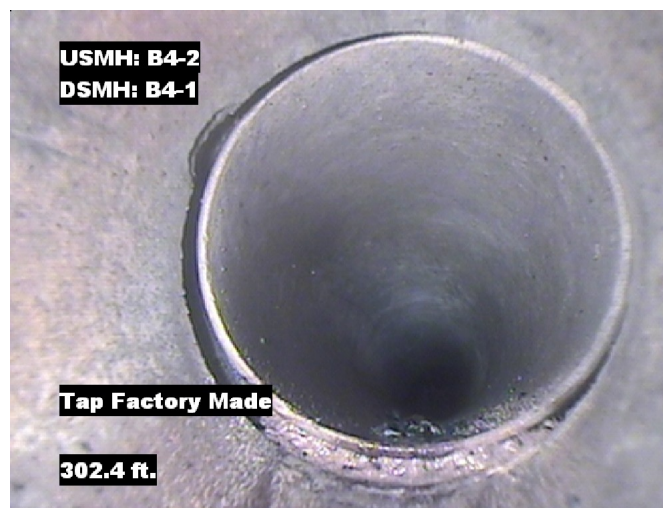
Distance: 302.4 ft. Grade: 0  
Condition: Tap Factory Made  
Remarks: N/A

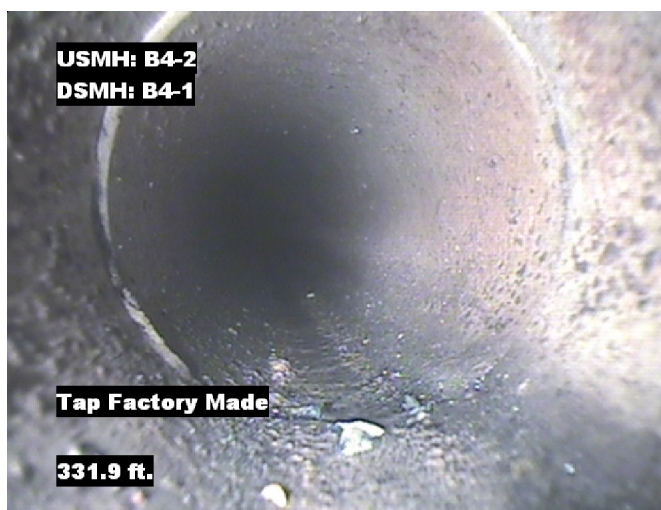
Distance: 331.9 ft. Grade: 0  
Condition: Tap Factory Made  
Remarks: N/A

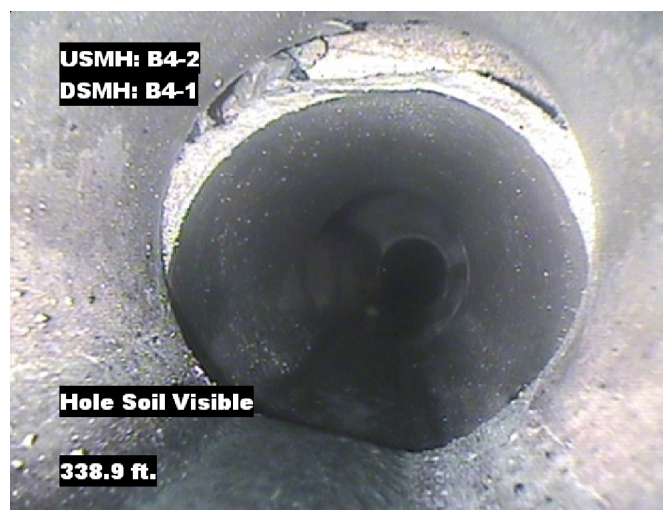
Distance: 338.9 ft. Grade: 5  
Condition: Hole Soil Visible  
Remarks: N/A

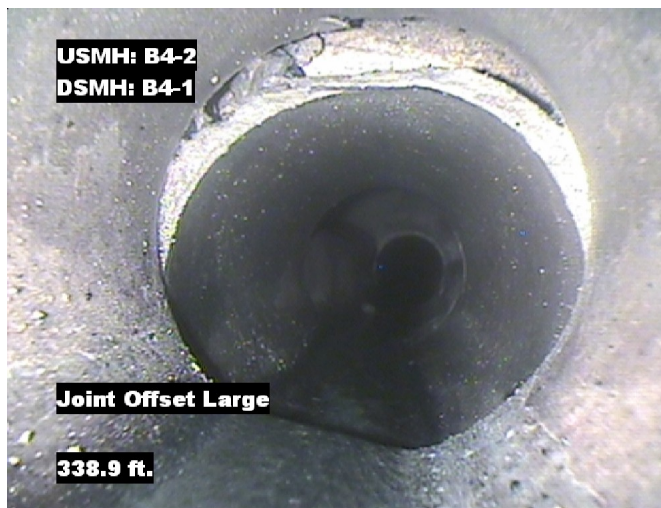
Distance: 338.9 ft. Grade: 2  
Condition: Joint Offset Large  
Remarks: N/A

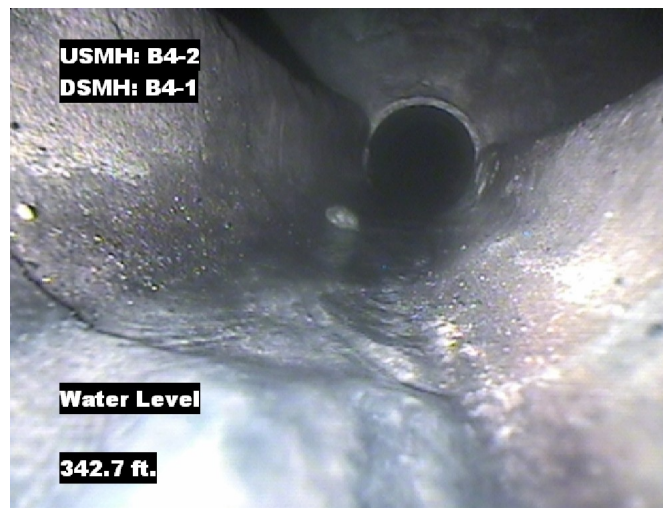
Distance: 342.7 ft. Grade: 0  
Condition: Water Level  
Remarks: N/A

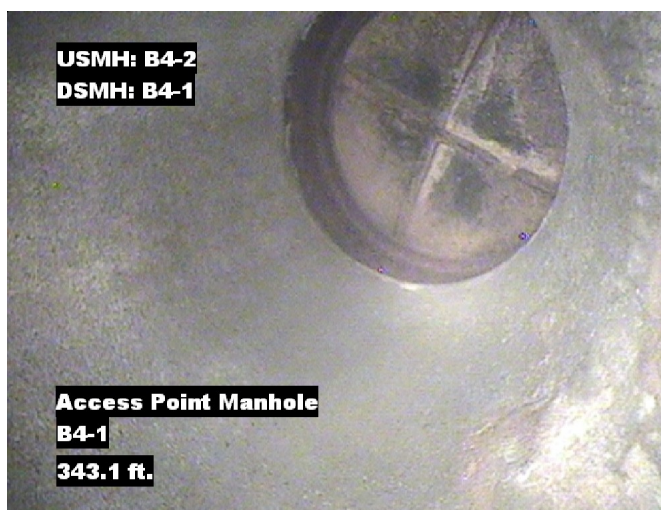
Distance: 343.1 ft. Grade: 0  
Condition: Access Point Manhole  
Remarks: B4-1
