## Defect Listing

Pipe Segment Refere... <b>B4-3_B4-2</b>	City <b>Oliver Springs</b>	Street <b>Butler St</b>	Material <b>Fibreglass Reinforc...</b>	Location C... <b>Light High...</b>	Sewer Use <b>Sanitary</b>
Upstream MH <b>B4-3</b>	Total Length <b>226.8</b>	Year Laid	Shape <b>Circular</b>	Location Details	
DS Manhole <b>B4-2</b>	Length surveyed <b>226.8</b>	Year Renewed	Height <b>8</b>	Width <b>8</b>	Pipe Joint... <b>N/A</b>

SPR <b>N/A</b>	MPR <b>N/A</b>	PO Number <b>4397-03</b>	Customer <b>GRW</b>
SPRI <b>N/A</b>	MPRI <b>N/A</b>	Work Order <b>4397-02</b>	Purpose <b>Pre-Rehabilitation Survey</b>
QSR <b>N/A</b>	QMR <b>N/A</b>		
OPR <b>N/A</b>	Surveyed By <b>Charlie Gordon</b>	Direction <b>Downstream</b>	Date <b>20150904</b>
OPRI <b>N/A</b>	Certificate Number <b>U-615-07000491</b>	Pre-Cleaning <b>Jetting</b>	Time <b>11:35</b>
	Date Cleaned <b>20150904</b>	End Time <b>11:51</b>	Weather <b>Dry</b>
			Additional Info

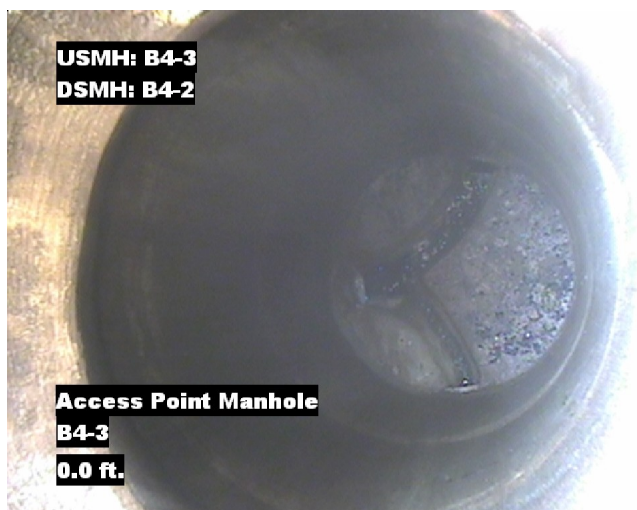
Distance: 0.0 ft. Grade: 0  
Condition: Access Point Manhole  
Remarks: B4-3

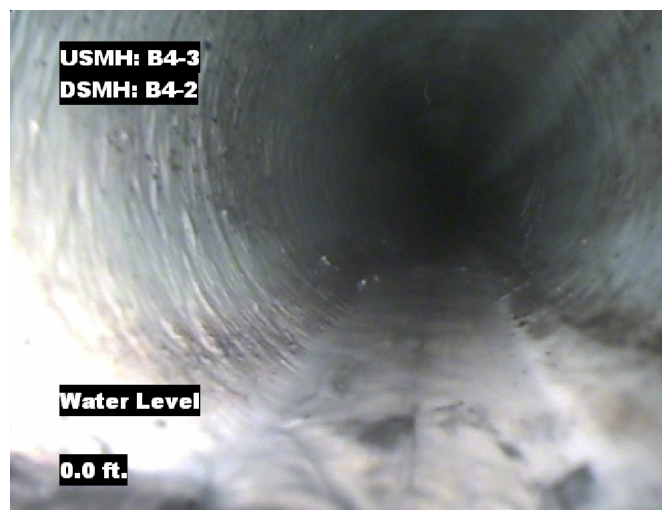
Distance: 0.0 ft. Grade: 0  
Condition: Water Level  
Remarks: N/A

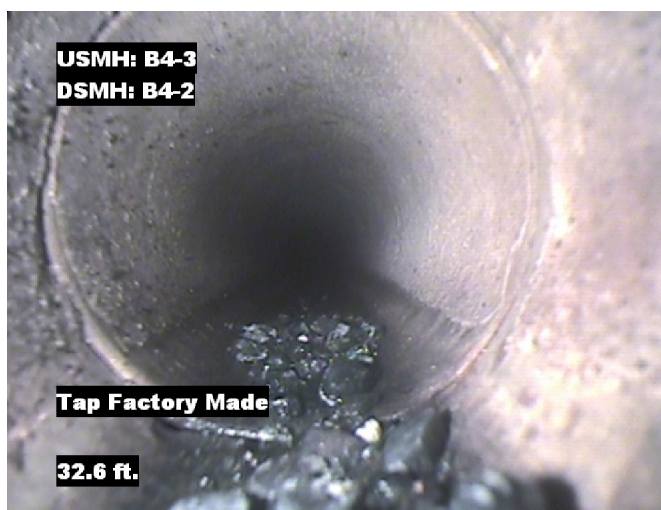
Distance: 32.6 ft. Grade: 0  
Condition: Tap Factory Made  
Remarks: N/A

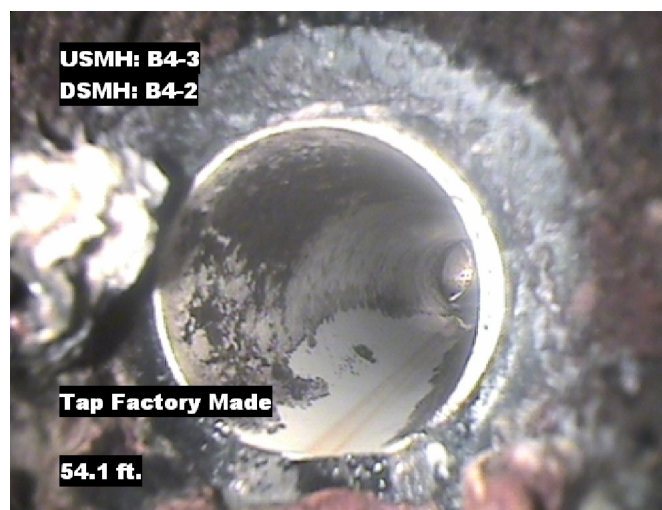
Distance: 54.1 ft. Grade: 0  
Condition: Tap Factory Made  
Remarks: N/A

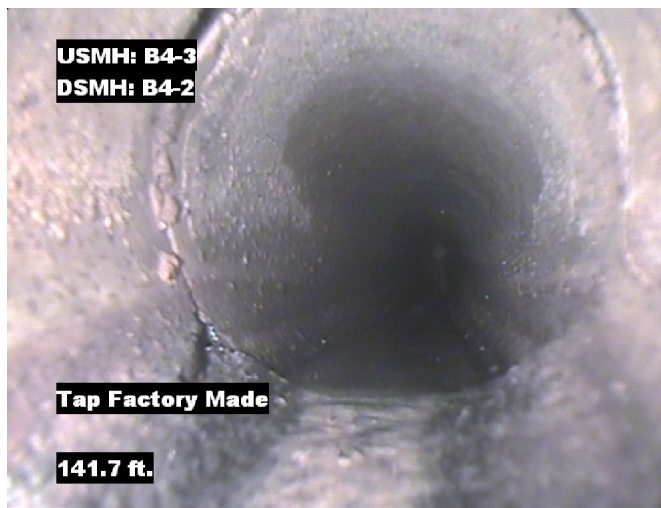
Distance: 141.7 ft. Grade: 0  
Condition: Tap Factory Made  
Remarks: N/A

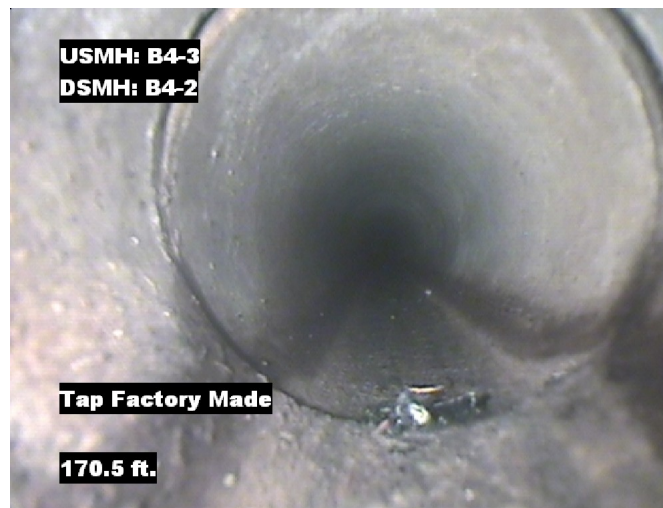
Distance: 170.5 ft. Grade: 0  
Condition: Tap Factory Made  
Remarks: N/A

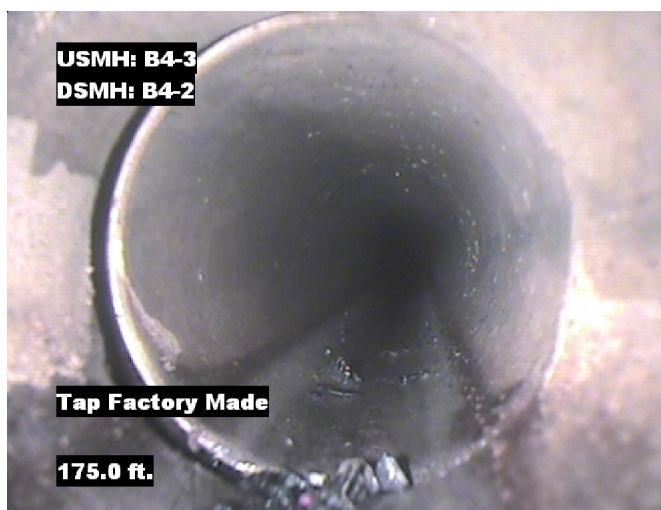
Distance: 175.0 ft. Grade: 0  
Condition: Tap Factory Made  
Remarks: N/A

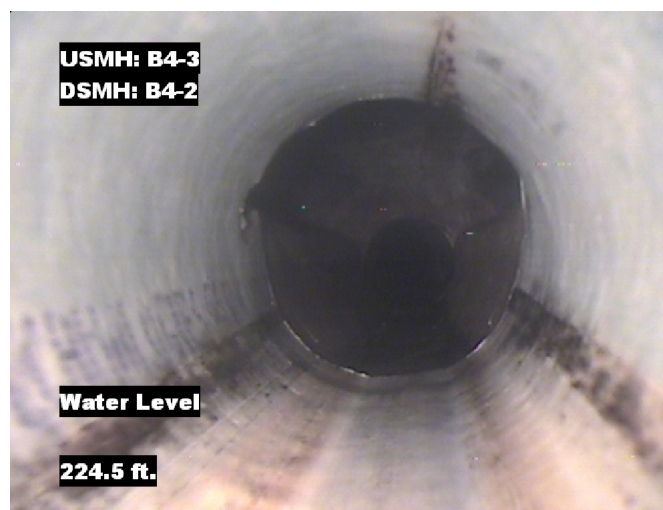
Distance: 224.5 ft. Grade: 0  
Condition: Water Level  
Remarks: N/A

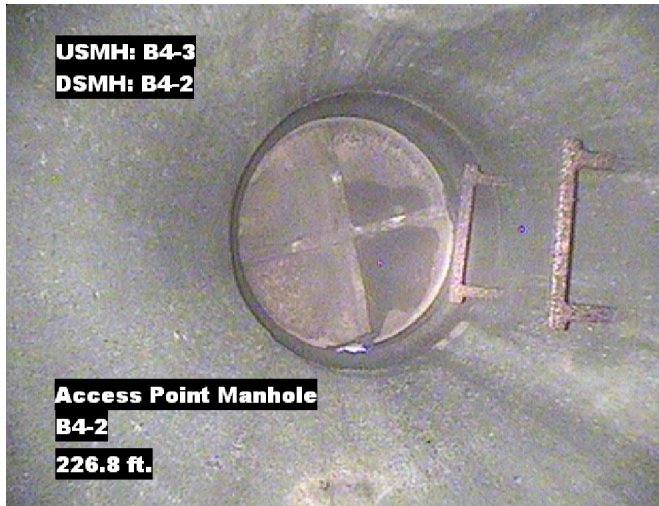
Distance: 226.8 ft. Grade: 0  
Condition: Access Point Manhole  
Remarks: B4-2
