Pipe Segment Refere		City		Street	Mat	Material		Sewer Use	
B4-4_B4-3 Upstream MH		Oliver Springs		Kansas ST	Concrete F	Concrete Pipe (non		Sanitary	
		Total	_ength	Year Laid	Sha	ape	Location	n Details	
B4	1-4	21	3.2		Circ	ular			
DS Ma	anhole	Length :	surveyed	Year Renewed	Height	Width	Width Pipe Joint		
B4	1-3	21	3.2		8	8 8 4			
SPR	3	MPR	16	PO Number 4397-03		Customer GRW			
-									
SPRI	3	MPRI	2	Work Order					
QSR	3100	QMR	2800	4397-02		Pre-Rehabilitation Survey			
OF	PR	Surveyed By		Direction	Da	Date		a label	
1	9	Charlie_Gordon		Downstream	2015	20150904			
OF	PRI	Certificate Number		Pre-Cleaning	Tir	Time			
2.1		U-615-07000491		Jetting 13		13:05			
		Date C	leaned	End	End Time		Additional Info		
		2015	0904	13:18

Image Report 4/Page

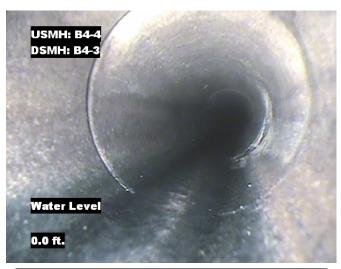
Distance: 0.0 ft. Grade: 0

Condition: Water Level

Remarks: N/A

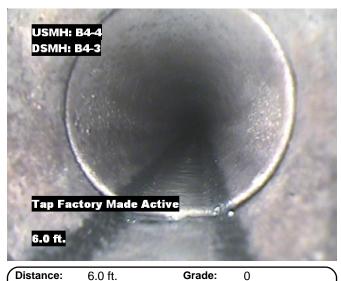
Distance:6.0 ft.Grade:Condition:Tap Factory Made Active

Remarks: N/A

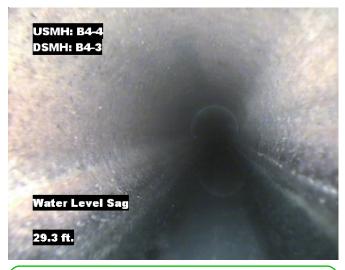
Distance: 29.2 ft. Grade: 2

Condition: Water Level Sag

Remarks: N/A

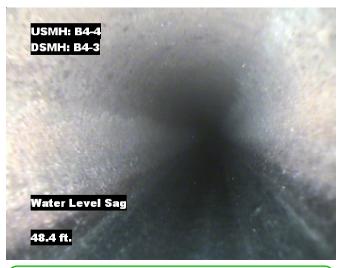
Distance: 48.2 ft. Grade: 2

Condition: Water Level Sag

Remarks: N/A

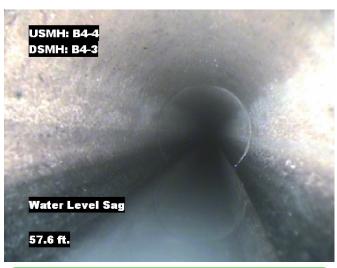
Distance: 57.5 ft. Grade: 2

Condition: Water Level Sag

Remarks: N/A

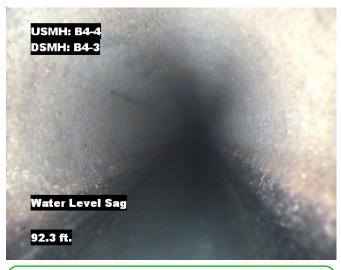
Distance: 92.2 ft. Grade: 2

Condition: Water Level Sag

Remarks: N/A

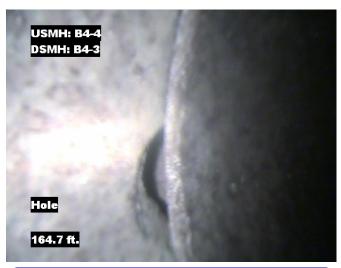
Distance: 164.7 ft. Grade: 3

Condition: Hole Remarks: N/A

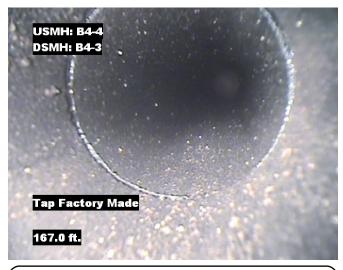
Distance: 167.0 ft. Grade: 0

Condition: Tap Factory Made

Remarks: N/A

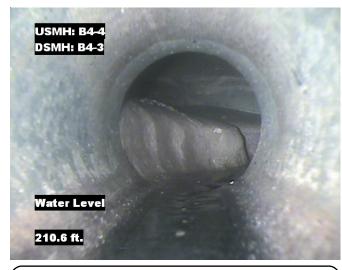
Distance: 210.6 ft. Grade: 0

Condition: Water Level

Remarks: N/A

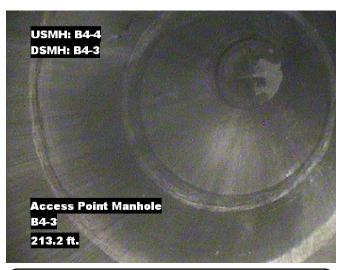
Distance: 213.2 ft. Grade: 0

Condition: Access Point Manhole

Remarks: B4-3
