Defect Listing

Pipe Segment Refere... B4-5_B4-4	City Oliver Springs	Street Wilson	Material Concrete Pipe (non-...	Location C... Light High...	Sewer Use Sanitary
Upstream MH B4-5	Total Length 249.1	Year Laid	Shape Circular	Location Details	
DS Manhole B4-4	Length surveyed 92.2	Year Renewed	Height 8	Width 8	Pipe Joint... 4

SPR 8	MPR 4	PO Number 4397-03	Customer GRW
SPRI 2.7	MPRI 2	Work Order 4397-02	Purpose Pre-Rehabilitation Survey
QSR 5121	QMR 2200		
OPR 12	Surveyed By Charlie Gordon	Direction Upstream	Date 20150904
OPRI 2.4	Certificate Number U-615-07000491	Pre-Cleaning Jetting	Time 10:59
	Date Cleaned 20150904	End Time 11:10	Weather Dry
		Additional Info

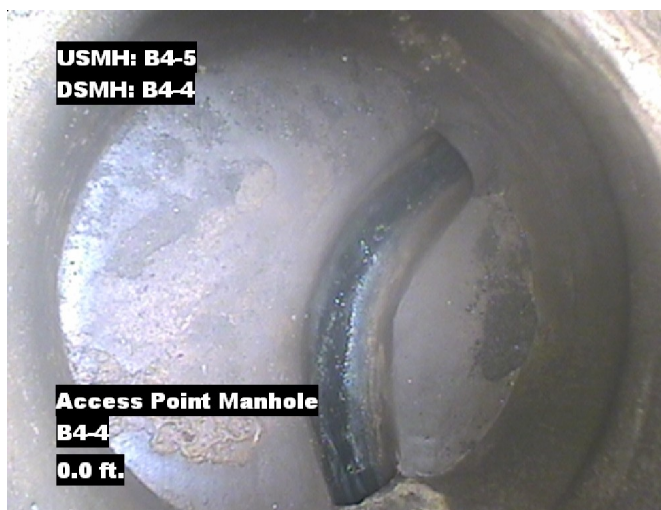
Distance: 0.0 ft. Grade: 0
Condition: Access Point Manhole
Remarks: B4-4

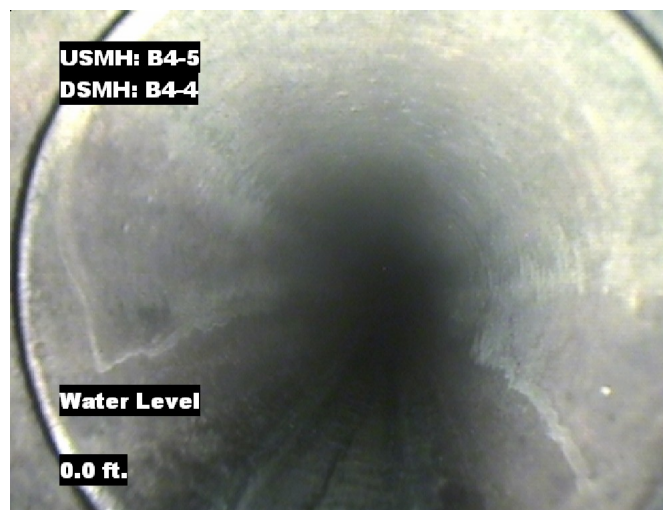
Distance: 0.0 ft. Grade: 0
Condition: Water Level
Remarks: N/A

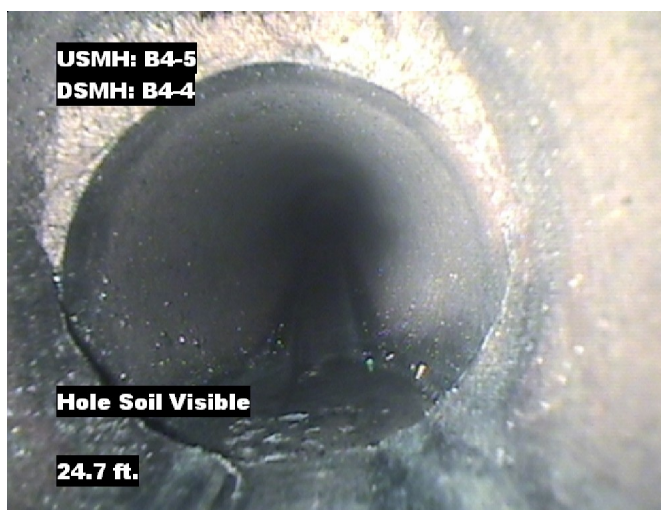
Distance: 24.7 ft. Grade: 5
Condition: Hole Soil Visible
Remarks: N/A

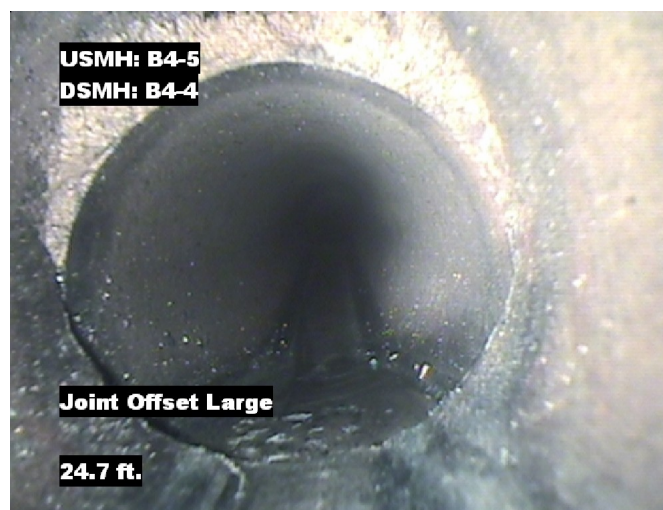
Distance: 24.7 ft. Grade: 2
Condition: Joint Offset Large
Remarks: N/A

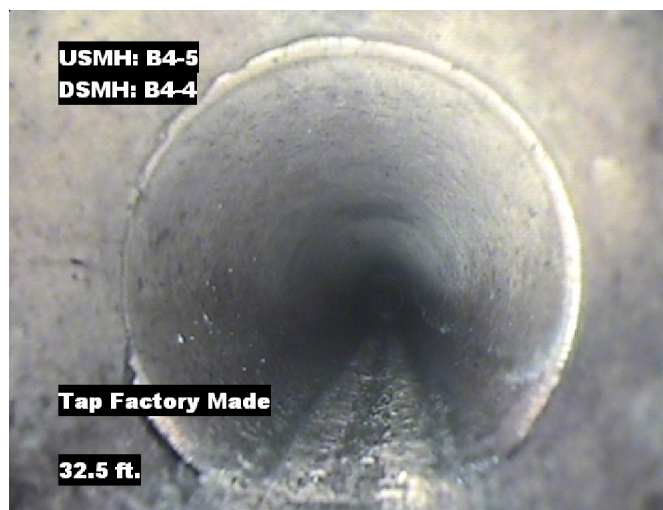
Distance: 32.5 ft. Grade: 0
Condition: Tap Factory Made
Remarks: N/A

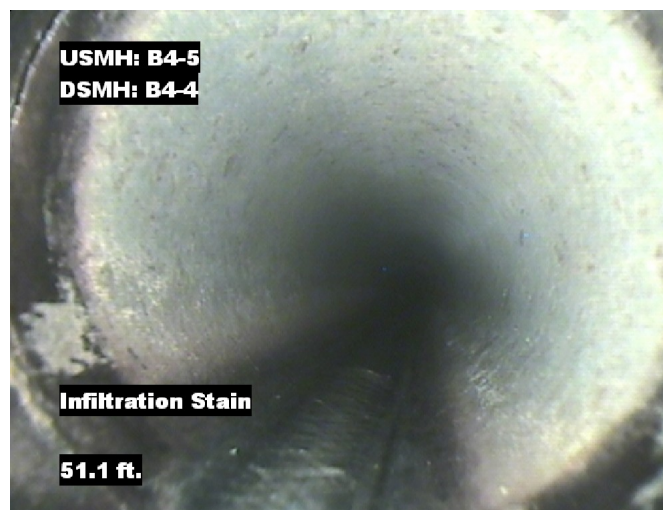
Distance: 51.1 ft. Grade: 0
Condition: Infiltration Stain
Remarks: N/A

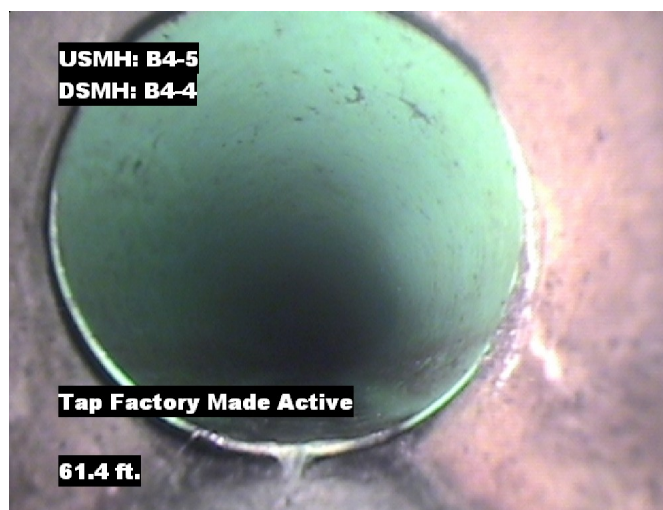
Distance: 61.4 ft. Grade: 0
Condition: Tap Factory Made Active
Remarks: N/A

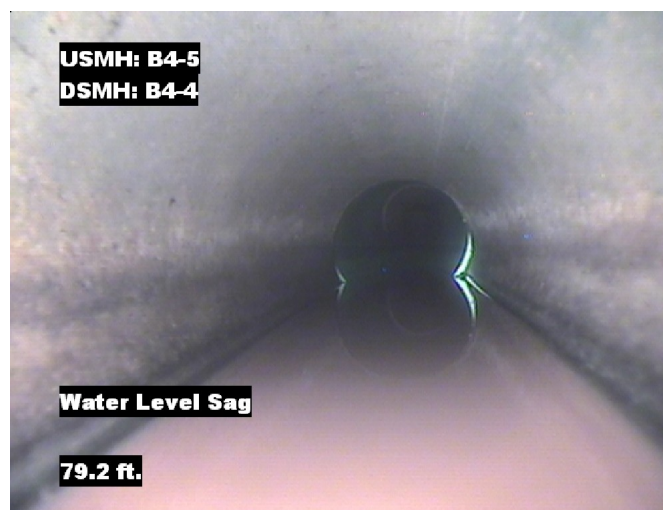
Distance: 79.1 ft. Grade: 2
Condition: Water Level Sag
Remarks: N/A

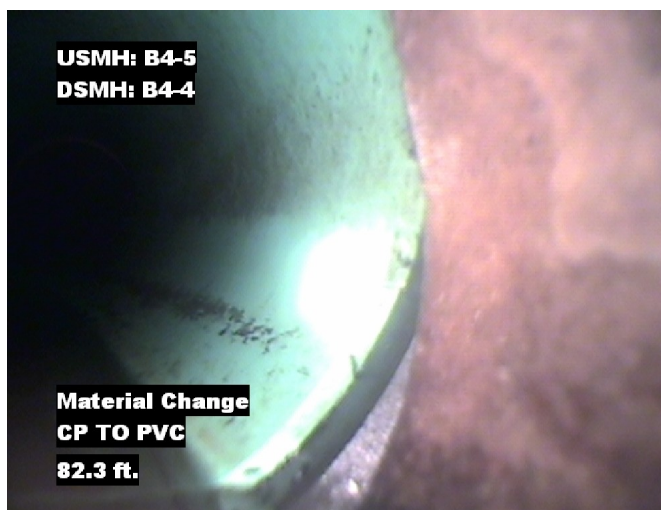
Distance: 82.3 ft. Grade: 0
Condition: Material Change
Remarks: CP TO PVC

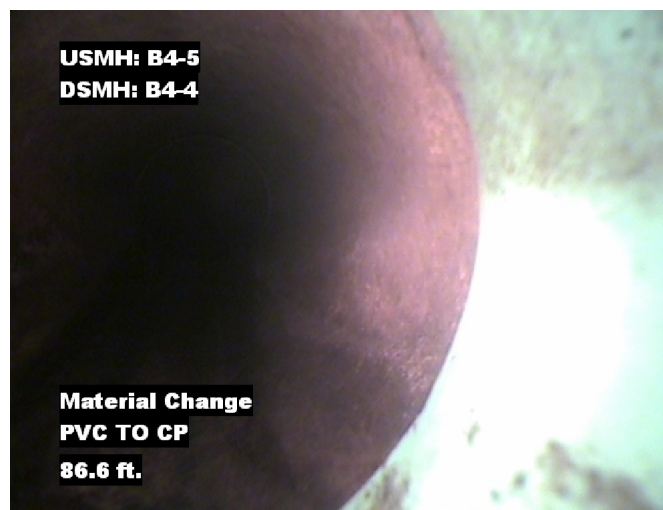
Distance: 86.6 ft. Grade: 0
Condition: Material Change
Remarks: PVC TO CP

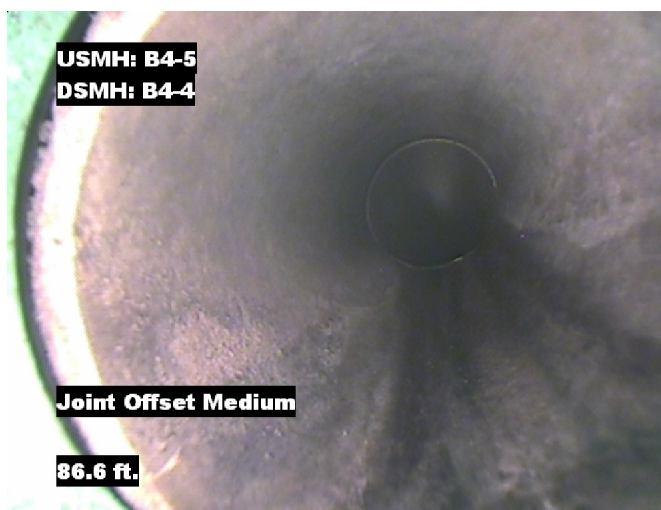
Distance: 86.6 ft. Grade: 1
Condition: Joint Offset Medium
Remarks: N/A

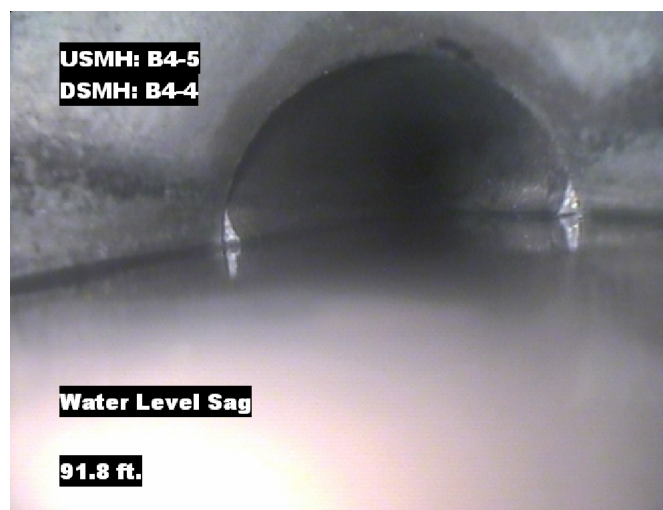
Distance: 91.8 ft. Grade: 2
Condition: Water Level Sag
Remarks: N/A

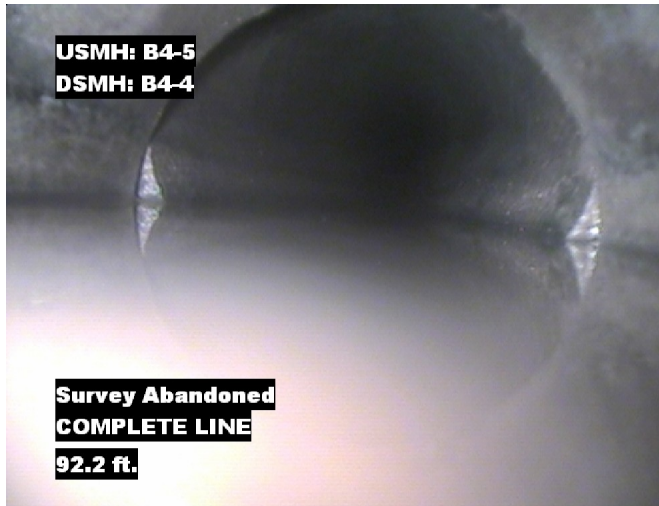
Distance: 92.2 ft. Grade: 0
Condition: Survey Abandoned
Remarks: COMPLETE LINE
