Defect Listing

Pipe Segment Refere... B4-6_B4-5	City Oliver Springs	Street wilson Rd	Material Concrete Pipe (non-...	Location C... Light High...	Sewer Use Sanitary
Upstream MH B4-6	Total Length 160.2	Year Laid	Shape Circular	Location Details	
DS Manhole B4-5	Length surveyed 160.2	Year Renewed	Height 8	Width 8	Pipe Joint... 4

SPR N/A	MPR 2	PO Number 4397-03	Customer GRW
SPRI N/A	MPRI 2	Work Order 4397-02	Purpose Pre-Rehabilitation Survey
QSR N/A	QMR 2100		
OPR 2	Surveyed By Charlie Gordon	Direction Upstream	Date 20150904
OPRI 2	Certificate Number U-615-07000491	Pre-Cleaning Jetting	Time 10:09
	Date Cleaned 20150904	End Time 10:20	Weather Dry
		Additional Info

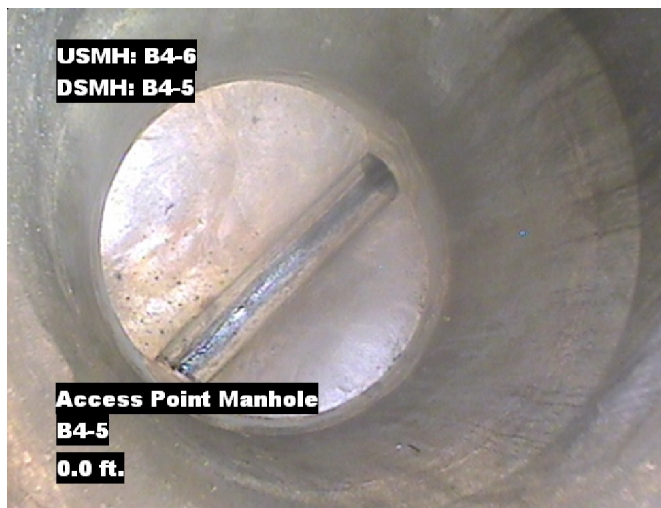
Distance: 0.0 ft. Grade: 0
Condition: Access Point Manhole
Remarks: B4-5

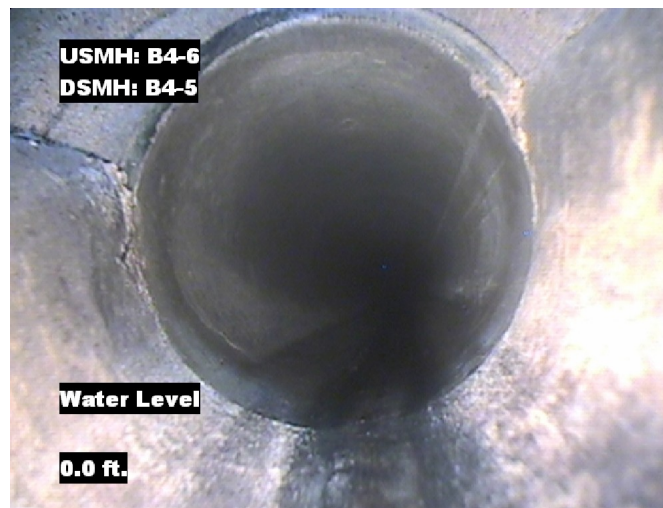
Distance: 0.0 ft. Grade: 0
Condition: Water Level
Remarks: N/A

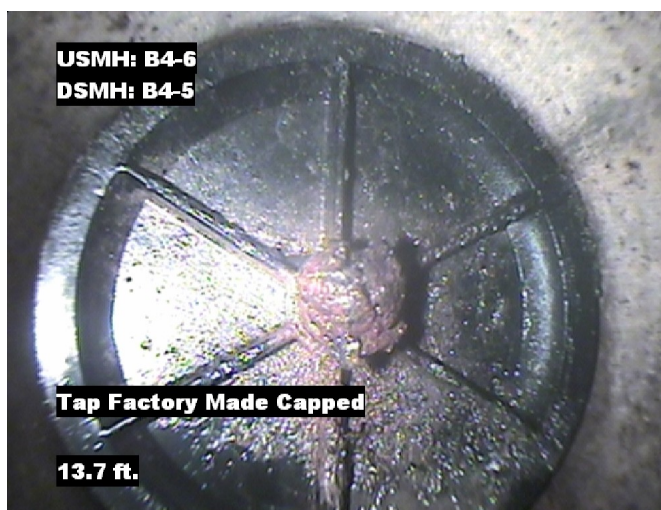
Distance: 13.7 ft. Grade: 0
Condition: Tap Factory Made Capped
Remarks: N/A

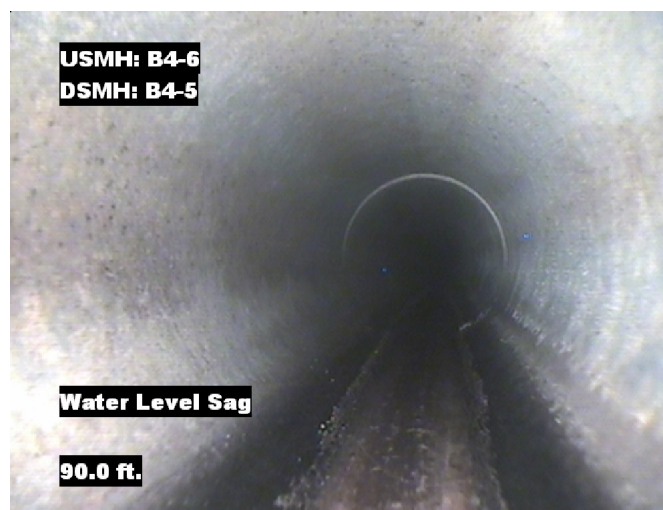
Distance: 90.0 ft. Grade: 2
Condition: Water Level Sag
Remarks: N/A

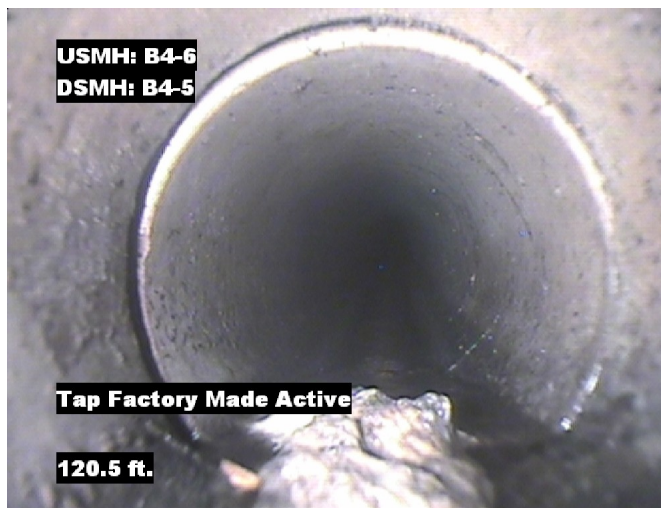
Distance: 120.5 ft. Grade: 0
Condition: Tap Factory Made Active
Remarks: N/A

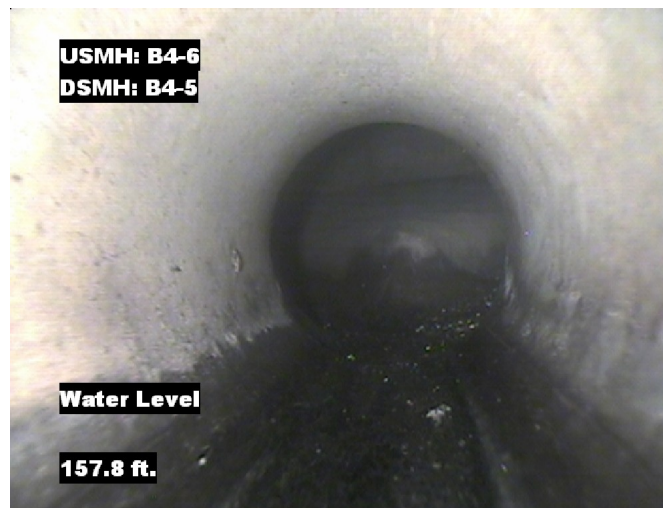
Distance: 157.7 ft. Grade: 0
Condition: Water Level
Remarks: N/A

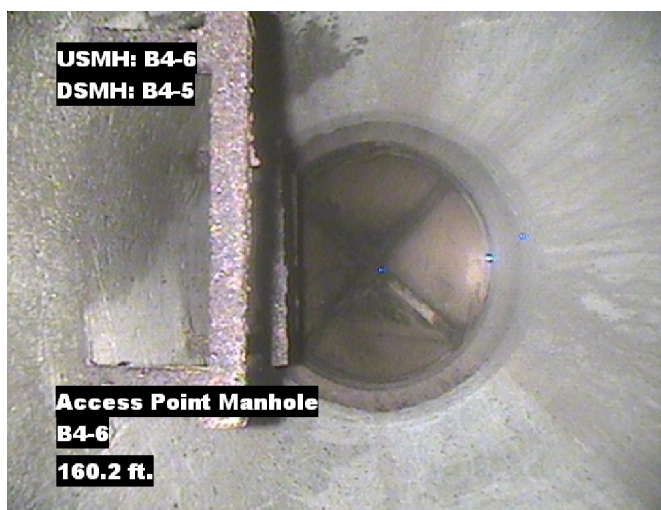
Distance: 160.2 ft. Grade: 0
Condition: Access Point Manhole
Remarks: B4-6
