## Defect Listing

Pipe Segment Refere... <b>B5-1_B-21</b>	City <b>Oliver Springs</b>	Street <b>Highway#61</b>	Material <b>Fibreglass Reinforc...</b>	Location C... <b>Main Highw...</b>	Sewer Use <b>Sanitary</b>
Upstream MH <b>B5-1</b>	Total Length <b>41.9</b>	Year Laid	Shape <b>Circular</b>	Location Details	
DS Manhole <b>B-21</b>	Length surveyed <b>41.9</b>	Year Renewed	Height <b>8</b>	Width <b>8</b>	Pipe Joint... <b>N/A</b>

SPR <b>N/A</b>	MPR <b>N/A</b>	PO Number <b>4397-03</b>		Customer <b>GRW</b>	
SPRI <b>N/A</b>	MPRI <b>N/A</b>	Work Order <b>4397-02</b>		Purpose <b>Pre-Rehabilitation Survey</b>	
QSR <b>N/A</b>	QMR <b>N/A</b>				
OPR <b>N/A</b>	Surveyed By <b>Charlie_Gordon</b>	Direction <b>Upstream</b>	Date <b>20150904</b>	Media label	
OPRI <b>N/A</b>	Certificate Number <b>U-615-07000491</b>	Pre-Cleaning <b>Jetting</b>	Time <b>09:08</b>	Weather <b>Dry</b>	
Date Cleaned <b>20150904</b>			End Time <b>09:13</b>	Additional Info

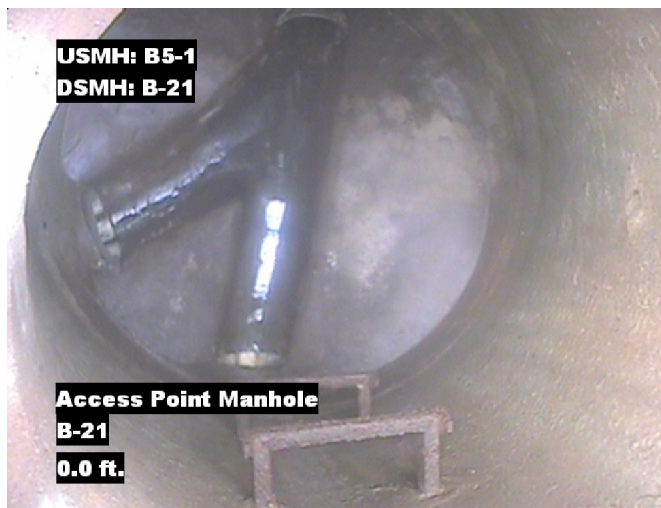
Distance: 0.0 ft. Grade: 0  
Condition: Access Point Manhole  
Remarks: B-21

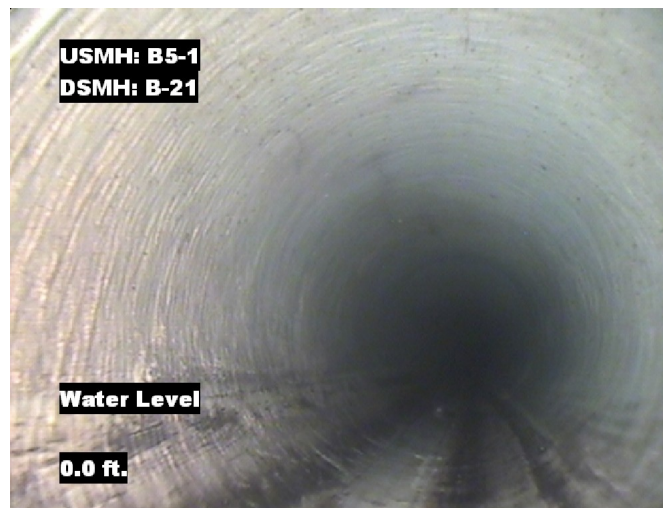
Distance: 0.0 ft. Grade: 0  
Condition: Water Level  
Remarks: N/A

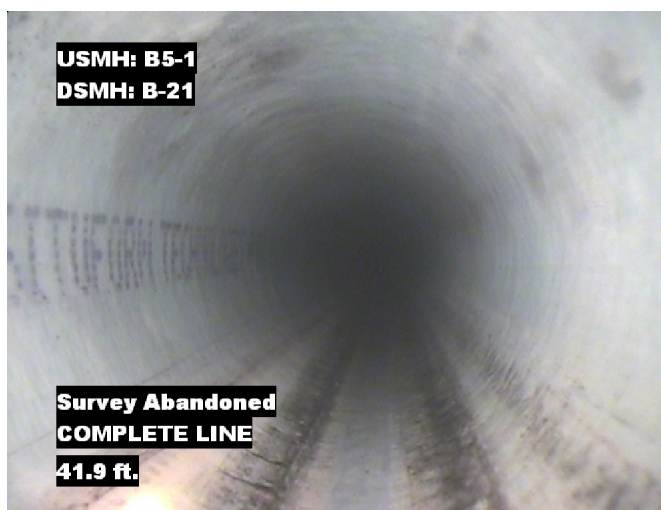
Distance: 41.9 ft. Grade: 0  
Condition: Survey Abandoned  
Remarks: COMPLETE LINE
