Defect Listing

Pipe Segment Refere... B5-2 B5-1	City Oliver Springs	Street Highway #61	Material Concrete Pipe (non-...	Location C... Main Highw...	Sewer Use Sanitary
Upstream MH B5-2	Total Length 339.5	Year Laid	Shape Circular	Location Details	
DS Manhole B5-1	Length surveyed 339.5	Year Renewed	Height 8	Width 8	Pipe Joint... 4

SPR N/A	MPR 4	PO Number 4397-03	Customer GRW
SPRI N/A	MPRI 2	Work Order 4397-02	Purpose Pre-Rehabilitation Survey
QSR N/A	QMR 2200		
OPR 4	Surveyed By Charlie Gordon	Direction Upstream	Date 20150904
OPRI 2	Certificate Number U-615-07000491	Pre-Cleaning Jetting	Time 07:15
	Date Cleaned 20150904	End Time 07:39	Weather Dry
			Media label
			Additional Info

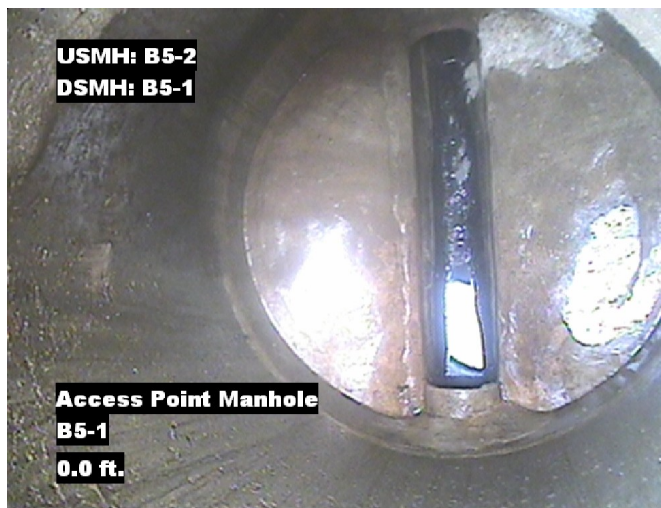
Distance: 0.0 ft. Grade: 0
Condition: Access Point Manhole
Remarks: B5-1

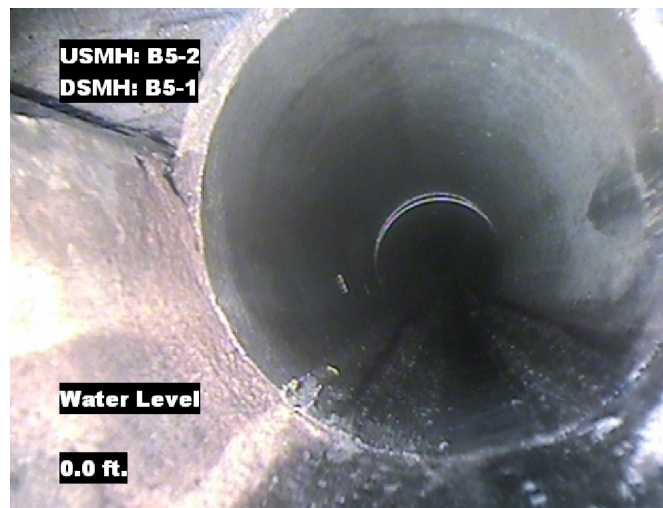
Distance: 0.0 ft. Grade: 0
Condition: Water Level
Remarks: N/A

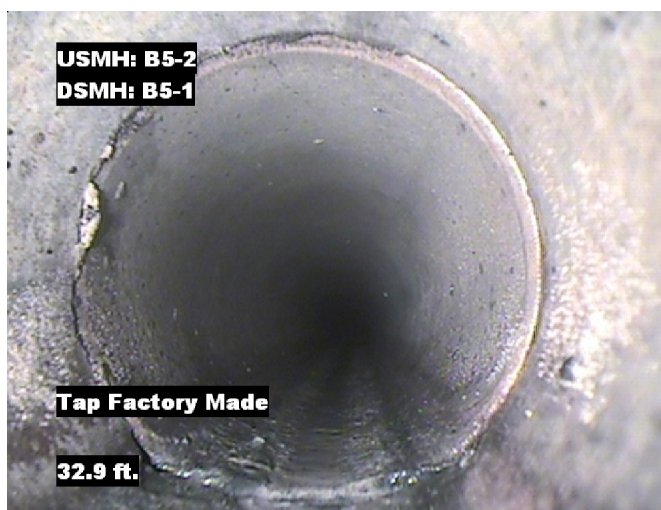
Distance: 32.9 ft. Grade: 0
Condition: Tap Factory Made
Remarks: N/A

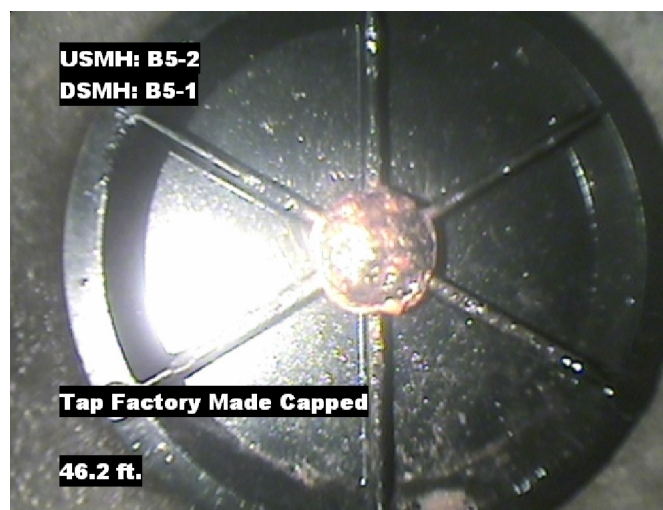
Distance: 46.2 ft. Grade: 0
Condition: Tap Factory Made Capped
Remarks: N/A

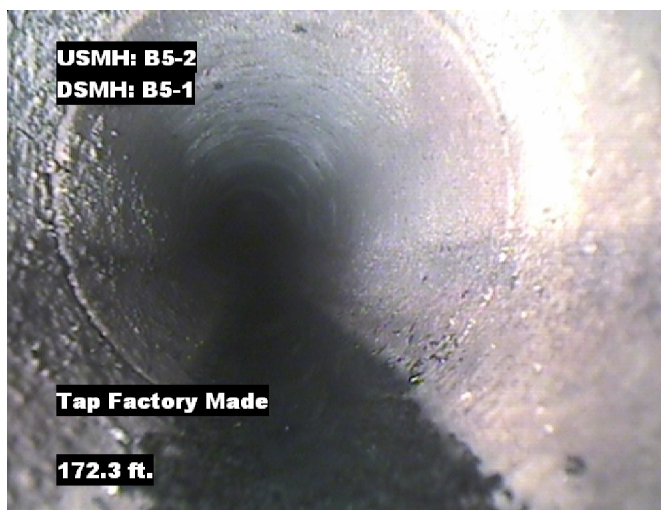
Distance: 172.3 ft. Grade: 0
Condition: Tap Factory Made
Remarks: N/A

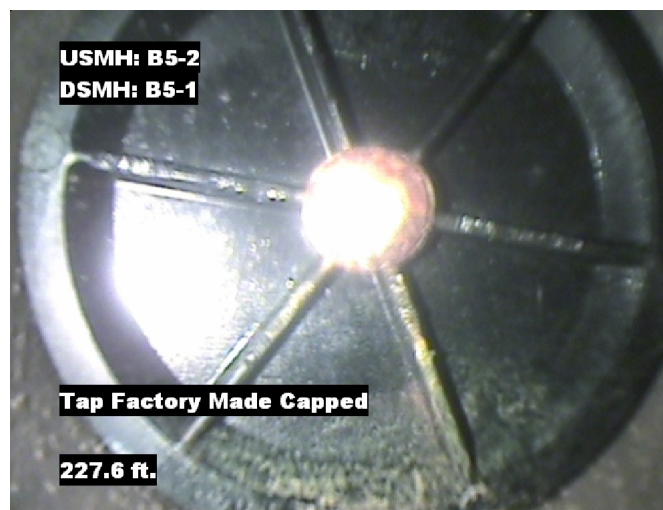
Distance: 227.6 ft. Grade: 0
Condition: Tap Factory Made Capped
Remarks: N/A

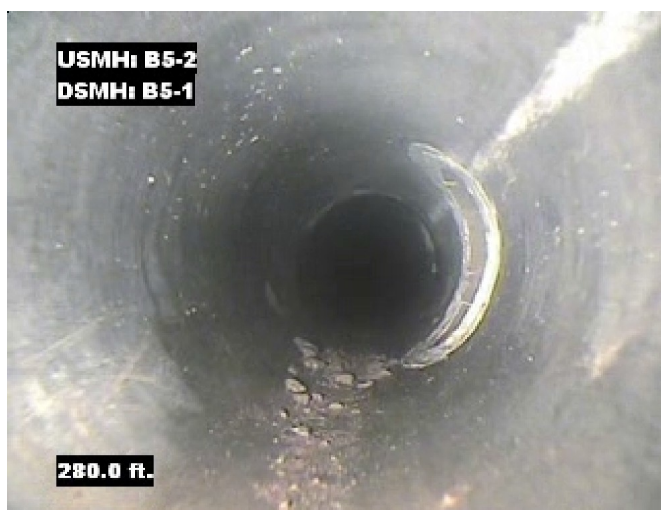
Distance: 279.8 ft. Grade: 2
Condition: Deposits Settled Fine
Remarks: N/A

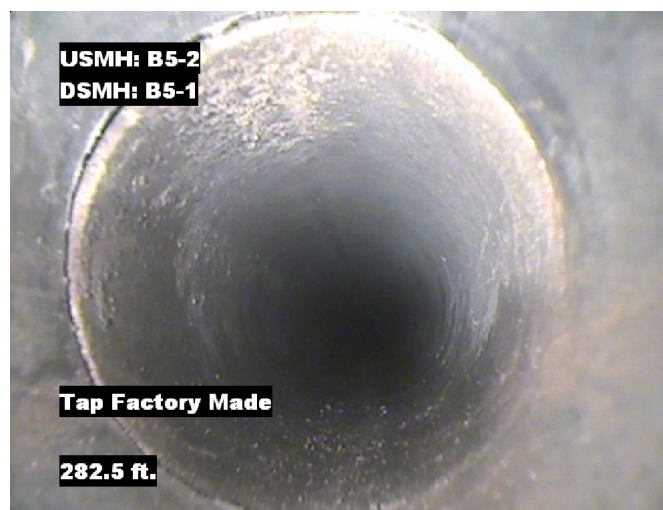
Distance: 282.5 ft. Grade: 0
Condition: Tap Factory Made
Remarks: N/A

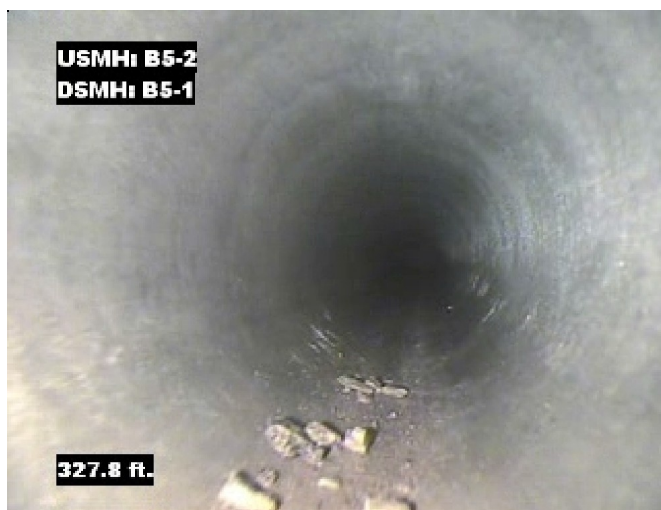
Distance: 327.8 ft. Grade: 2
Condition: Deposits Settled Gravel
Remarks: N/A

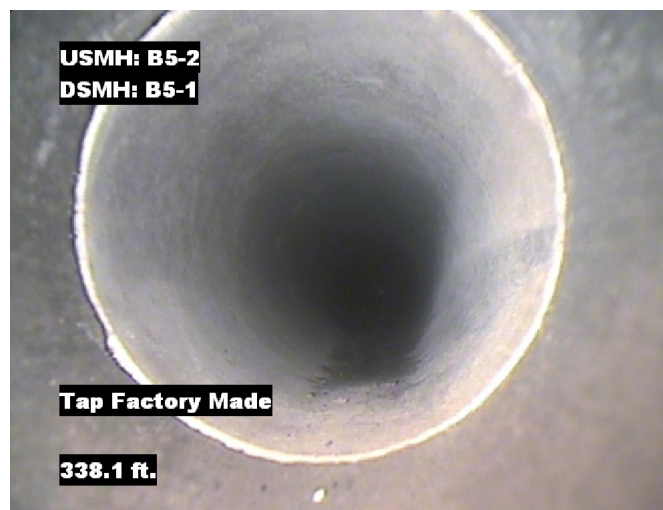
Distance: 338.1 ft. Grade: 0
Condition: Tap Factory Made
Remarks: N/A

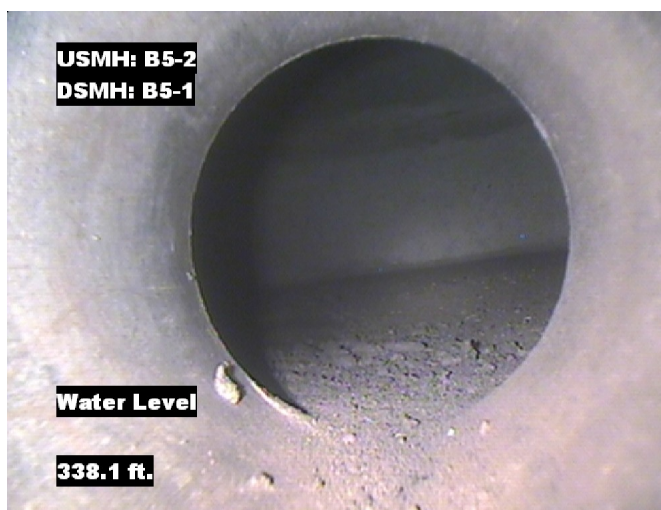
Distance: 338.1 ft. Grade: 0
Condition: Water Level
Remarks: N/A

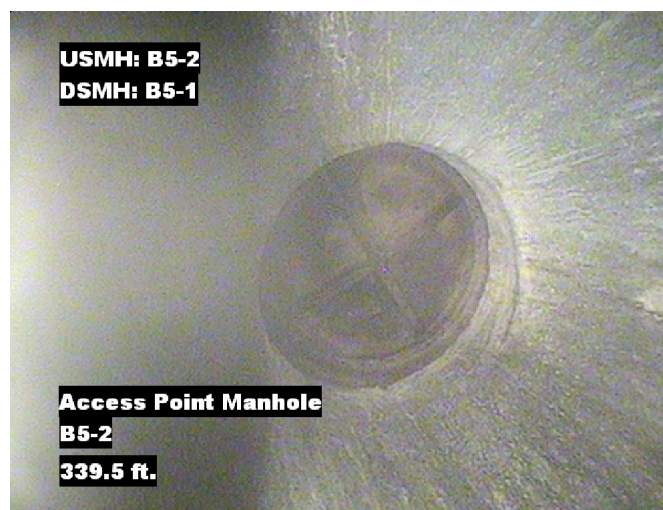
Distance: 339.5 ft. Grade: 0
Condition: Access Point Manhole
Remarks: B5-2
