## Defect Listing

Pipe Segment Refere... <b>C-10_C-9</b>	City <b>Oliver Springs</b>	Street <b>Shoopman Dr</b>	Material <b>Fibreglass Reinforc...</b>	Location C... <b>Easement/R...</b>	Sewer Use <b>Sanitary</b>
Upstream MH <b>C-10</b>	Total Length <b>356.7</b>	Year Laid	Shape <b>Circular</b>	Location Details	
DS Manhole <b>C-9</b>	Length surveyed <b>356.7</b>	Year Renewed	Height <b>8</b>	Width <b>8</b>	Pipe Joint... <b>N/A</b>

SPR <b>3</b>	MPR <b>44</b>	PO Number <b>4397-03</b>	Customer <b>GRW</b>
SPRI <b>3</b>	MPRI <b>4</b>	Work Order <b>4397-02</b>	Purpose <b>Pre-Rehabilitation Survey</b>
QSR <b>3100</b>	QMR <b>4A00</b>		
OPR <b>47</b>	Surveyed By <b>Barry Rogers</b>	Direction <b>Downstream</b>	Date <b>20150723</b>
OPRI <b>3.9</b>	Certificate Number <b>U-1012-16405</b>	Pre-Cleaning <b>Jetting</b>	Time <b>09:34</b>
	Date Cleaned <b>20150723</b>	End Time <b>09:51</b>	Weather <b>Heavy Rain</b>
			Media label
			Additional Info

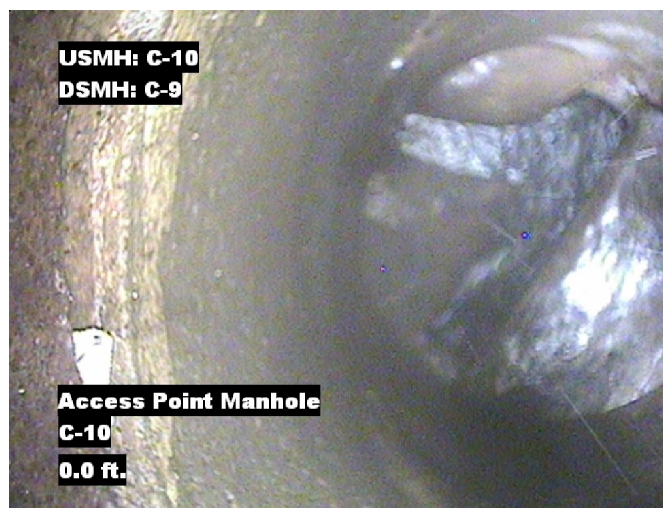
Distance: 0.0 ft. Grade: 0  
Condition: Access Point Manhole  
Remarks: C-10

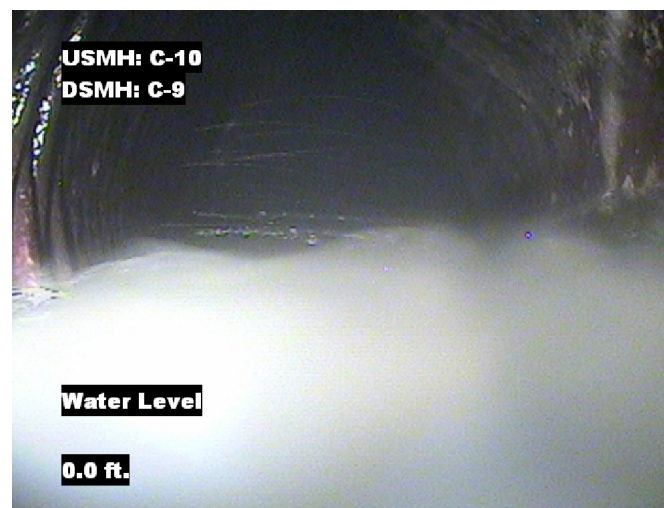
Distance: 0.0 ft. Grade: 0  
Condition: Water Level  
Remarks: N/A

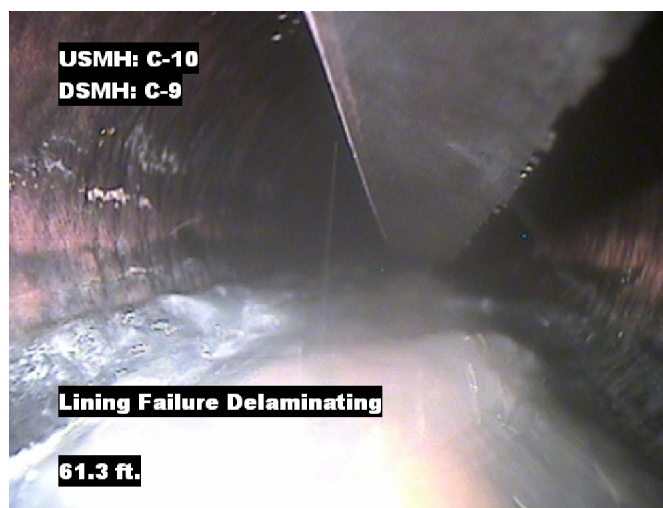
Distance: 61.3 ft. Grade: 3  
Condition: Lining Failure Delaminating  
Remarks: N/A

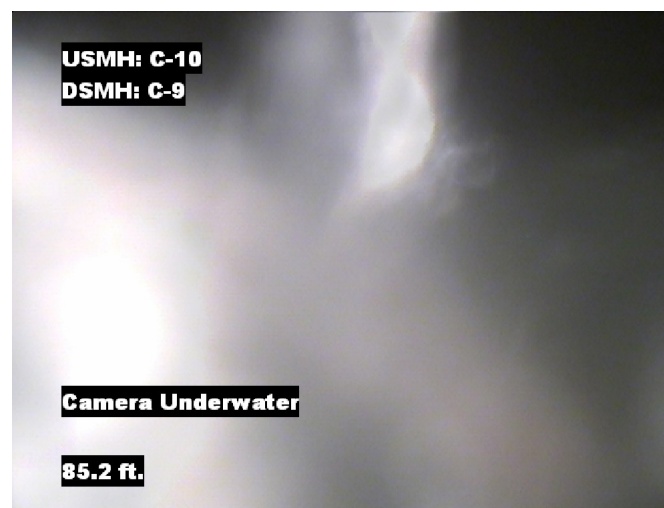
Distance: 85.2 ft. Grade: 4  
Condition: Camera Underwater  
Remarks: N/A

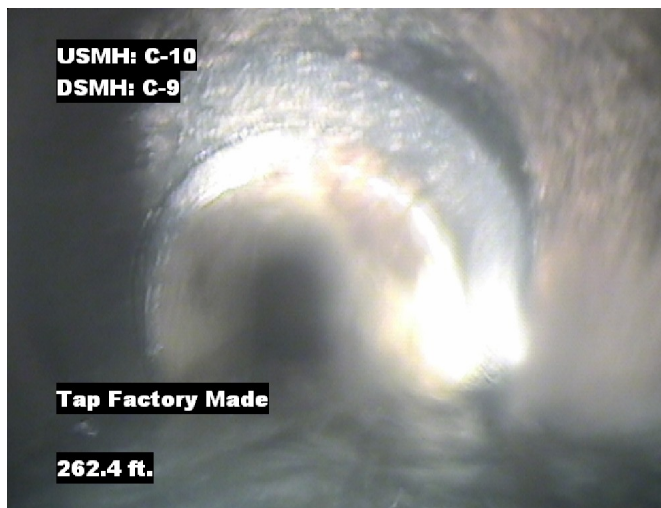
Distance: 262.4 ft. Grade: 0  
Condition: Tap Factory Made  
Remarks: N/A

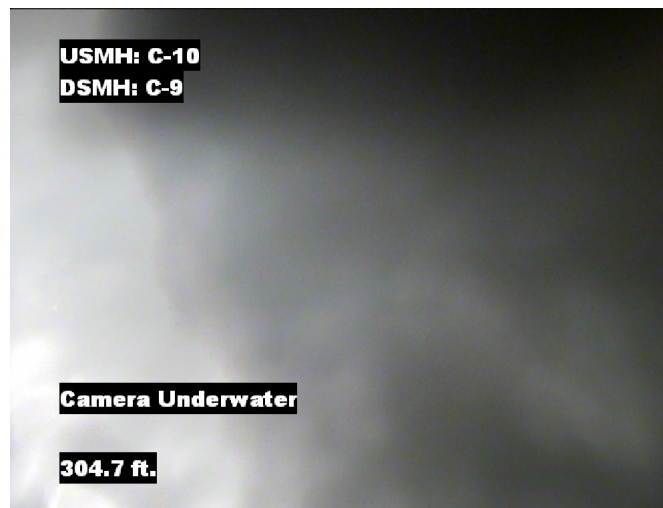
Distance: 304.7 ft. Grade: 4  
Condition: Camera Underwater  
Remarks: N/A

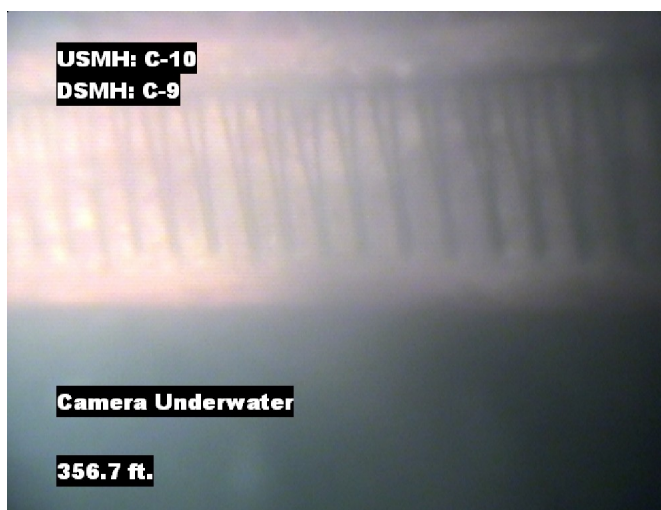
Distance: 356.6 ft. Grade: 4  
Condition: Camera Underwater  
Remarks: N/A

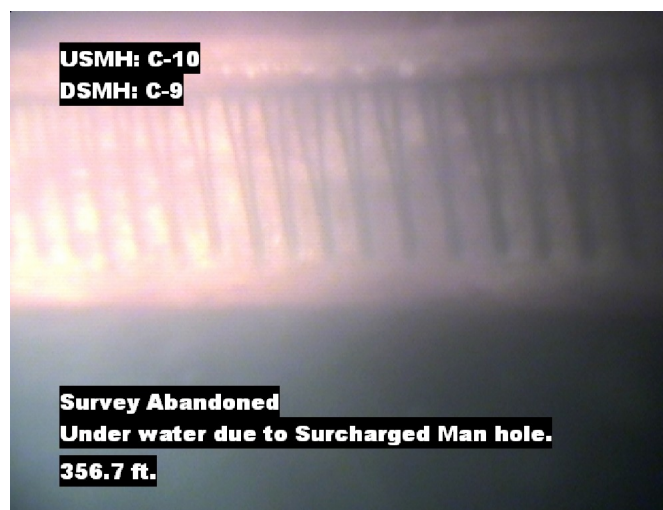
Distance: 356.7 ft. Grade: 0  
Condition: Survey Abandoned  
Remarks: Under water due to Surcharged Man hole.
