Defect Listing

Image Report 4/Page

PACP Conditions

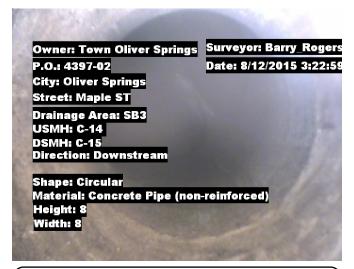
Distance: 0.0 ft. Grade: 0

Condition: Access Point Manhole

Remarks: C-14

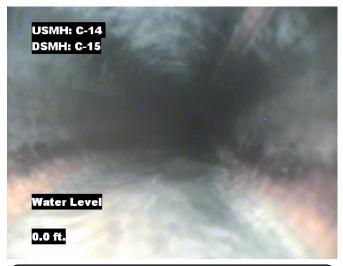
Distance: 0.0 ft. Grade: 0

Condition: Water Level

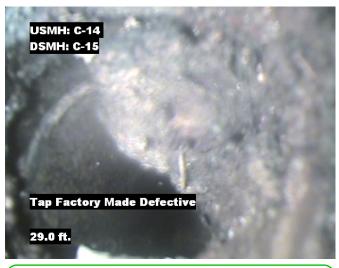
Distance: 29.0 ft. **Grade**: 2 **Condition**: Tap Factory Made Defective

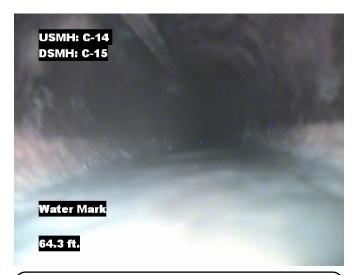
Distance: 64.3 ft. Grade: 0

Condition: Water Mark Remarks: N/A

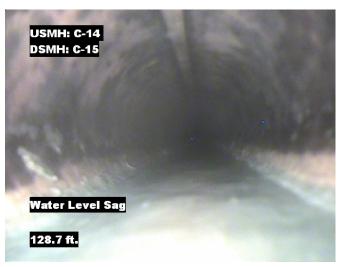
Distance: 128.7 ft. Grade: 2

Condition: Water Level Sag

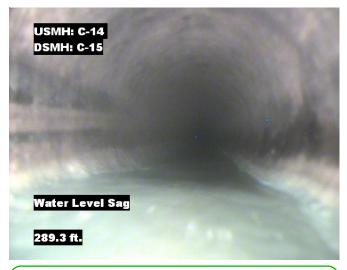
Distance: 289.3 ft. Grade: 2

Condition: Water Level Sag

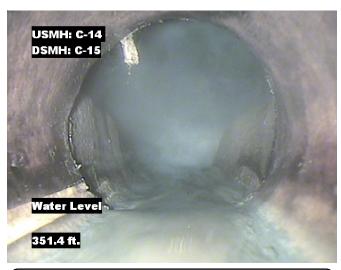
Distance: 351.4 ft. Grade: 0

Condition: Water Level
