Defect Listing

Pipe Segment Refere... C-15_C-14	City Oliver Springs	Street Easement	Material Fibreglass Reinforc...	Location C... Easement/R...	Sewer Use Sanitary
Upstream MH C-15	Total Length 172.1	Year Laid	Shape Circular	Location Details	
DS Manhole C-14	Length surveyed 172.1	Year Renewed	Height 8	Width 8	Pipe Joint... N/A

Image Report 4/Page

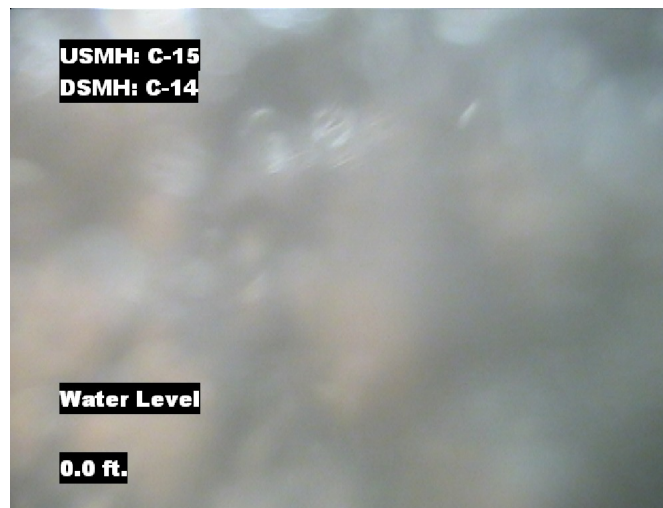
Distance: 0.0 ft. Grade: 0
Condition: Water Level
Remarks: N/A

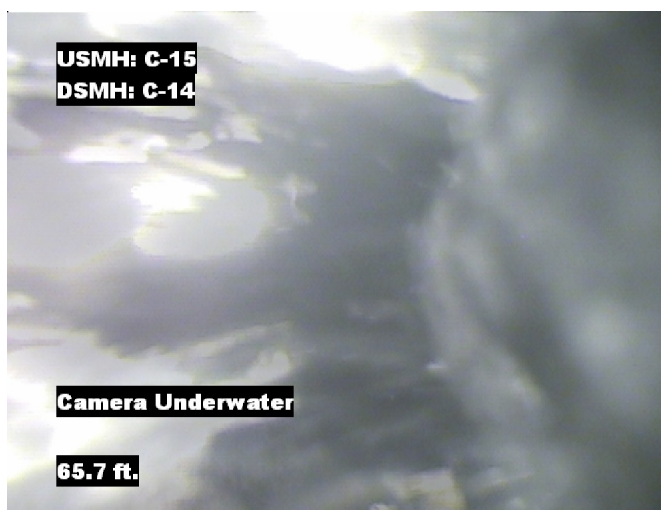
Distance: 65.7 ft. Grade: 4
Condition: Camera Underwater
Remarks: N/A

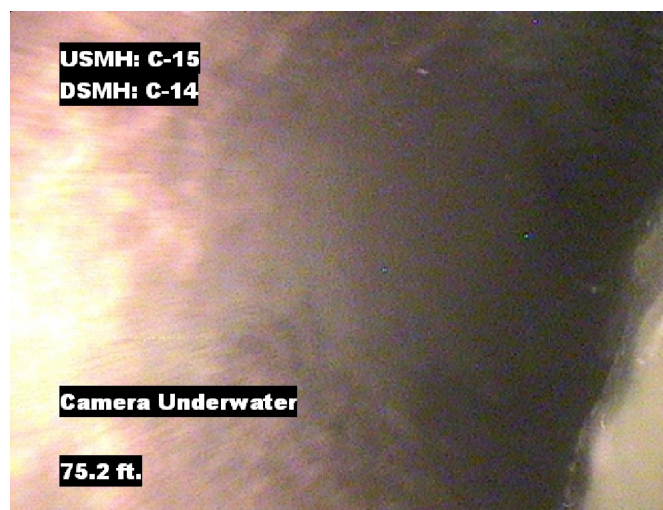
Distance: 74.5 ft. Grade: 4
Condition: Camera Underwater
Remarks: N/A

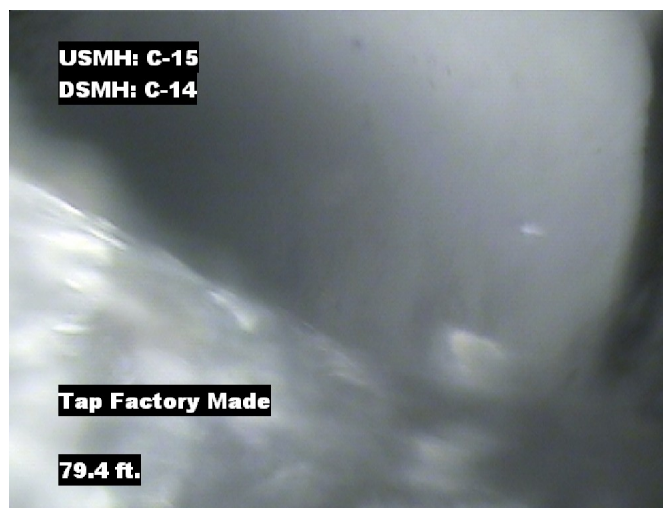
Distance: 79.4 ft. Grade: 0
Condition: Tap Factory Made
Remarks: N/A

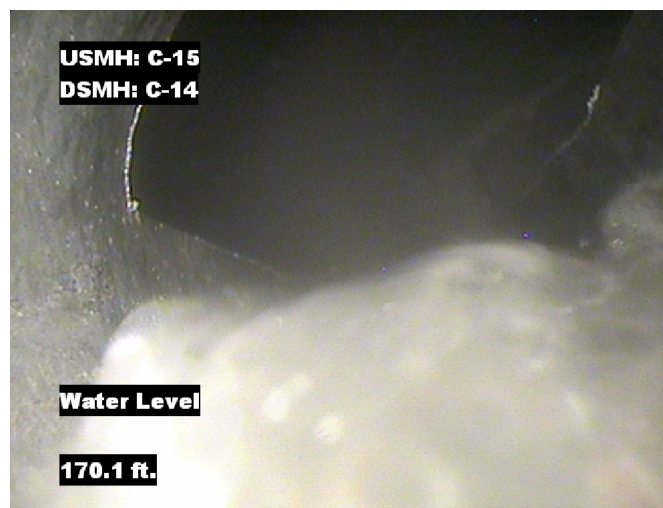
Distance: 170.1 ft. Grade: 0
Condition: Water Level
Remarks: N/A
