Defect Listing

Pipe Segment Refere... C-16_C-15	City Oliver Springs	Street Steward Ln	Material Fibreglass Reinforc...	Location C... Light High...	Sewer Use Sanitary
Upstream MH C-16	Total Length 236.7	Year Laid	Shape Circular	Location Details	
DS Manhole C-15	Length surveyed 236.7	Year Renewed	Height 8	Width 8	Pipe Joint... N/A

SPR N/A	MPR N/A	PO Number 4397-03		Customer GRW	
SPRI N/A	MPRI N/A	Work Order 4397-02		Purpose Pre-Rehabilitation Survey	
QSR N/A	QMR N/A				
OPR N/A	Surveyed By Barry Rogers	Direction Downstream	Date 20150720	Media label	
OPRI N/A	Certificate Number U-1012-16405	Pre-Cleaning Jetting	Time 08:14	Weather Dry	
Date Cleaned 20150720			End Time 08:34	Additional Info

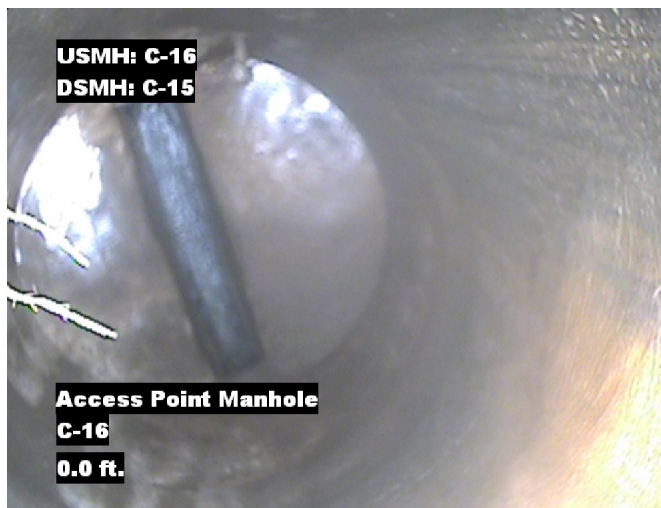
Distance: 0.0 ft. Grade: 0
Condition: Access Point Manhole
Remarks: C-16

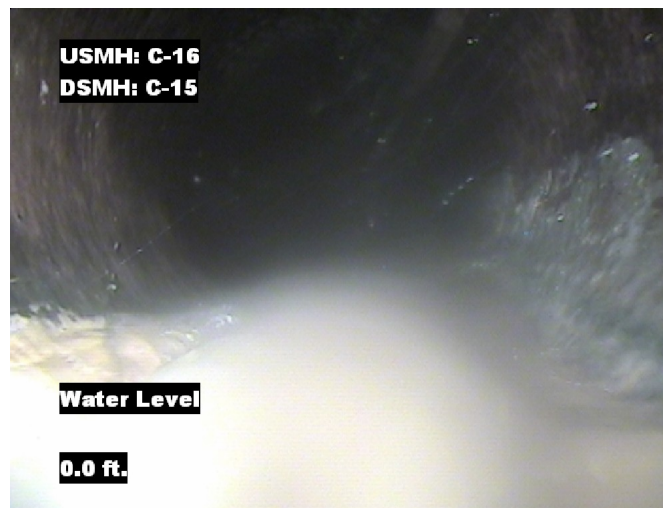
Distance: 0.0 ft. Grade: 0
Condition: Water Level
Remarks: N/A

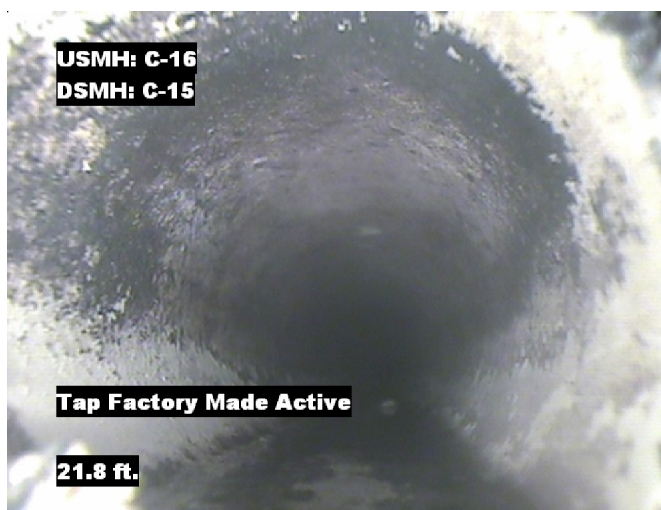
Distance: 21.8 ft. Grade: 0
Condition: Tap Factory Made Active
Remarks: N/A

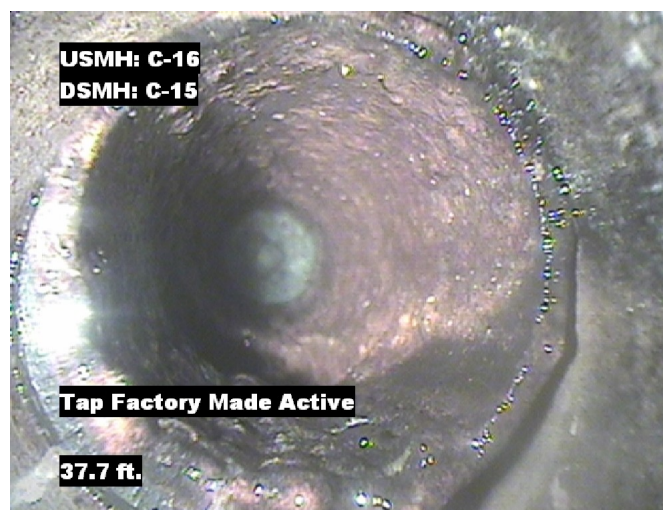
Distance: 37.7 ft. Grade: 0
Condition: Tap Factory Made Active
Remarks: N/A

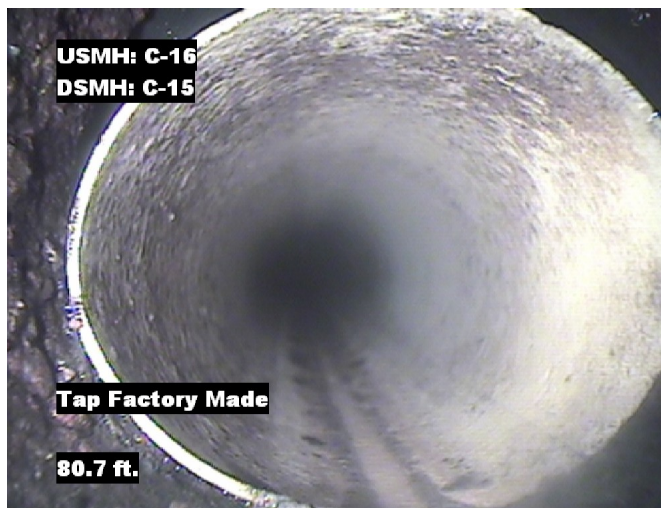
Distance: 80.7 ft. Grade: 0
Condition: Tap Factory Made
Remarks: N/A

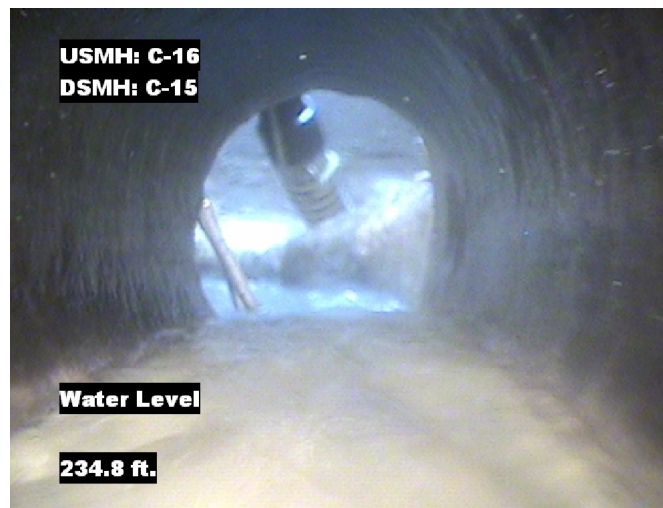
Distance: 234.7 ft. Grade: 0
Condition: Water Level
Remarks: N/A

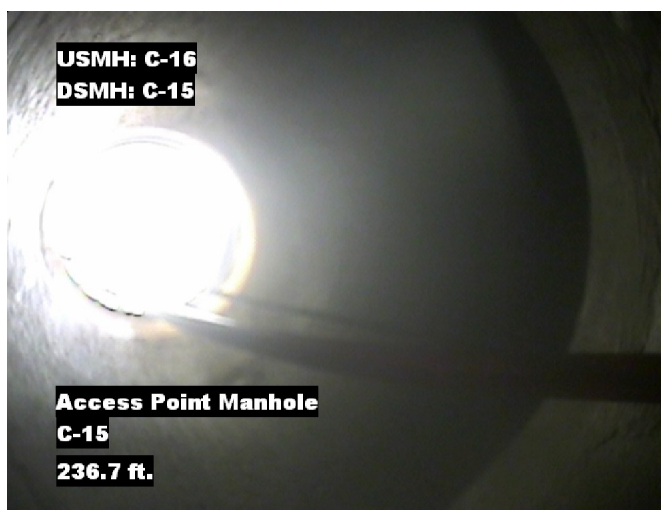
Distance: 236.7 ft. Grade: 0
Condition: Access Point Manhole
Remarks: C-15
