Defect Listing

Pipe Segment Refere... C-18_C-16	City Oliver Springs	Street Maples Ave	Material Concrete Pipe (non-...	Location C... Light High...	Sewer Use Sanitary
Upstream MH C-18	Total Length 176.3	Year Laid	Shape Circular	Location Details	
DS Manhole C-16	Length surveyed 176.3	Year Renewed	Height 8	Width 8	Pipe Joint... 4

Image Report 4/Page

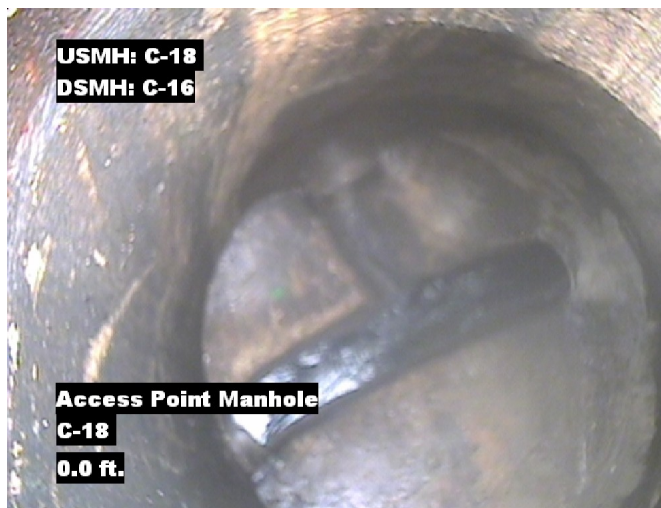
Distance: 0.0 ft. Grade: 0
Condition: Access Point Manhole
Remarks: C-18

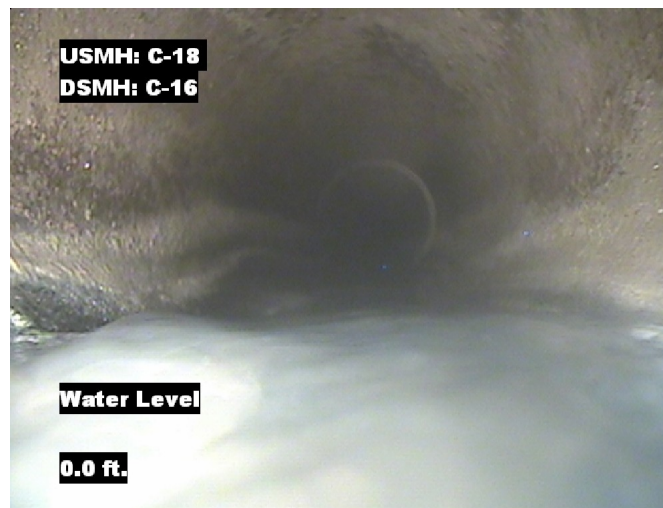
Distance: 0.0 ft. Grade: 0
Condition: Water Level
Remarks: N/A

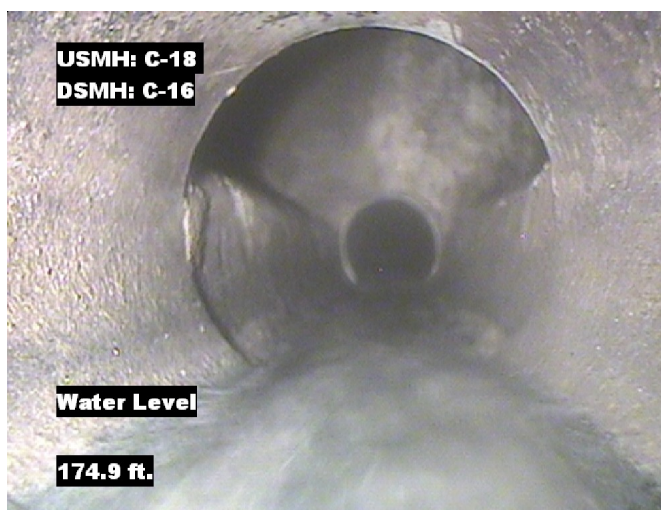
Distance: 174.9 ft. Grade: 0
Condition: Water Level
Remarks: N/A

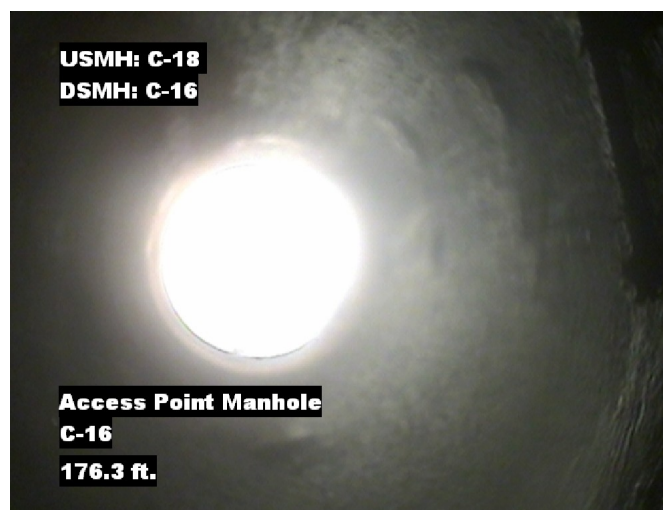
Distance: 176.3 ft. Grade: 0
Condition: Access Point Manhole
Remarks: C-16
