Defect Listing

Pipe Segment Refere... C-19_C-18	City Oliver Springs	Street Maple Ave	Material Concrete Pipe (non-...	Location C... Light High...	Sewer Use Sanitary
Upstream MH C-19	Total Length 330.1	Year Laid	Shape Circular	Location Details	
DS Manhole C-18	Length surveyed 330.1	Year Renewed	Height 8	Width 8	Pipe Joint... 4

Image Report 4/Page

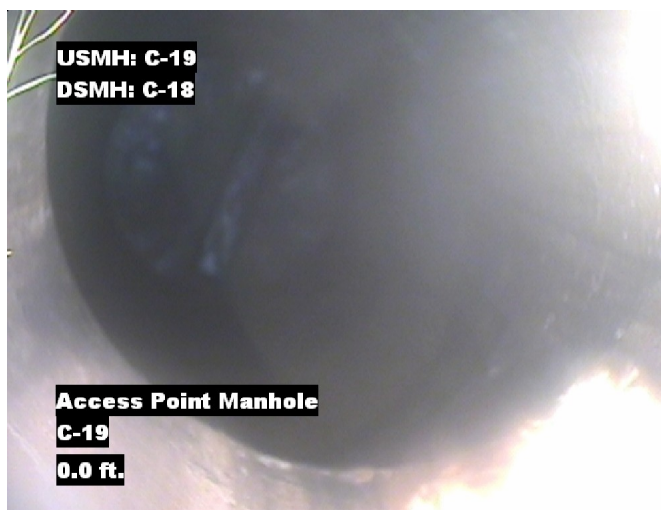
Distance: 0.0 ft. Grade: 0
Condition: Access Point Manhole
Remarks: C-19

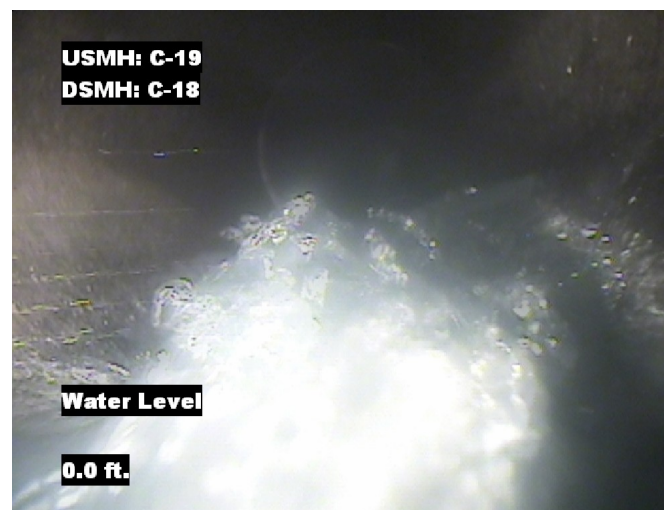
Distance: 0.0 ft. Grade: 0
Condition: Water Level
Remarks: N/A

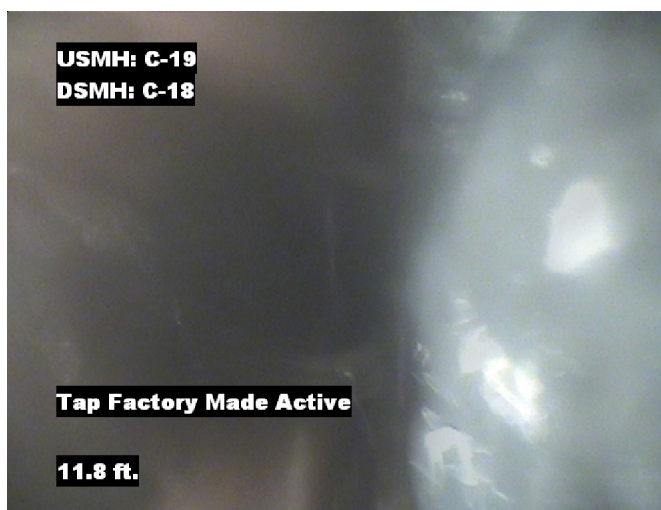
Distance: 11.8 ft. Grade: 0
Condition: Tap Factory Made Active
Remarks: N/A

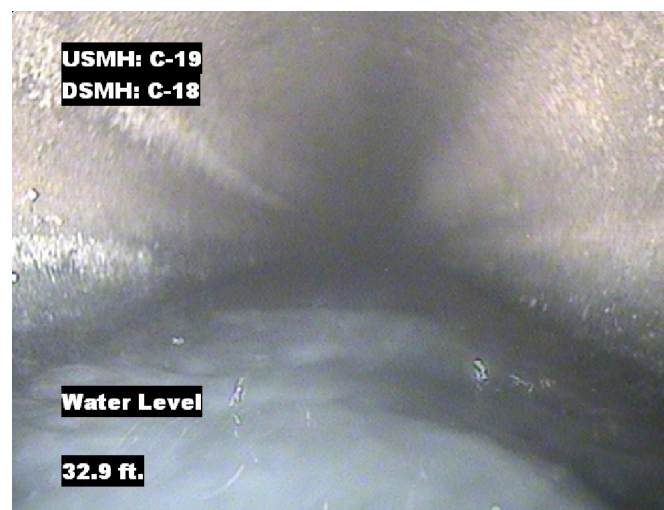
Distance: 32.9 ft. Grade: 0
Condition: Water Level
Remarks: N/A

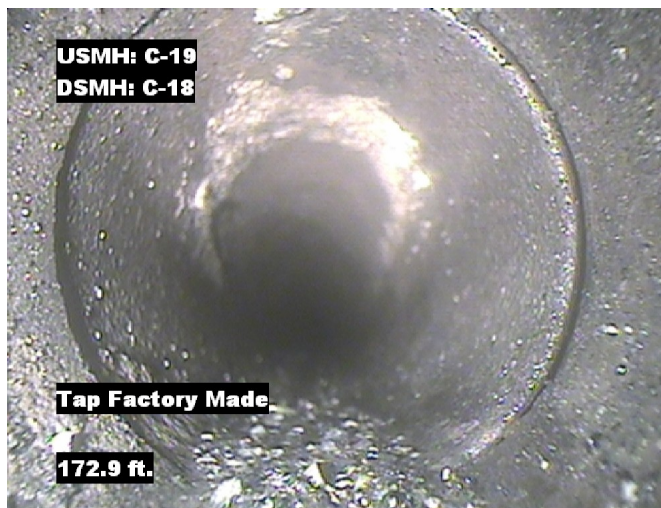
Distance: 172.9 ft. Grade: 0
Condition: Tap Factory Made
Remarks: N/A

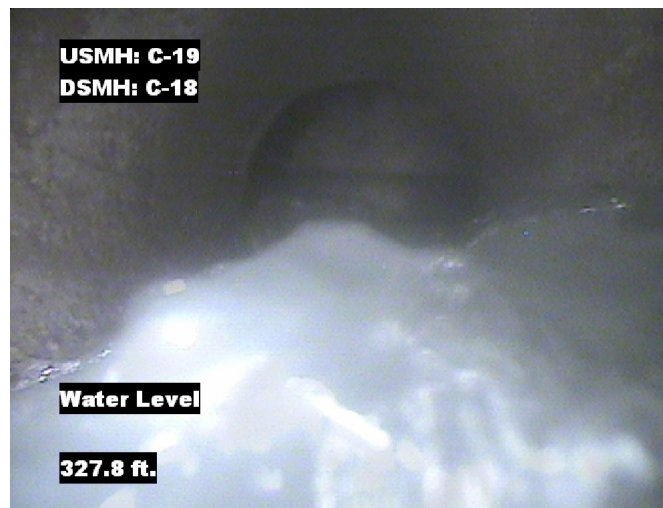
Distance: 327.8 ft. Grade: 0
Condition: Water Level
Remarks: N/A

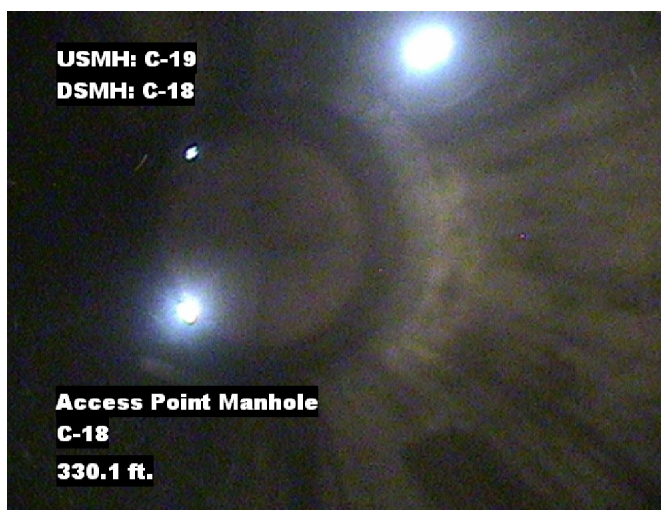
Distance: 330.1 ft. Grade: 0
Condition: Access Point Manhole
Remarks: C-18
