Defect Listing

Pipe Segment Refere... C-20_C-19	City Oliver Springs	Street hwy 62	Material Concrete Pipe (non-...	Location C... Light High...	Sewer Use Sanitary
Upstream MH C-20	Total Length 312.4	Year Laid	Shape Circular	Location Details	
DS Manhole C-19	Length surveyed 312.4	Year Renewed	Height 8	Width 8	Pipe Joint... 4

SPR N/A	MPR N/A	PO Number 4397-03		Customer GRW	
SPRI N/A	MPRI N/A	Work Order 4397-02		Purpose Pre-Rehabilitation Survey	
QSR N/A	QMR N/A				
OPR N/A	Surveyed By Barry Rogers	Direction Downstream	Date 20150717	Media label	
OPRI N/A	Certificate Number U-1012-16405	Pre-Cleaning Jetting	Time 08:15	Weather Dry	
Date Cleaned 20150717			End Time 08:33	Additional Info

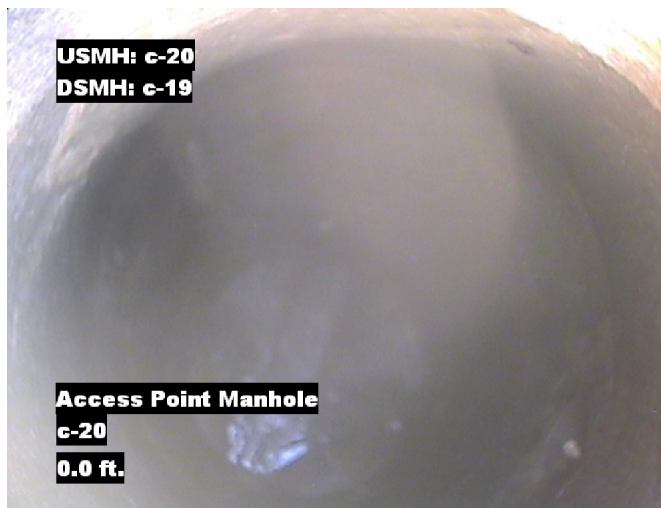
Distance: 0.0 ft. Grade: 0
Condition: Access Point Manhole
Remarks: c-20

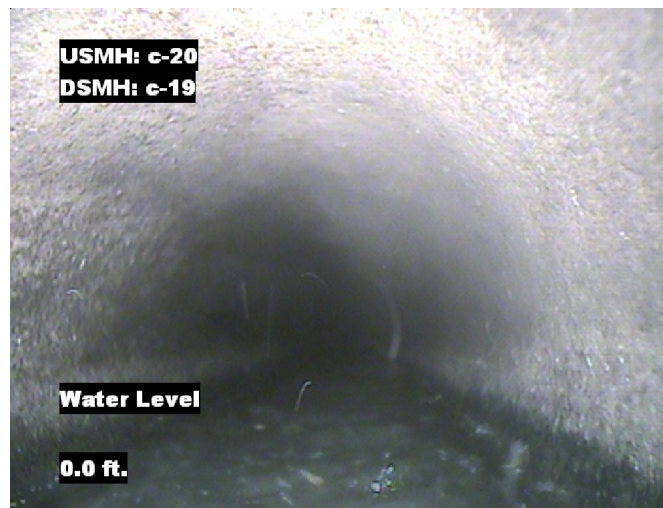
Distance: 0.0 ft. Grade: 0
Condition: Water Level
Remarks: N/A

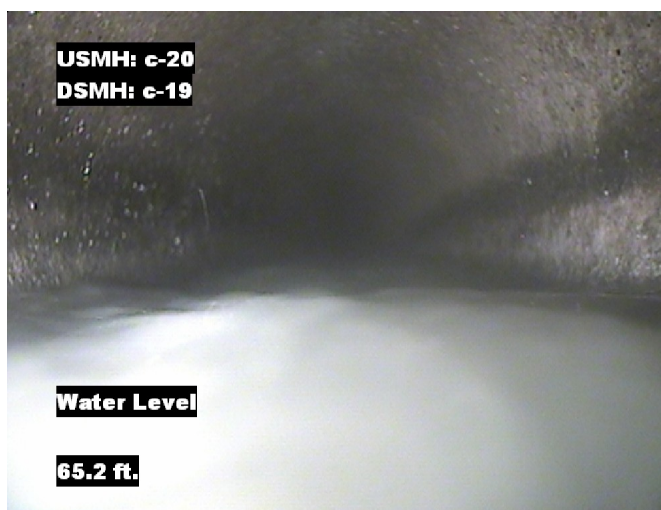
Distance: 65.2 ft. Grade: 0
Condition: Water Level
Remarks: N/A

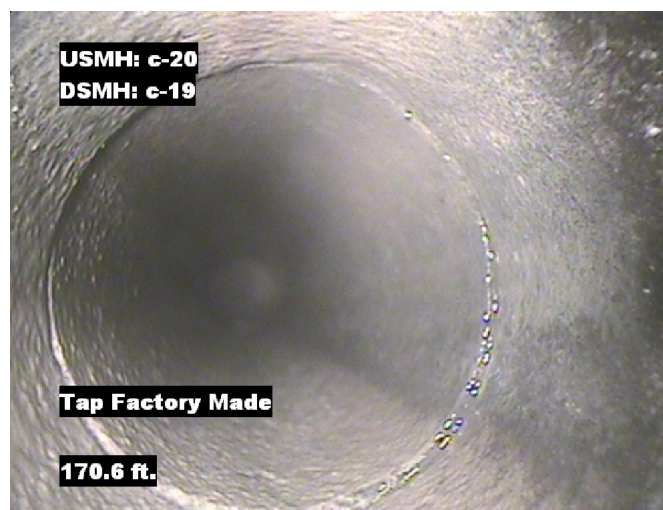
Distance: 170.6 ft. Grade: 0
Condition: Tap Factory Made
Remarks: N/A

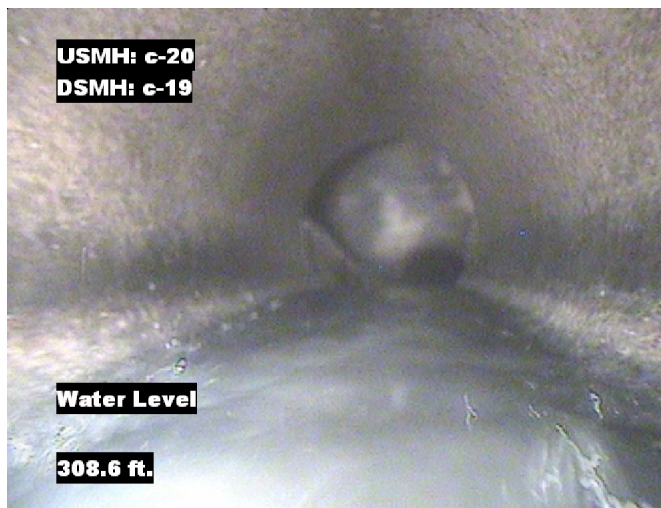
Distance: 308.5 ft. Grade: 0
Condition: Water Level
Remarks: N/A

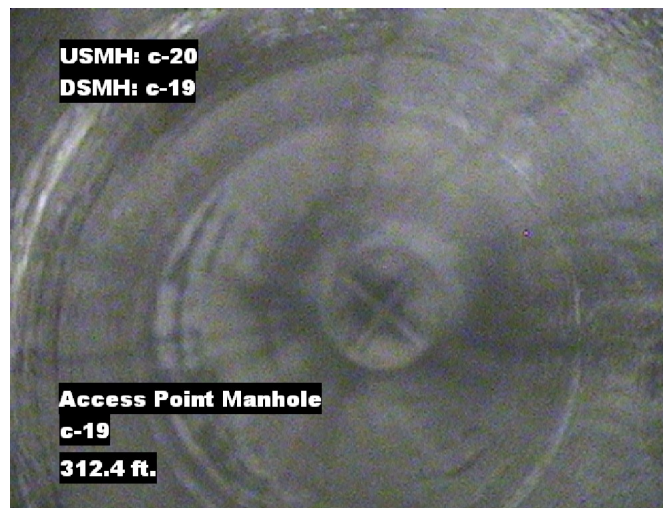
Distance: 312.4 ft. Grade: 0
Condition: Access Point Manhole
Remarks: c-19
