## Defect Listing

| Pipe Segment Refere...<br><b>C-21_C-20</b> | City<br><b>Oliver Springs</b> | Street<br><b>Hwy 61</b> | Material<br><b>Fibreglass Reinf...</b> | Location C...<br><b>Main Highw...</b> | Sewer Use<br><b>Sanitary</b> |

| SPRI<br><b>N/A</b> | MPRI<br><b>N/A</b> | Work Order<br><b>4397-02</b> | | Purpose<br><b>Pre-Rehabilitation Survey</b> | |

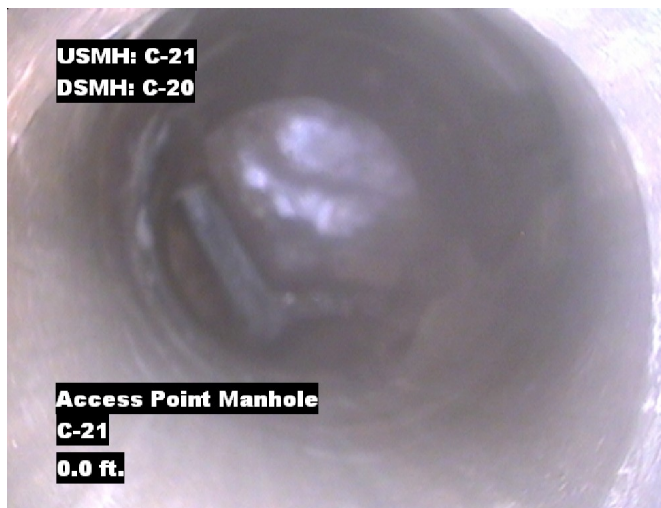
Distance: 0.0 ft. Grade: 0  
Condition: Access Point Manhole  
Remarks: C-21

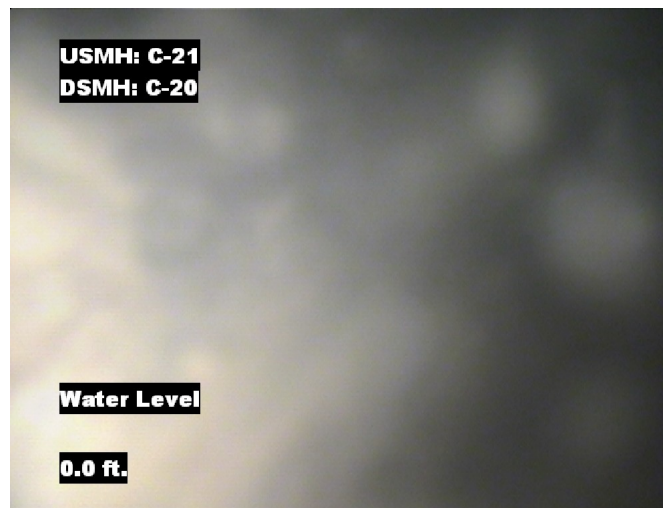
| Distance | Condition | Cont. Dfct. | Values | | | Joint | Clock Position | | Grade |
|---|---|---|---|---|---|---|---|---|---|
| 0.0 ft. | Water Level | | | | 30 | <input type="checkbox"/> | | | |

Distance: 0.0 ft. Grade: 0  
Condition: Water Level  
Remarks: N/A

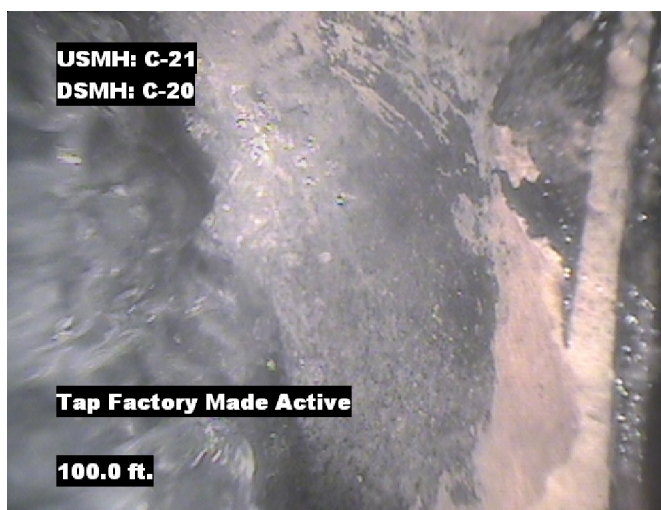
| Distance | Condition | Cont. Dfct. | Values | | | Joint | Clock Position | | Grade |
|---|---|---|---|---|---|---|---|---|---|
| 100.0 ft. | Tap Factory Made Active | | 8 | | 0 | <input type="checkbox"/> | 6 | | |

Distance: 100.0 ft. Grade: 0  
Condition: Tap Factory Made Active  
Remarks: N/A

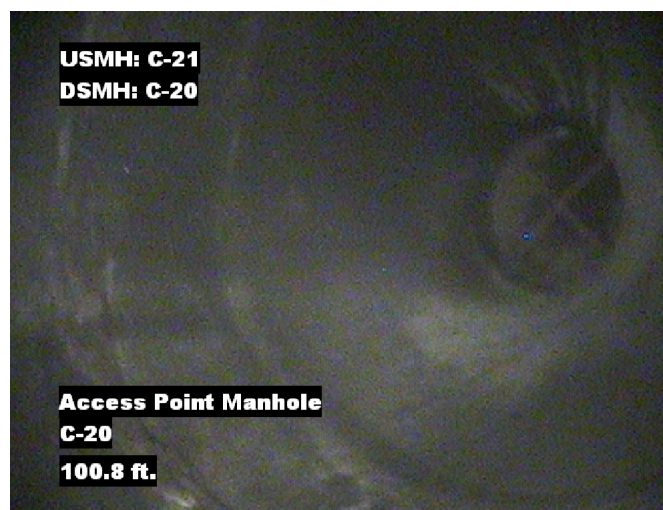
Distance: 100.8 ft. Grade: 0  
Condition: Access Point Manhole  
Remarks: C-20
