Defect Listing

Pipe Segment Refere... C-22_C-21	City Oliver Springs	Street Edmonds Dr	Material Fibreglass Reinforc...	Location C... Light High...	Sewer Use Sanitary
Upstream MH C-22	Total Length 206.6	Year Laid	Shape Circular	Location Details	
DS Manhole C-21	Length surveyed 206.6	Year Renewed	Height 8	Width 8	Pipe Joint... N/A

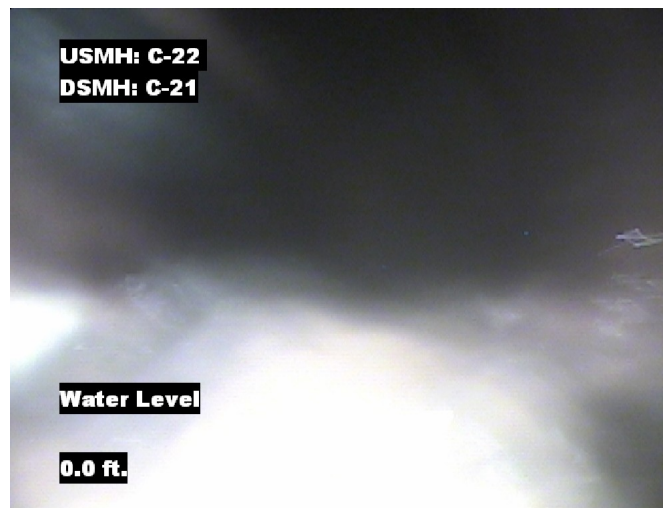
Distance: 0.0 ft. Grade: 0
Condition: Water Level
Remarks: N/A

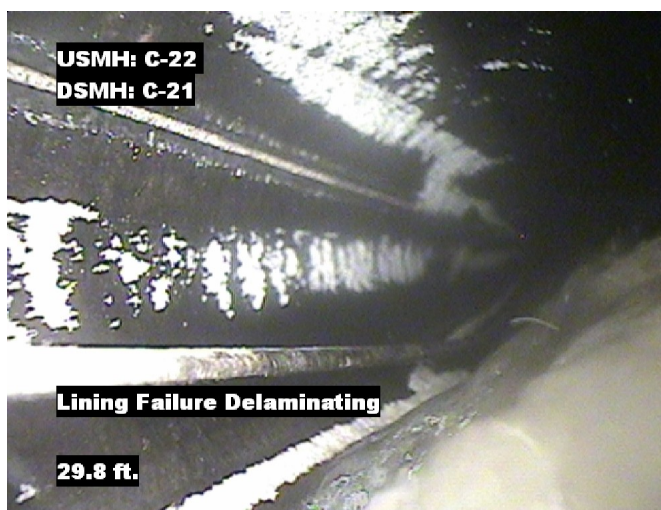
Distance: 29.8 ft. Grade: 3
Condition: Lining Failure Delaminating
Remarks: N/A

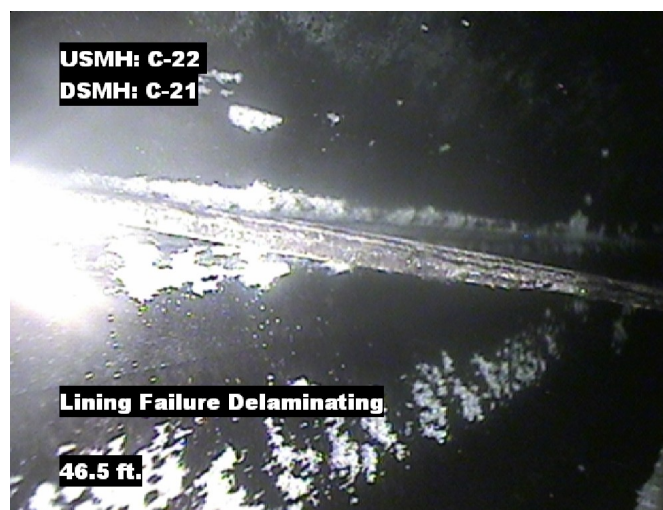
Distance: 46.5 ft. Grade: 3
Condition: Lining Failure Delaminating
Remarks: N/A

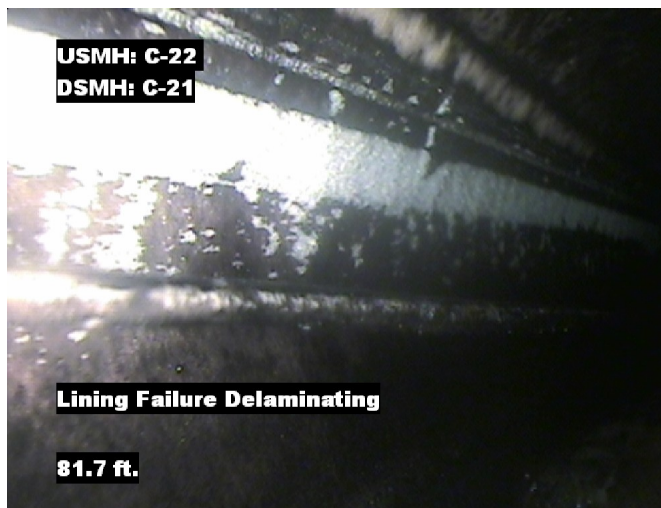
Distance: 81.7 ft. Grade: 3
Condition: Lining Failure Delaminating
Remarks: N/A

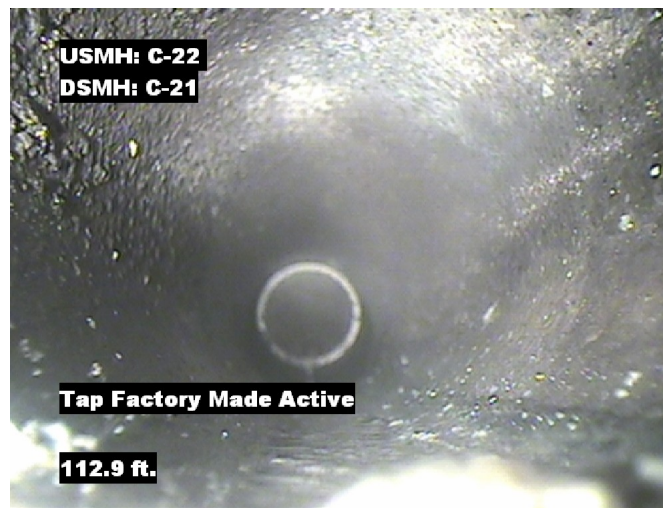
Distance: 112.9 ft. Grade: 0
Condition: Tap Factory Made Active
Remarks: N/A

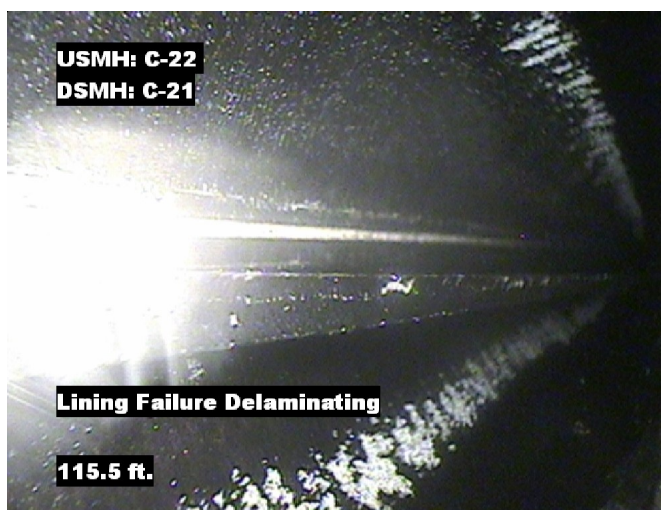
Distance: 115.5 ft. Grade: 3
Condition: Lining Failure Delaminating
Remarks: N/A

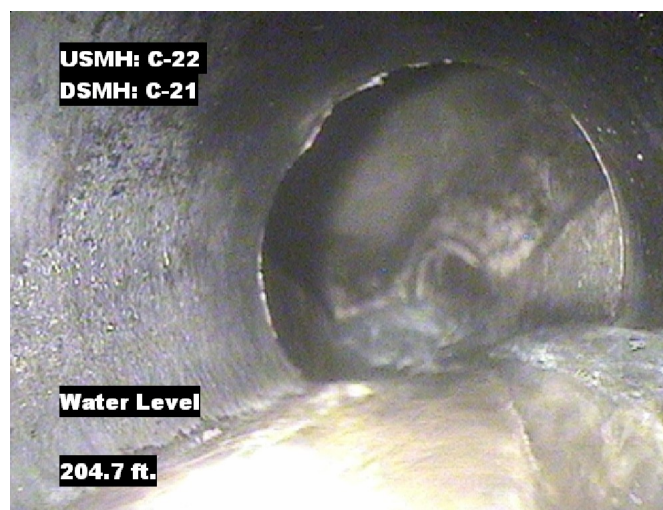
Distance: 204.7 ft. Grade: 0
Condition: Water Level
Remarks: N/A
