## Defect Listing

Pipe Segment Refere...	City	Street	Material	Location C...	Sewer Use
<b>C-23_C-22</b>	<b>Oliver Springs</b>	<b>Edmonds Dr</b>	<b>Concrete Pipe (non-...</b>	<b>Yard</b>	<b>Sanitary</b>
Upstream MH	Total Length	Year Laid	Shape	Location Details	
<b>C-23</b>	<b>90.7</b>		<b>Circular</b>		
DS Manhole	Length surveyed	Year Renewed	Height	Width	Pipe Joint...
<b>C-22</b>	<b>90.7</b>		<b>8</b>	<b>8</b>	<b>4</b>

SPR	N/A	MPR	2	PO Number	Customer
SPRI	N/A	MPRI	2	<b>4397-03</b>	<b>GRW</b>
QSR	N/A	QMR	2100	Work Order	Purpose
				<b>4397-02</b>	<b>Pre-Rehabilitation Survey</b>
OPR	Surveyed By	Direction	Date	Media label	
<b>2</b>	<b>Barry Rogers</b>	<b>Downstream</b>	<b>20150715</b>		
OPRI	Certificate Number	Pre-Cleaning	Time	Weather	
<b>2</b>	<b>U-1012-16405</b>	<b>Jetting</b>	<b>07:40</b>	<b>Damp</b>	
Date Cleaned			End Time	Additional Info	
<b>20150715</b>			<b>07:48</b>

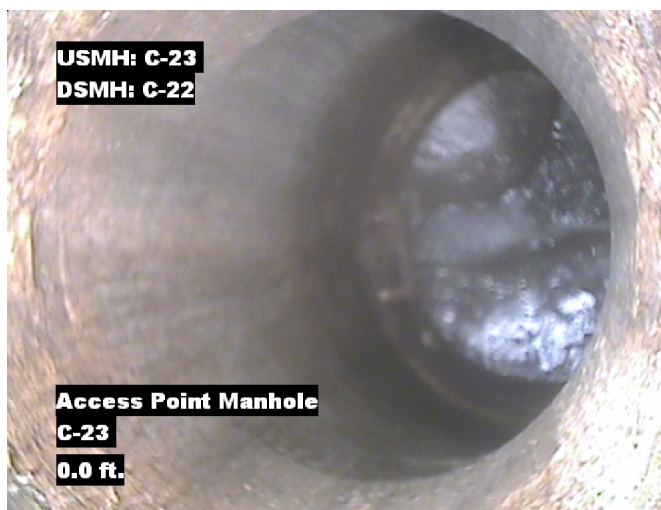
Distance: 0.0 ft. Grade: 0  
Condition: Access Point Manhole  
Remarks: C-23

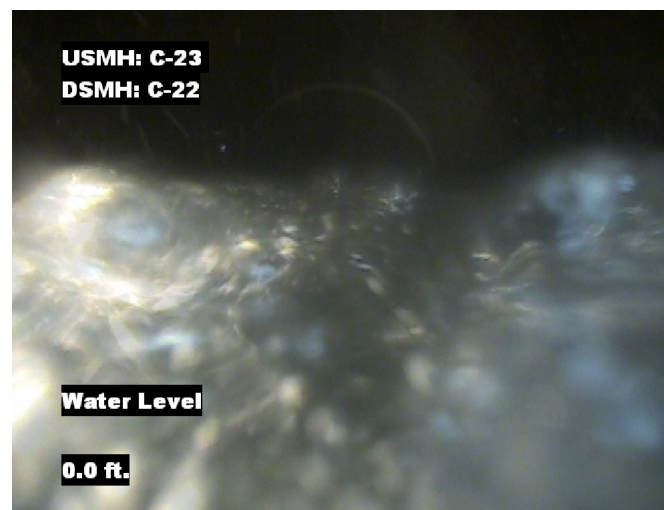
Distance: 0.0 ft. Grade: 0  
Condition: Water Level  
Remarks: N/A

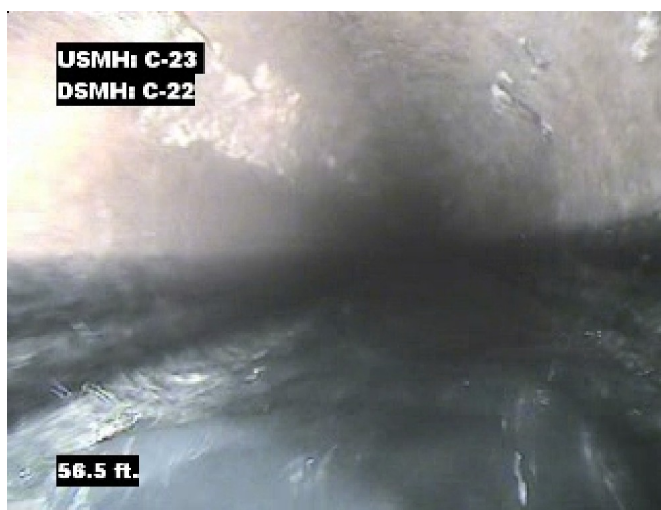
Distance: 56.6 ft. Grade: 2  
Condition: Deposits Attached Grease  
Remarks: N/A

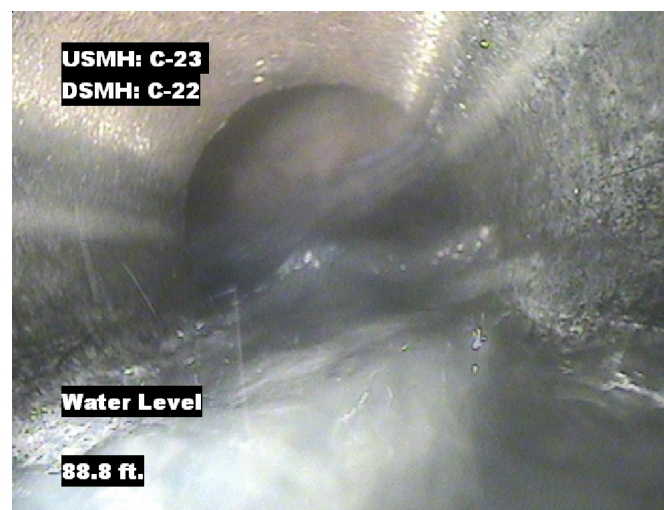
Distance: 88.8 ft. Grade: 0  
Condition: Water Level  
Remarks: N/A

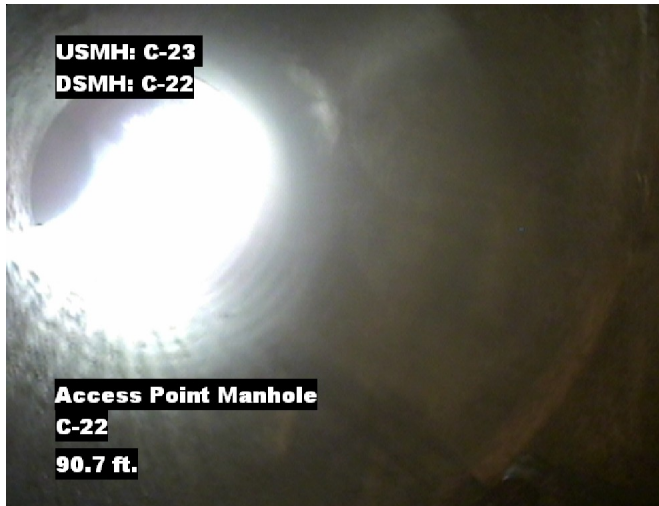
Distance: 90.7 ft. Grade: 0  
Condition: Access Point Manhole  
Remarks: C-22
