Defect Listing

Pipe Segment Refere... C-24_C-23	City Oliver Springs	Street edmonds dr	Material Fibreglass Reinf...	Location C... Yard	Sewer Use Sanitary
Upstream MH C-24	Total Length 327.8	Year Laid	Shape Circular	Location Details	
DS Manhole C-23	Length surveyed 327.8	Year Renewed	Height 8	Width 8	Pipe Joint... N/A

SPR N/A	MPR N/A	PO Number 4397-03	Customer GRW
SPRI N/A	MPRI N/A	Work Order 4397-02	Purpose Pre-Rehabilitation Survey
QSR N/A	QMR N/A		
OPR N/A	Surveyed By Barry Rogers	Direction Upstream	Date 20150716
OPRI N/A	Certificate Number U-1012-16405	Pre-Cleaning Jetting	Time 12:46
	Date Cleaned 20150716	End Time 13:09	Weather Dry
		Additional Info

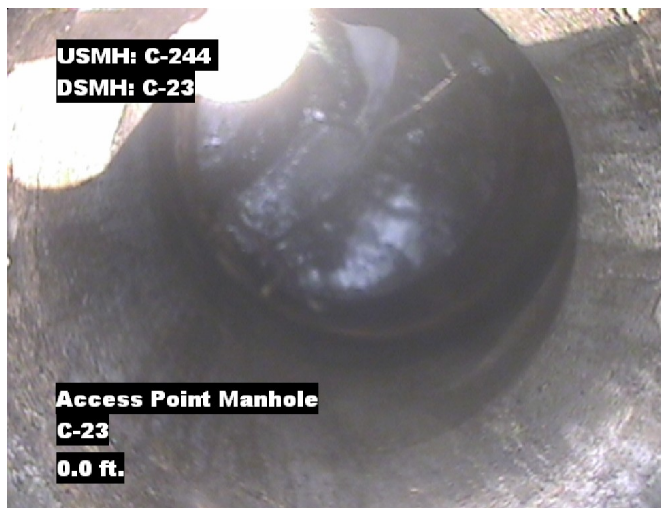
Distance: 0.0 ft. Grade: 0
Condition: Access Point Manhole
Remarks: C-23

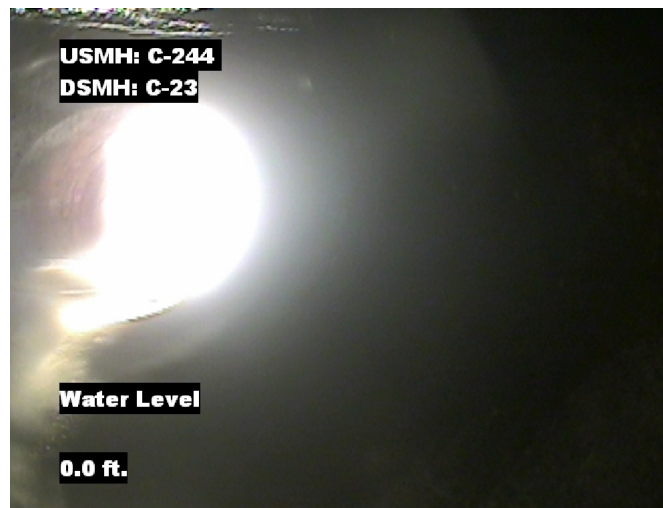
Distance: 0.0 ft. Grade: 0
Condition: Water Level
Remarks: N/A

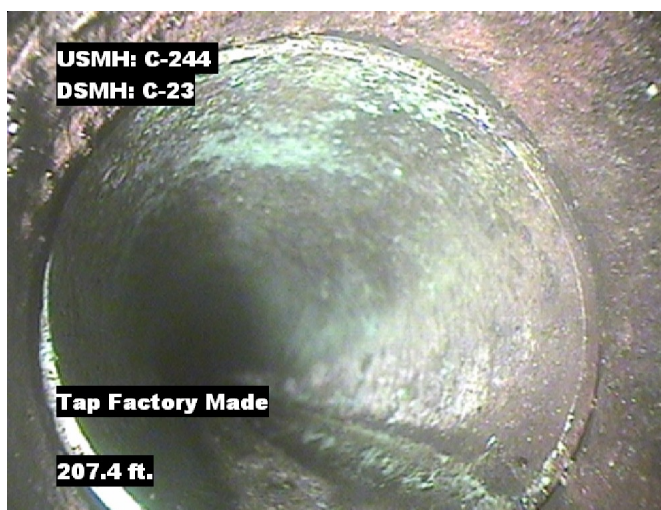
Distance: 207.4 ft. Grade: 0
Condition: Tap Factory Made
Remarks: N/A

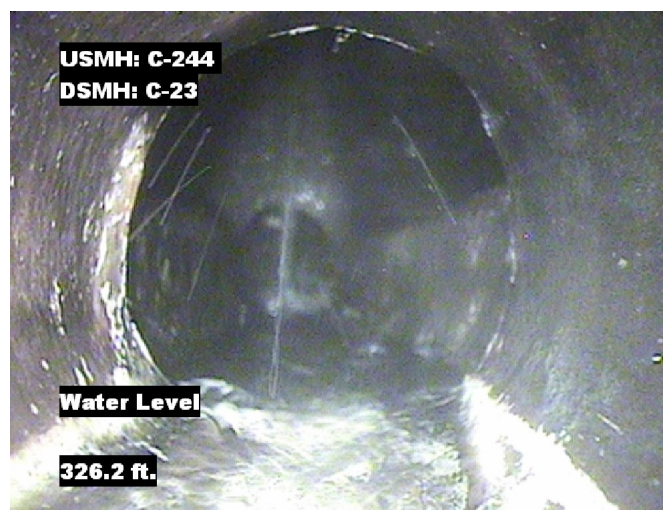
Distance: 326.2 ft. Grade: 0
Condition: Water Level
Remarks: N/A

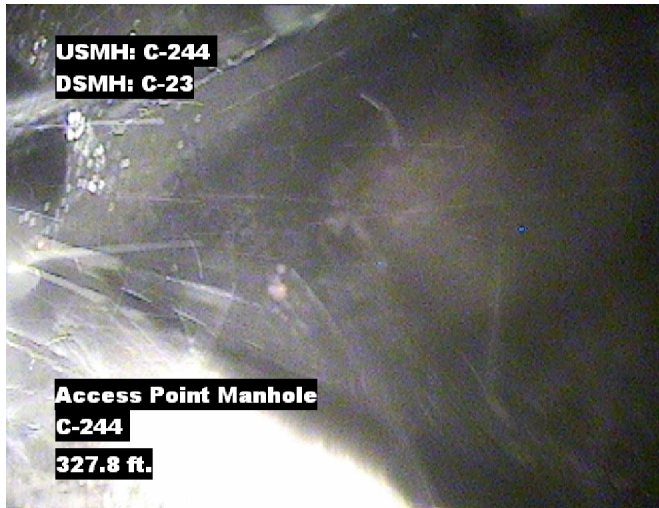
Distance: 327.8 ft. Grade: 0
Condition: Access Point Manhole
Remarks: C-24
