## Defect Listing

Pipe Segment Refere... <b>C-25_C-24</b>	City <b>Oliver Springs</b>	Street <b>foxwood circle</b>	Material <b>Fibreglass Reinforc...</b>	Location C... <b>Easement/R...</b>	Sewer Use <b>Sanitary</b>
Upstream MH <b>C-25</b>	Total Length <b>292.8</b>	Year Laid	Shape <b>Circular</b>	Location Details <b>108</b>	
DS Manhole <b>C-24</b>	Length surveyed <b>292.8</b>	Year Renewed	Height <b>8</b>	Width <b>8</b>	Pipe Joint... <b>N/A</b>

SPR <b>N/A</b>	MPR <b>N/A</b>	PO Number <b>4397-03</b>	Customer <b>GRW</b>
SPRI <b>N/A</b>	MPRI <b>N/A</b>	Work Order <b>4397-02</b>	Purpose <b>Pre-Rehabilitation Survey</b>
QSR <b>N/A</b>	QMR <b>N/A</b>		
OPR <b>N/A</b>	Surveyed By <b>Barry_Rogers</b>	Direction <b>Downstream</b>	Date <b>20150716</b>
OPRI <b>N/A</b>	Certificate Number <b>U-1012-16405</b>	Pre-Cleaning <b>Jetting</b>	Time <b>11:05</b>
	Date Cleaned <b>20150716</b>	End Time <b>11:06</b>	Weather <b>Dry</b>
			Additional Info

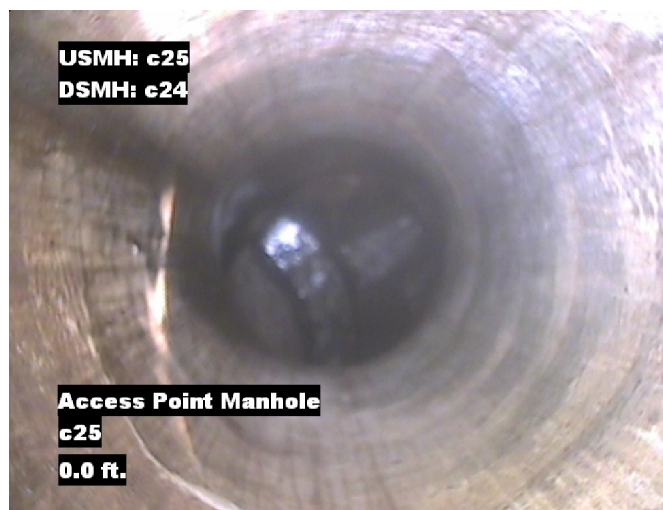
Distance: 0.0 ft. Grade: 0  
Condition: Access Point Manhole  
Remarks: c25

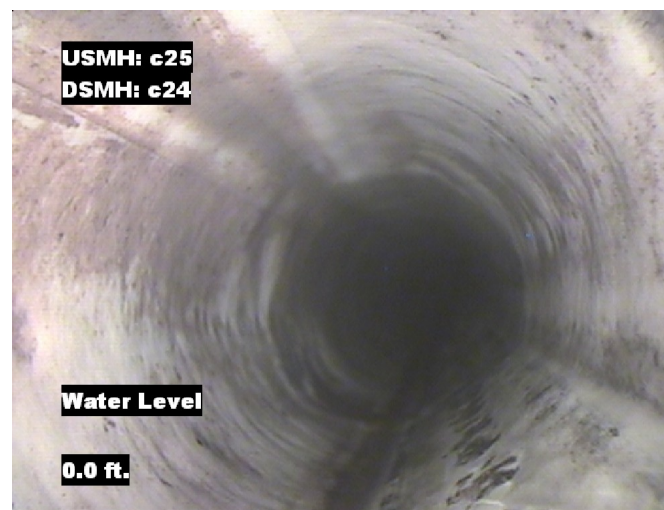
Distance: 0.0 ft. Grade: 0  
Condition: Water Level  
Remarks: N/A

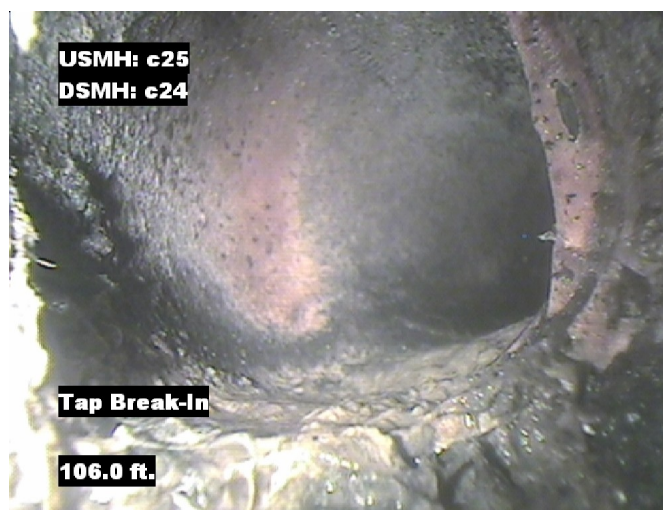
Distance: 106.0 ft. Grade: 0  
Condition: Tap Break-In  
Remarks: N/A

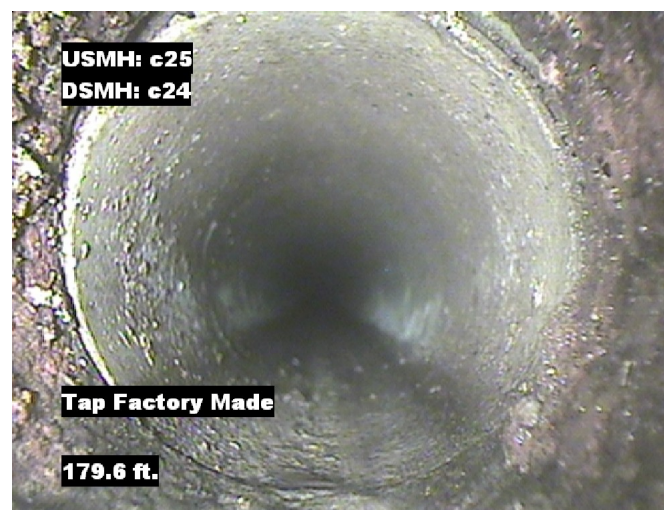
Distance: 179.6 ft. Grade: 0  
Condition: Tap Factory Made  
Remarks: N/A

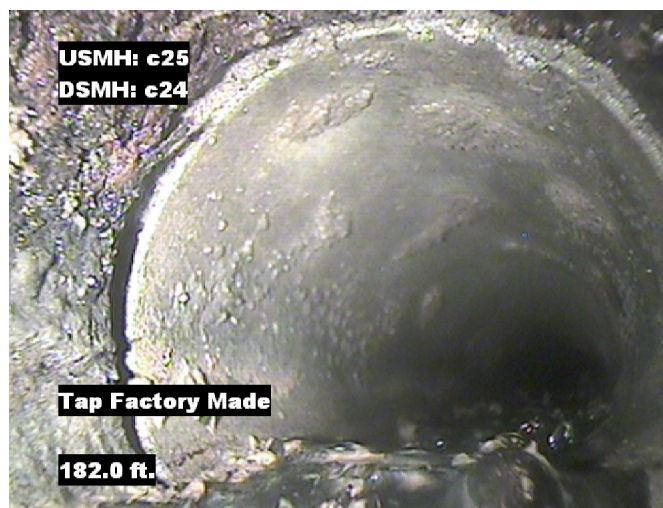
Distance: 182.0 ft. Grade: 0  
Condition: Tap Factory Made  
Remarks: N/A

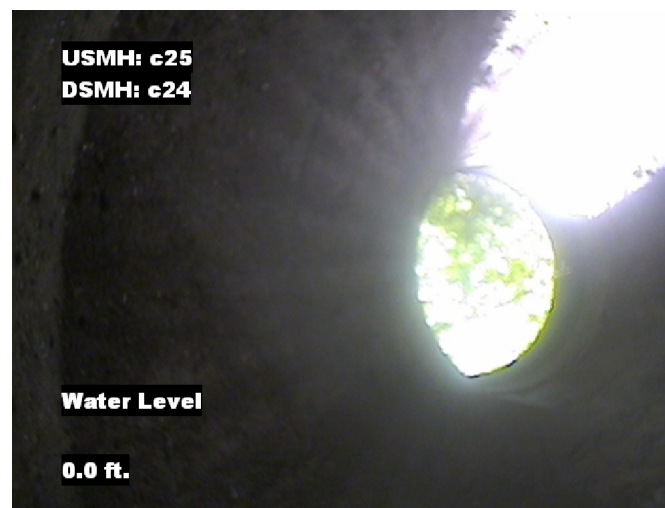
Distance: 292.0 ft. Grade: 0  
Condition: Water Level  
Remarks: N/A

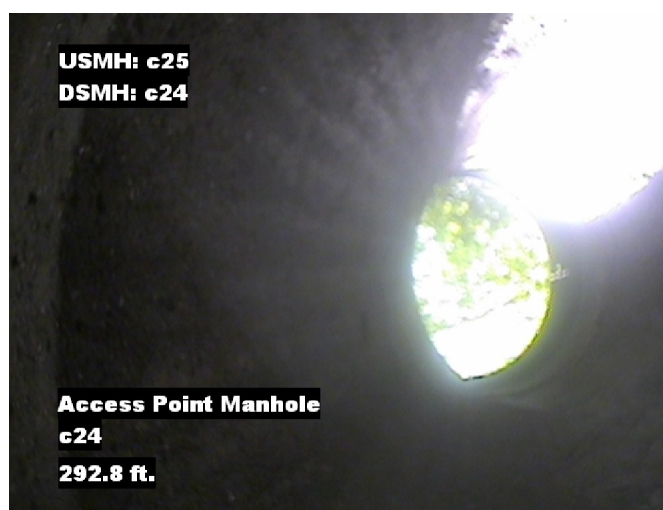
Distance: 292.8 ft. Grade: 0  
Condition: Access Point Manhole  
Remarks: c24
