Defect Listing

Pipe Segment Refere...	City	Street	Material	Location C...	Sewer Use
C-26_C-25	Oliver Springs	Foxwood	Concrete Pipe (non-...	Yard	Sanitary
Upstream MH	Total Length	Year Laid	Shape	Location Details	
C-26	298		Circular		
DS Manhole	Length surveyed	Year Renewed	Height	Width	Pipe Joint...
C-25	298		8	8	4

SPR	2	MPR	N/A	PO Number	Customer
SPRI	1	MPRI	N/A	4397-03	GRW
QSR	1200	QMR	N/A	Work Order	Purpose
				4397-02	Pre-Rehabilitation Survey
OPR		Surveyed By	Direction	Date	Media label
2		Barry Rogers	Downstream	20150713	
OPRI		Certificate Number	Pre-Cleaning	Time	Weather
1		U-1012-16405	Jetting	08:42	Damp
		Date Cleaned		End Time	Additional Info
		20150713		09:00

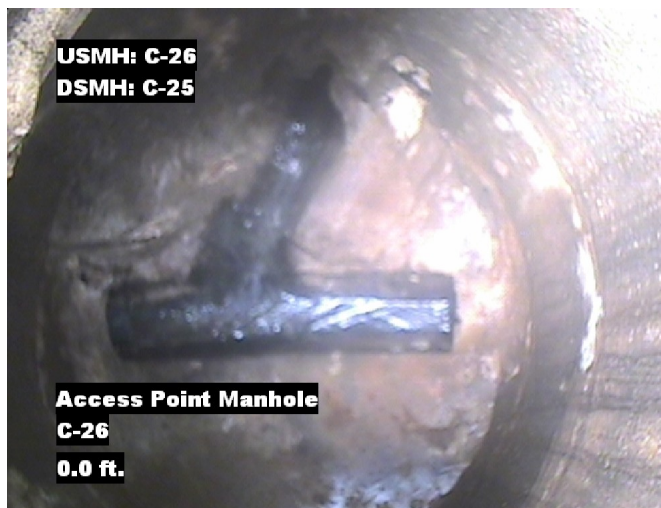
Distance: 0.0 ft. Grade: 0
Condition: Access Point Manhole
Remarks: C-26

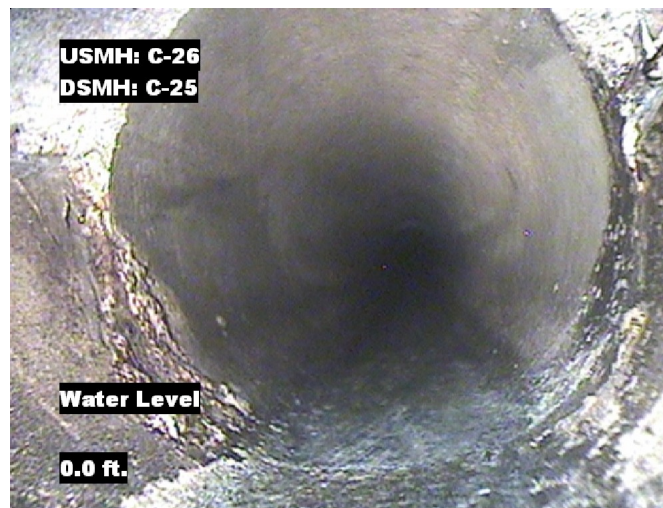
Distance: 0.0 ft. Grade: 0
Condition: Water Level
Remarks: N/A

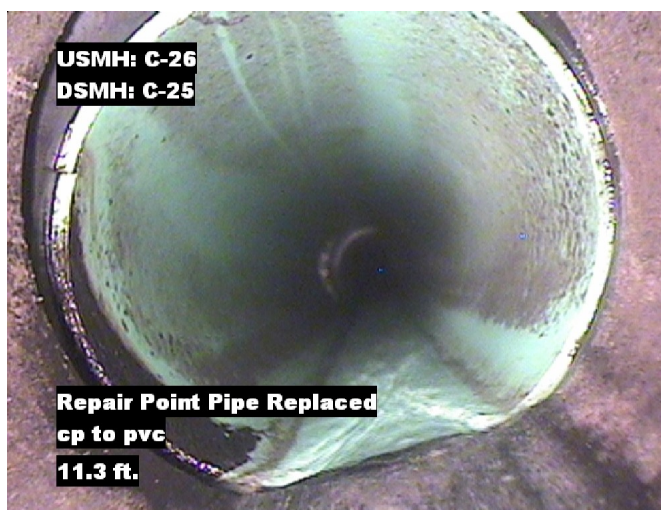
Distance: 11.3 ft. Grade: 0
Condition: Repair Point Pipe Replaced
Remarks: cp to pvc

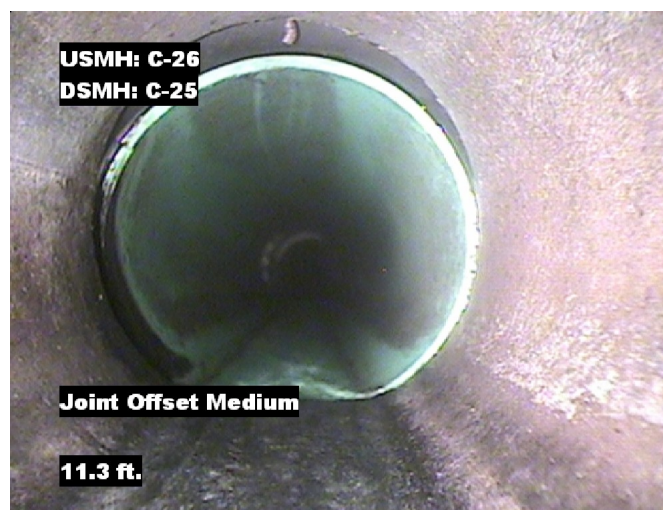
Distance: 11.3 ft. Grade: 1
Condition: Joint Offset Medium
Remarks: N/A

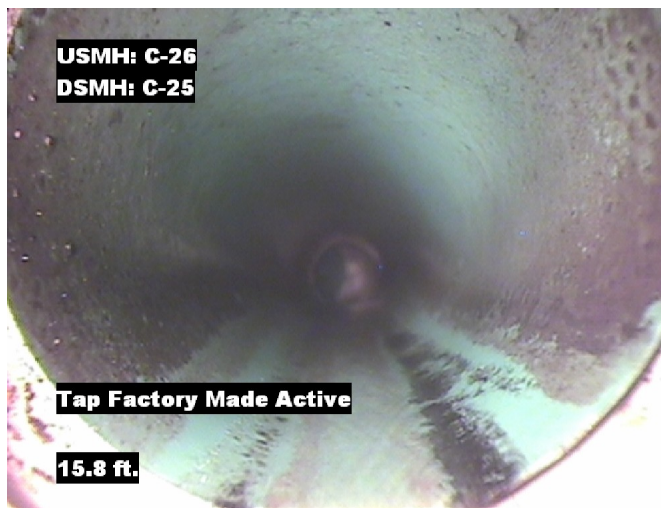
Distance: 15.8 ft. Grade: 0
Condition: Tap Factory Made Active
Remarks: N/A

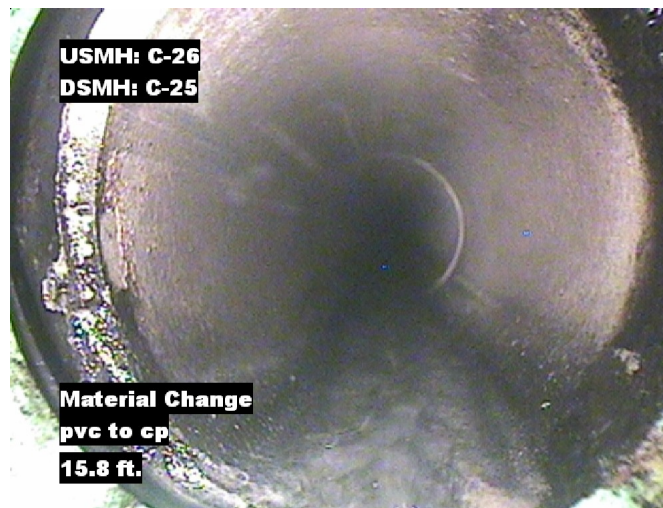
Distance: 15.8 ft. Grade: 0
Condition: Material Change
Remarks: pvc to cp

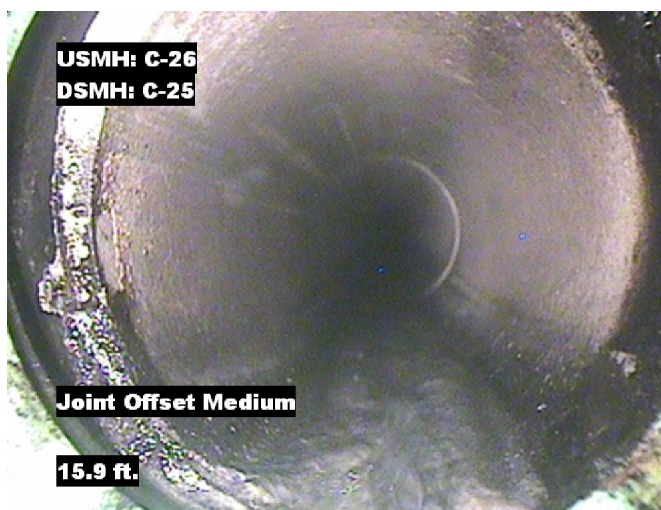
Distance: 15.9 ft. Grade: 1
Condition: Joint Offset Medium
Remarks: N/A

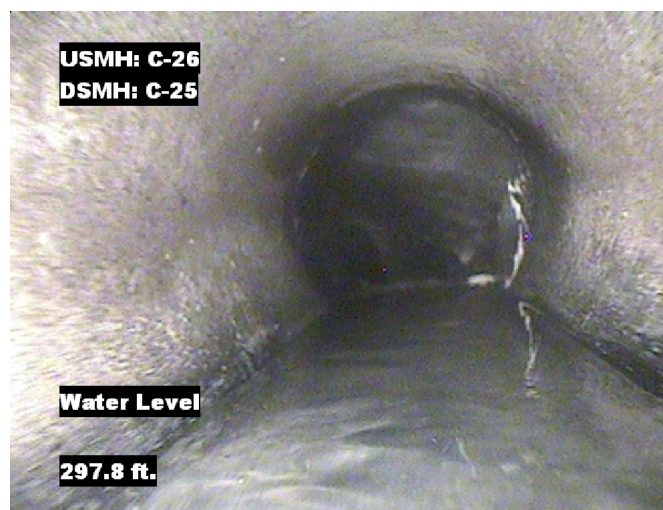
Distance: 297.8 ft. Grade: 0
Condition: Water Level
Remarks: N/A

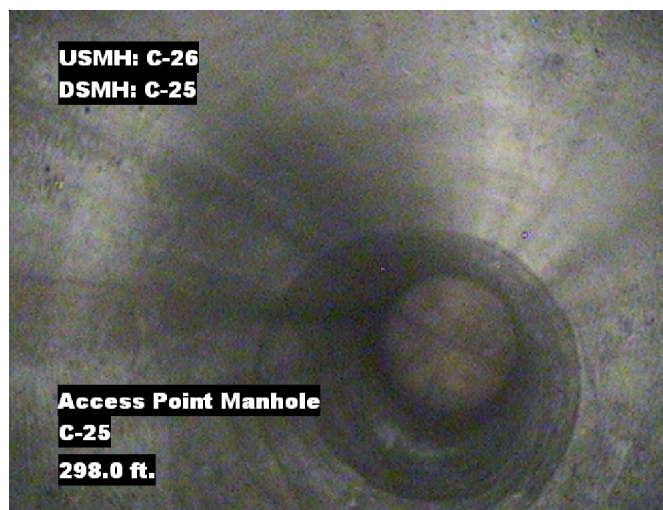
Distance: 298.0 ft. Grade: 0
Condition: Access Point Manhole
Remarks: C-25
