## **Defect Listing**

Pipe Segment Refere		City		Street	Mat	Material		Sewer Use	
C-28_	_C-26	Oliver	Springs	Foxwood Cir	Concrete F	Pipe (non Easement/F		Sanitary	
Upstream MH		Total Length		Year Laid	Sha	ape	Location	Details	
C-	28	31	9.8		Circ	Circular			
DS Ma	anhole	Length s	surveyed	Year Renewed	Height	Width Pipe Joint			
C-	26	31	9.8		8 8 4				
SPR	N/A	MPR	2	PO Number			Customer		
0001		MPDI		4397-03			GRW		
SPRI	N/A	MPRI	2	Work Order		Purpose			
QSR	N/A	QMR	2100	4397-02		Pre-Rehabilitation St		urvey	
OF	PR	Surve	yed By	Direction	Date Media label		label		
2	2	Barry_Rogers		Upstream	20150713				
OF	PRI	Certificate Number		Pre-Cleaning	Time		Weather		
2	2 U-1012-16405		2-16405	Jetting 07:		07:54			
		Date C	leaned		End Time		Additional Info		
		2015	0713	08:12

## **Image Report 4/Page**

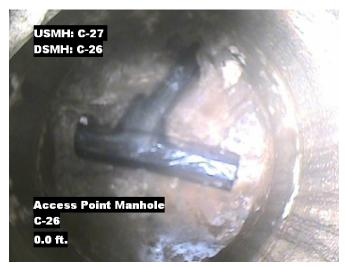
Distance: 0.0 ft. Grade: 0

Condition: Access Point Manhole

Remarks: C-26

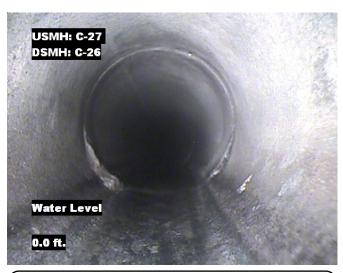
Distance: 0.0 ft. Grade: 0

Condition: Water Level

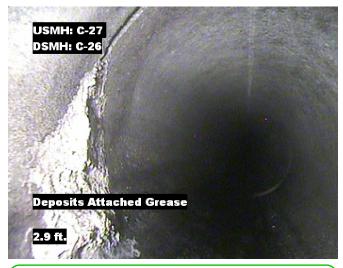
**Distance**: 2.9 ft. **Grade**: 2 **Condition**: Deposits Attached Grease

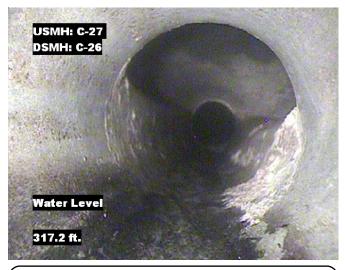
Distance: 317.2 ft. Grade: 0

Condition: Water Level

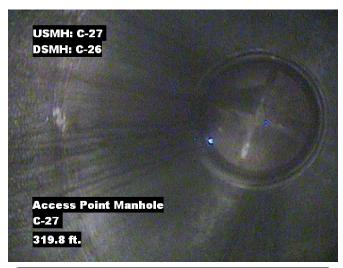
Distance: 319.8 ft. Grade: 0

Condition: Access Point Manhole

Remarks: C-27
