Defect Listing

Image Report 4/Page

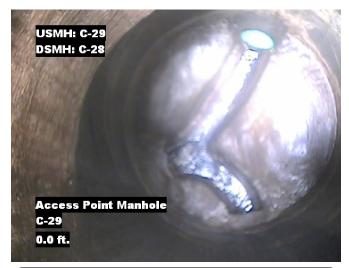
Distance: 0.0 ft. Grade: 0

Condition: Access Point Manhole

Remarks: C-29

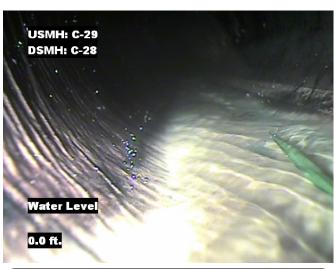
Distance: 0.0 ft. Grade: 0

Condition: Water Level

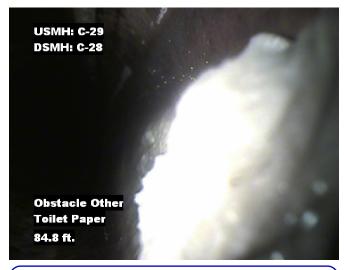
Distance: 84.8 ft. Grade: 3

Condition: Obstacle Other **Remarks:** Toilet Paper

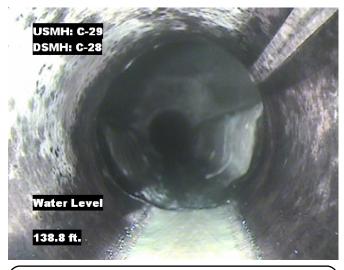
Distance: 138.8 ft. Grade: 0

Condition: Water Level

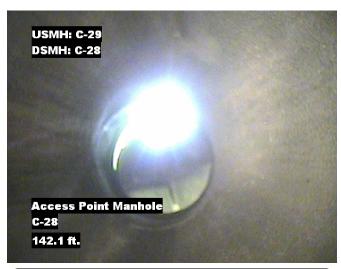
Distance: 142.1 ft. Grade: 0

Condition: Access Point Manhole

Remarks: C-28
