Defect Listing

Pipe Segment Refere		City		Street	Material		Location C	Sewer Use	
C-31_C-30		Oliver Springs		Richaeds Dr	Concrete F	Pipe (non	Light High	Sanitary	
Upstream MH		Total I	_ength	Year Laid	Sh	ape	Location	n Details	
C-	31	20	9.1		Circ	cular			
DS Manhole		Length surveyed		Year Renewed	Height	Width	Pipe Joint		
C-30		20	9.1		8	8	4		
SPR	7	MPR	4	PO Number 4397-03 Work Order		Customer			
2001	4.0					GRW			
SPRI	1.8	MPRI	2			Purpose			
QSR	2311	QMR	2200	4397-02		Pre-Rehabilitation Survey			
OF	PR	Surve	/ed By	Direction	Date		te Media label		
1	1	Barry_Rogers		Downstream	20150710				
OP	RI	Certificate Number		Pre-Cleaning	Time		Weather		
1.8		U-1012-16405		Jetting	09:47		Dry		
	Date Cleaned					End Time		Additional Info	
		2015	0710	09:48

Image Report 4/Page

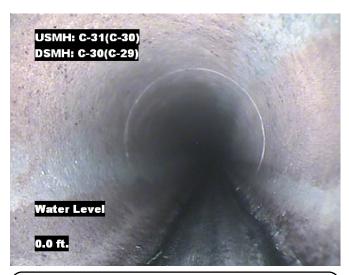
Distance: 0.0 ft. Grade: 0

Condition: Access Point Manhole

Remarks: C-31

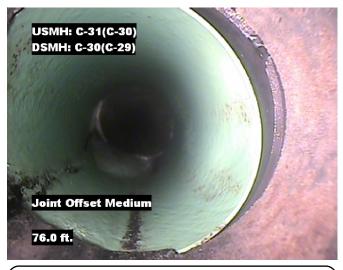
Distance: 76.0 ft. Grade: 1

Condition: Joint Offset Medium

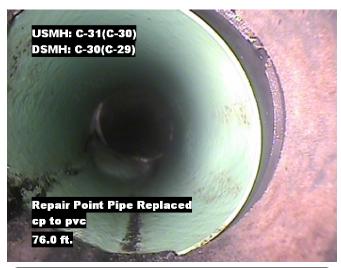
Distance: 76.0 ft. **Grade**: 0 **Condition**: Repair Point Pipe Replaced

Remarks: cp to pvc

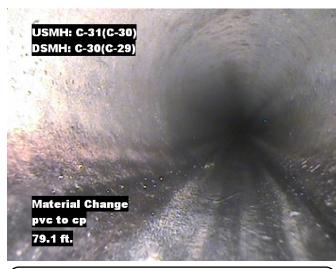
Distance: 79.1 ft. Grade: 0

Condition: Material Change

Remarks: pvc to cp

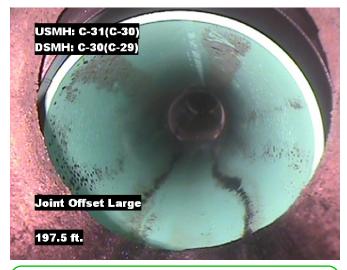
Distance: 197.5 ft. Grade: 2

Condition: Joint Offset Large

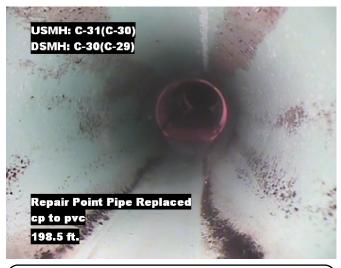
Distance: 198.5 ft. **Grade**: 0 **Condition**: Repair Point Pipe Replaced

Remarks: cp to pvc

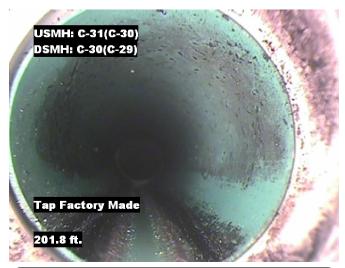
Distance: 201.8 ft. Grade: 0

Condition: Tap Factory Made

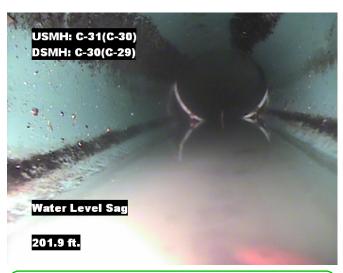
Distance: 201.9 ft. Grade: 2

Condition: Water Level Sag

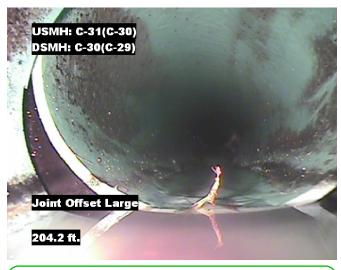
Distance: 204.2 ft. Grade: 2

Condition: Joint Offset Large

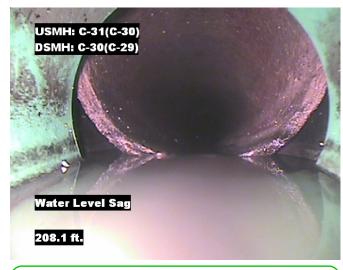
Distance: 208.1 ft. Grade: 2

Condition: Water Level Sag

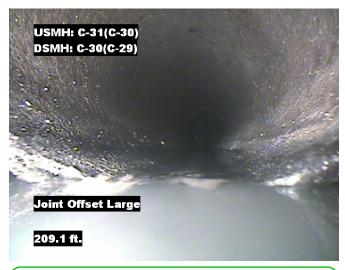
Distance: 209.1 ft. Grade: 2

Condition: Joint Offset Large

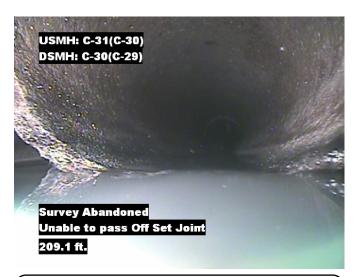
Distance: 209.1 ft. Grade: 0

Condition: Survey Abandoned

Remarks: Unable to pass Off Set Joint
