## Defect Listing

Pipe Segment Refere... <b>C-32_C-31</b>	City <b>Oliver Springs</b>	Street <b>Richaeds Dr</b>	Material <b>Concrete Pipe (non-...</b>	Location C... <b>Light High...</b>	Sewer Use <b>Sanitary</b>
Upstream MH <b>C-32</b>	Total Length <b>321.4</b>	Year Laid	Shape <b>Circular</b>	Location Details	
DS Manhole <b>C-31</b>	Length surveyed <b>321.4</b>	Year Renewed	Height <b>8</b>	Width <b>8</b>	Pipe Joint... <b>4</b>

SPR <b>2</b>	MPR <b>N/A</b>	PO Number <b>4397-03</b>	Customer <b>GRW</b>
SPRI <b>2</b>	MPRI <b>N/A</b>	Work Order <b>4397-02</b>	Purpose <b>Pre-Rehabilitation Survey</b>
QSR <b>2100</b>	QMR <b>N/A</b>		
OPR <b>2</b>	Surveyed By <b>Barry Rogers</b>	Direction <b>Downstream</b>	Date <b>20150710</b>
OPRI <b>2</b>	Certificate Number <b>U-1012-16405</b>	Pre-Cleaning <b>Jetting</b>	Time <b>08:44</b>
	Date Cleaned <b>20150710</b>	End Time <b>09:06</b>	Weather <b>Dry</b>
			Additional Info

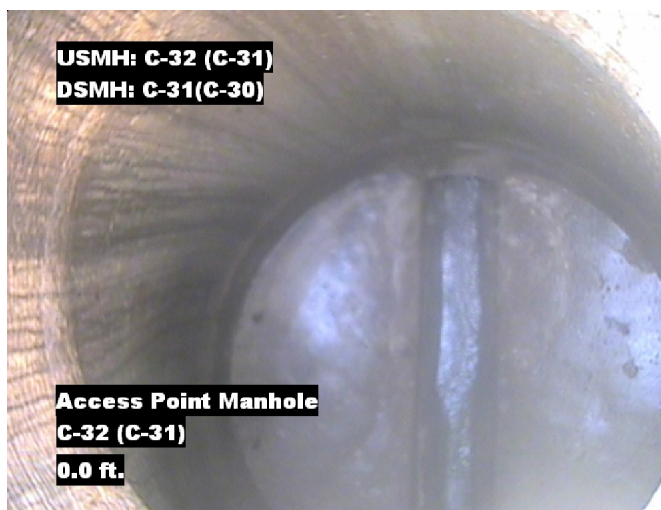
Distance: 0.0 ft. Grade: 0  
Condition: Access Point Manhole  
Remarks: C-32

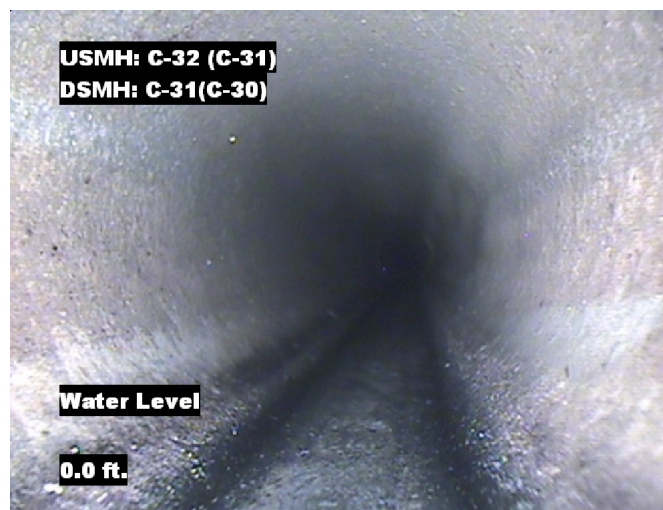
Distance: 0.0 ft. Grade: 0  
Condition: Water Level  
Remarks: N/A

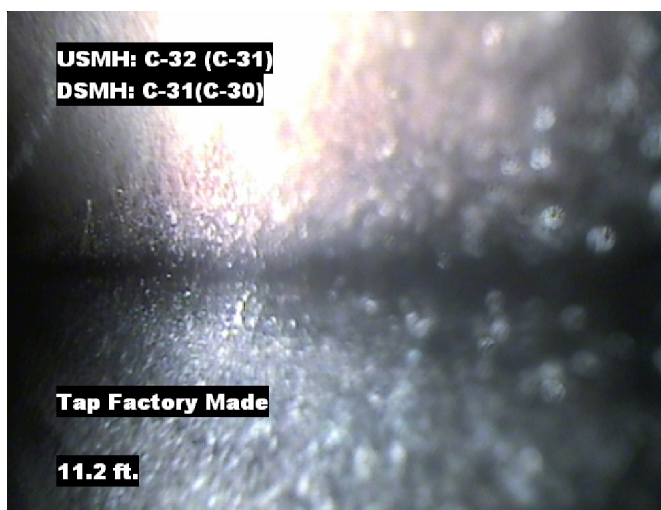
Distance: 11.2 ft. Grade: 0  
Condition: Tap Factory Made  
Remarks: N/A

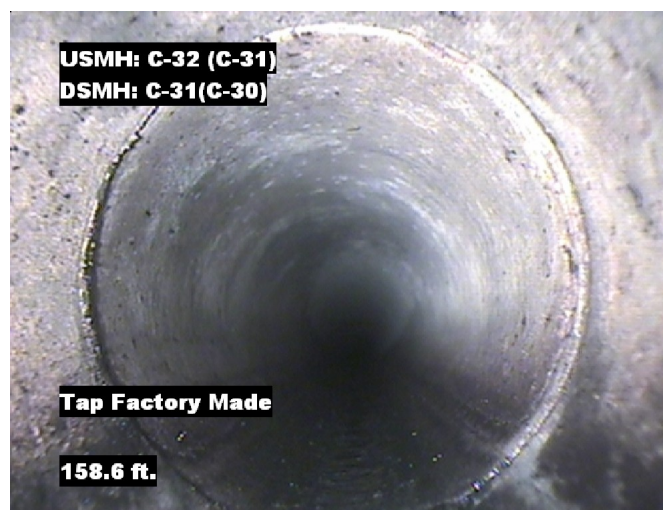
Distance: 158.6 ft. Grade: 0  
Condition: Tap Factory Made  
Remarks: N/A

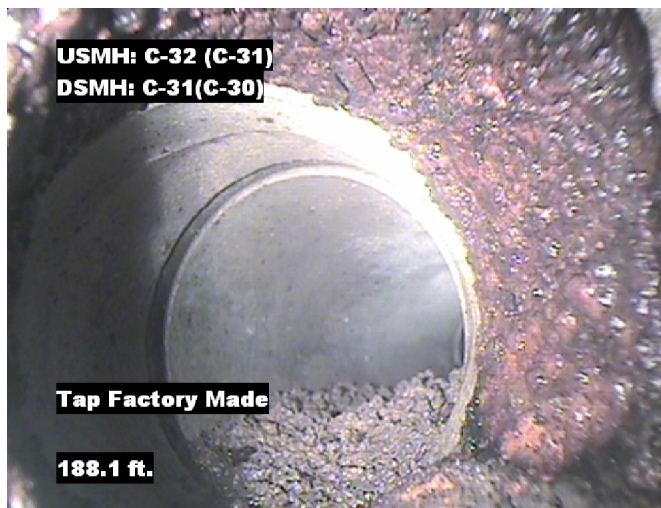
Distance: 188.1 ft. Grade: 0  
Condition: Tap Factory Made  
Remarks: N/A

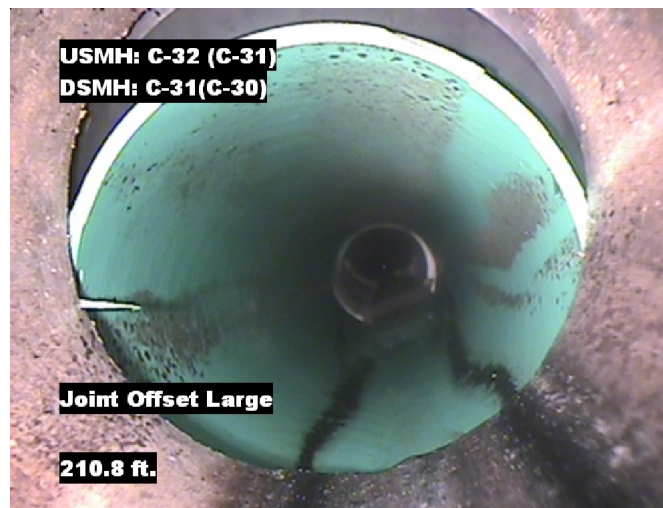
Distance: 210.8 ft. Grade: 2  
Condition: Joint Offset Large  
Remarks: N/A

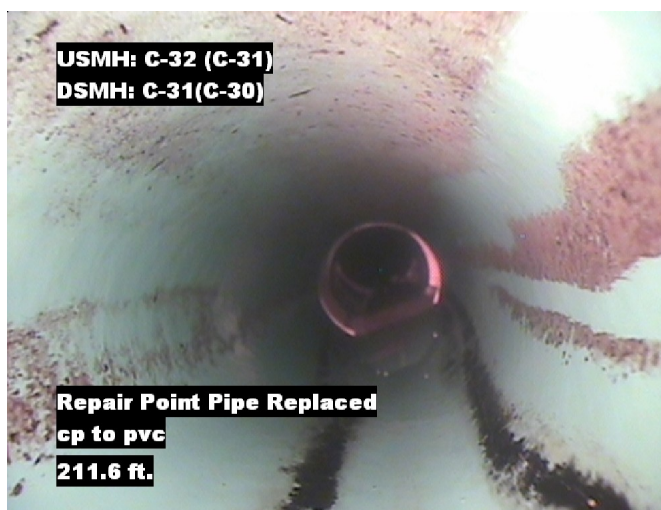
Distance: 211.6 ft. Grade: 0  
Condition: Repair Point Pipe Replaced  
Remarks: cp to pvc

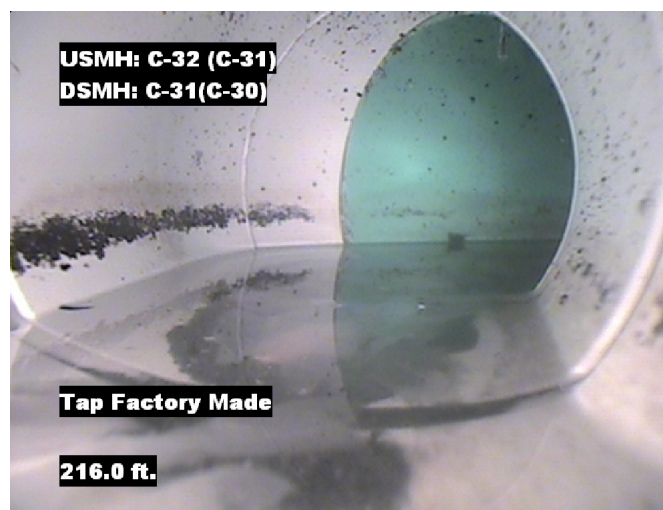
Distance: 216.0 ft. Grade: 0  
Condition: Tap Factory Made  
Remarks: N/A

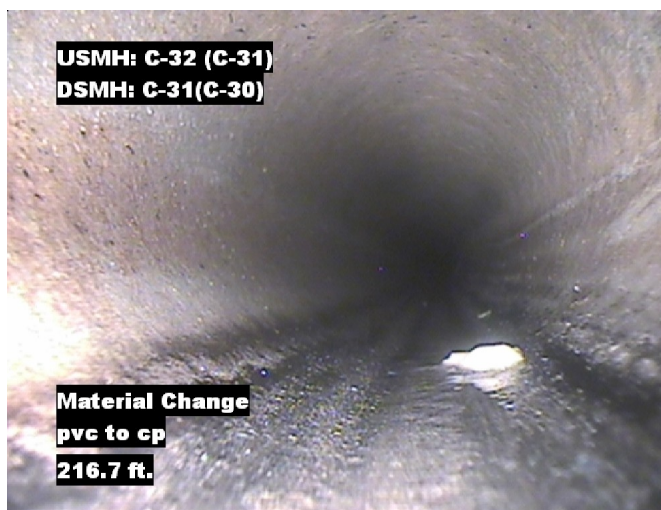
Distance: 216.7 ft.      Grade: 0  
Condition: Material Change  
Remarks: pvc to cp

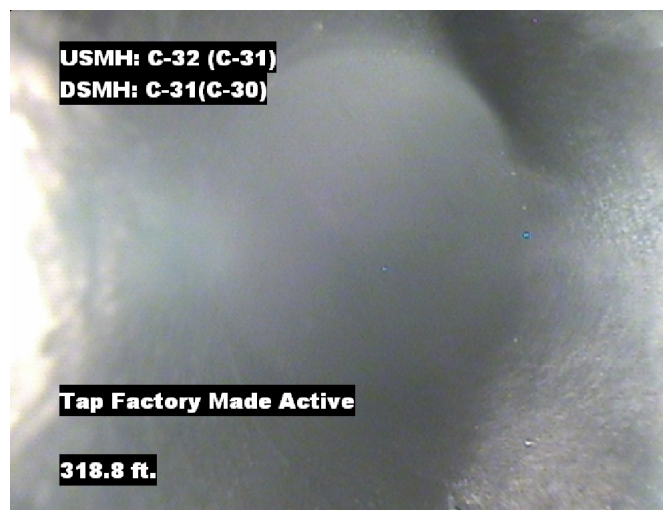
Distance: 318.8 ft.      Grade: 0  
Condition: Tap Factory Made Active  
Remarks: N/A

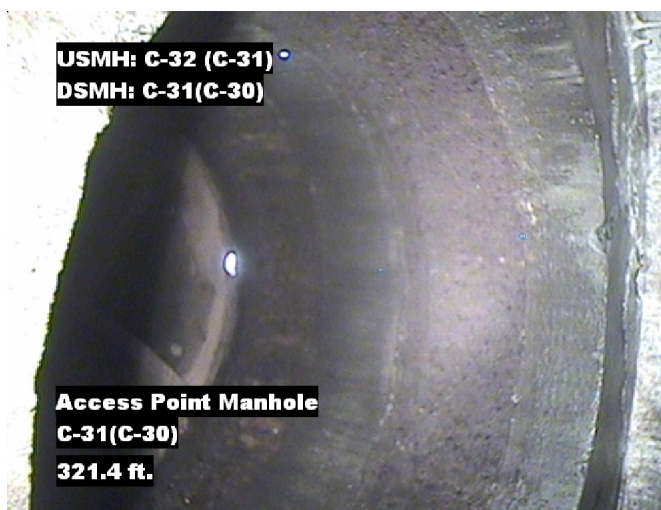
Distance: 321.4 ft.      Grade: 0  
Condition: Access Point Manhole  
Remarks: C-31
