Defect Listing

Pipe Segment Refere... C-33_C-32	City Oliver Springs	Street Richaeds DR	Material Concrete Pipe (non-...	Location C... Light High...	Sewer Use Sanitary
Upstream MH C-33	Total Length 281.2	Year Laid	Shape Circular	Location Details	
DS Manhole C-32	Length surveyed 281.2	Year Renewed	Height 8	Width 8	Pipe Joint... 4

SPR 9	MPR 2	PO Number 4397-03	Customer GRW
SPRI 3	MPRI 2	Work Order 4397-02	Purpose Pre-Rehabilitation Survey
QSR 5131	QMR 2100		
OPR 11	Surveyed By Barry Rogers	Direction Downstream	Date 20150710
OPRI 2.8	Certificate Number U-1012-16405	Pre-Cleaning Jetting	Time 08:03
	Date Cleaned 20150710	End Time 08:28	Weather Dry
			Media label
			Additional Info

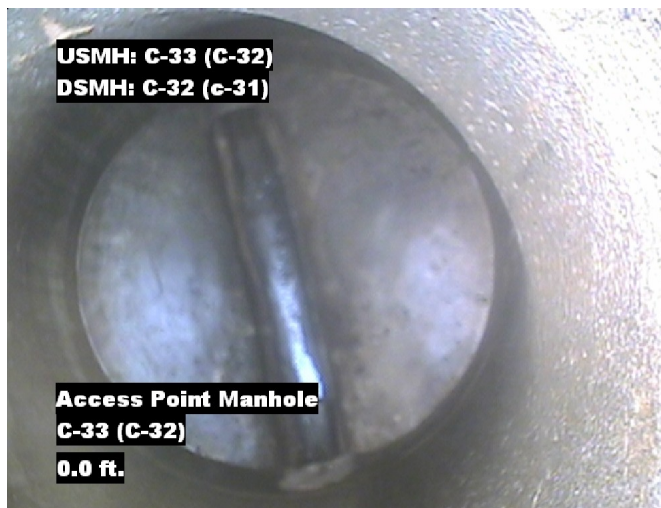
Distance: 0.0 ft. Grade: 0
Condition: Access Point Manhole
Remarks: C-33 (C-32)

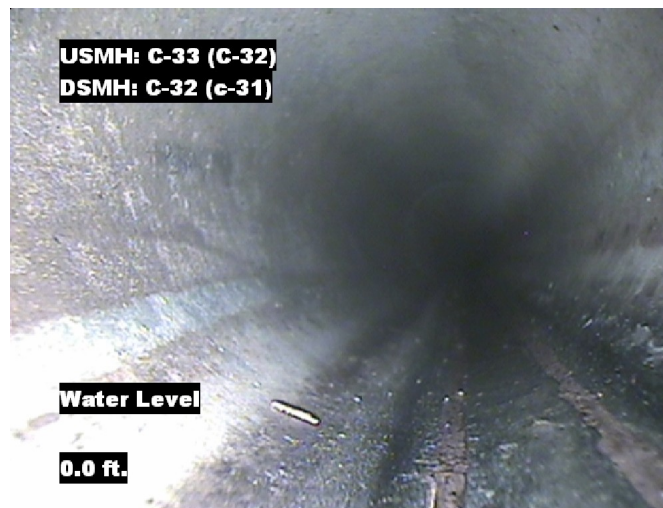
Distance: 0.0 ft. Grade: 0
Condition: Water Level
Remarks: N/A

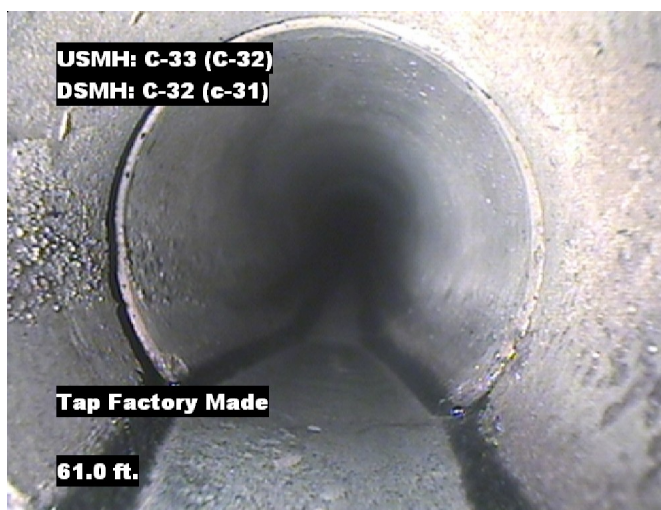
Distance: 61.0 ft. Grade: 0
Condition: Tap Factory Made
Remarks: N/A

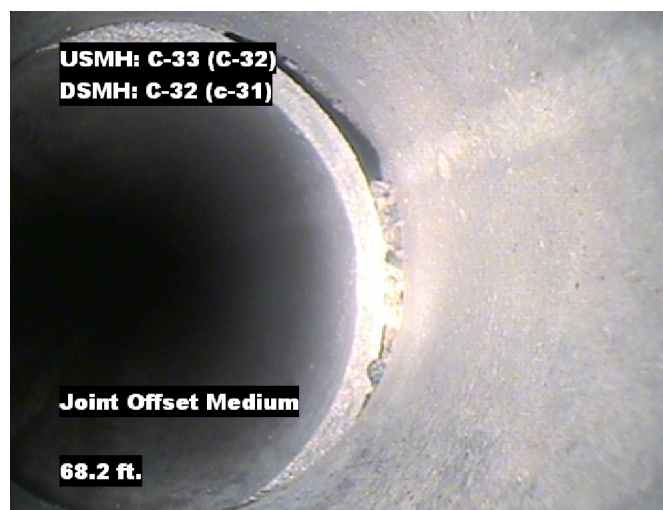
Distance: 68.2 ft. Grade: 1
Condition: Joint Offset Medium
Remarks: N/A

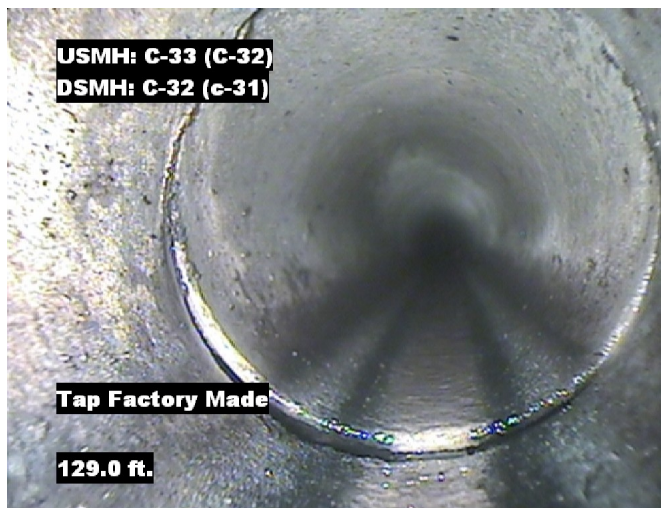
Distance: 129.0 ft. Grade: 0
Condition: Tap Factory Made
Remarks: N/A

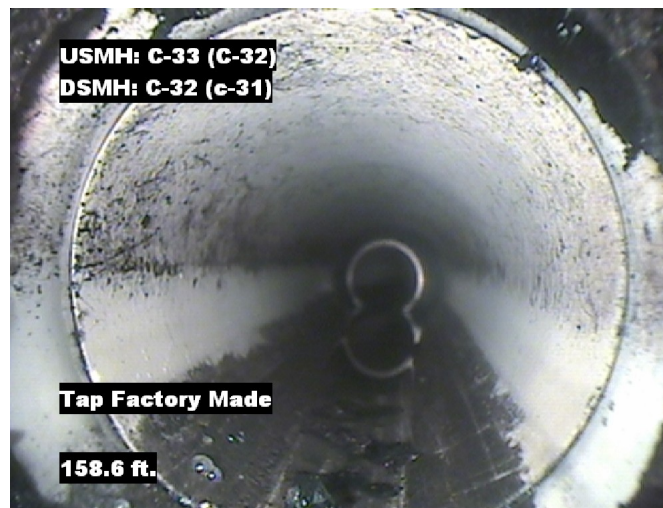
Distance: 158.6 ft. Grade: 0
Condition: Tap Factory Made
Remarks: N/A

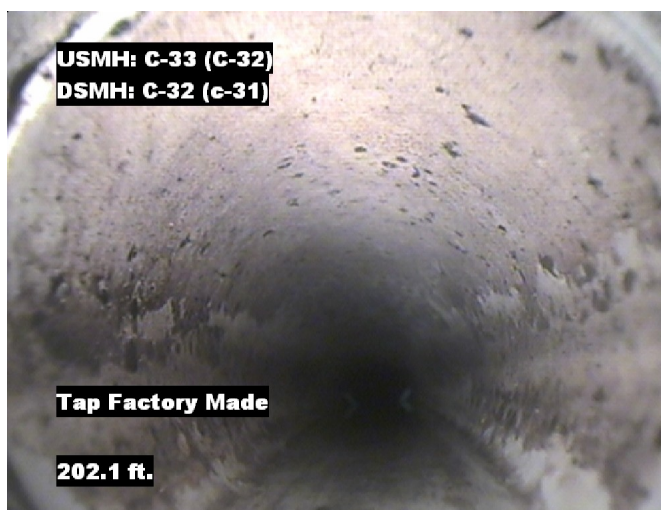
Distance: 202.1 ft. Grade: 0
Condition: Tap Factory Made
Remarks: N/A

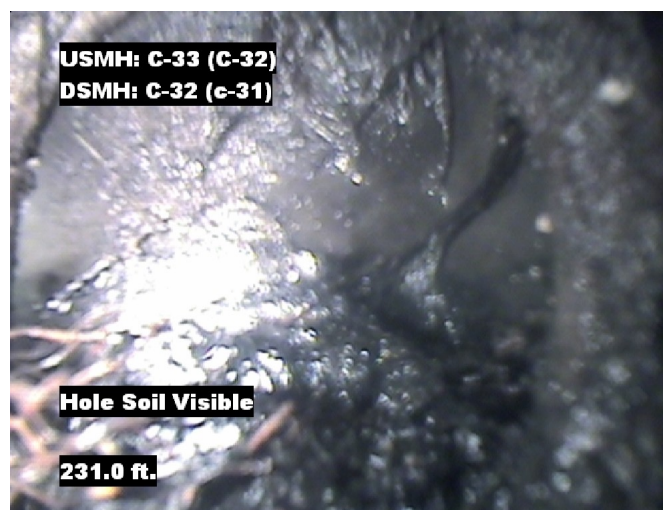
Distance: 231.0 ft. Grade: 5
Condition: Hole Soil Visible
Remarks: N/A

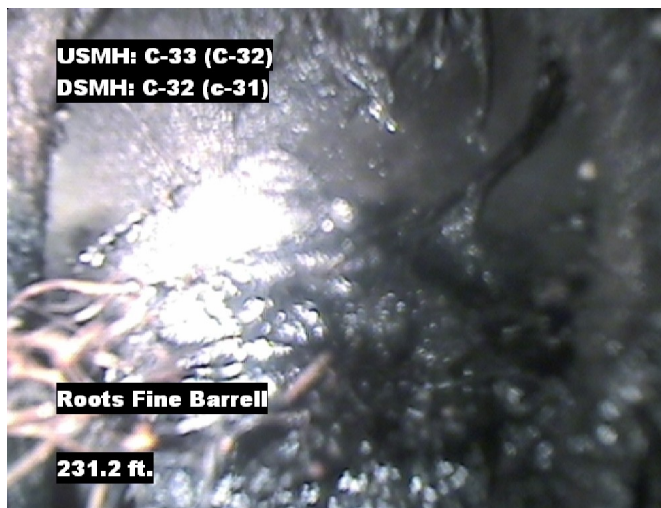
Distance: 231.2 ft. Grade: 2
Condition: Roots Fine Barrell
Remarks: N/A

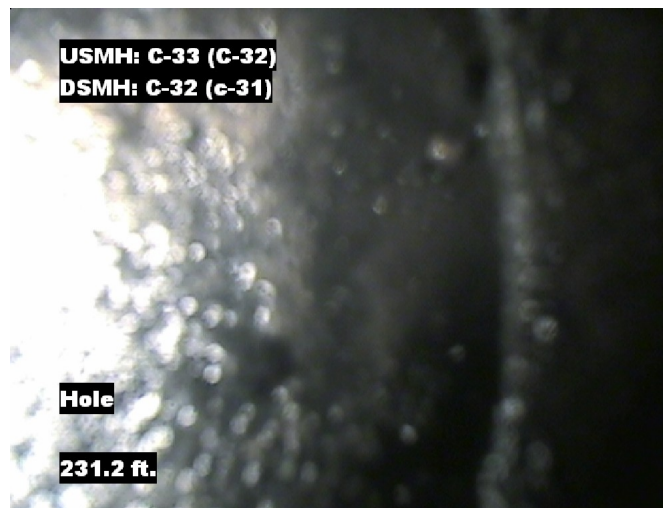
Distance: 231.2 ft. Grade: 3
Condition: Hole
Remarks: N/A

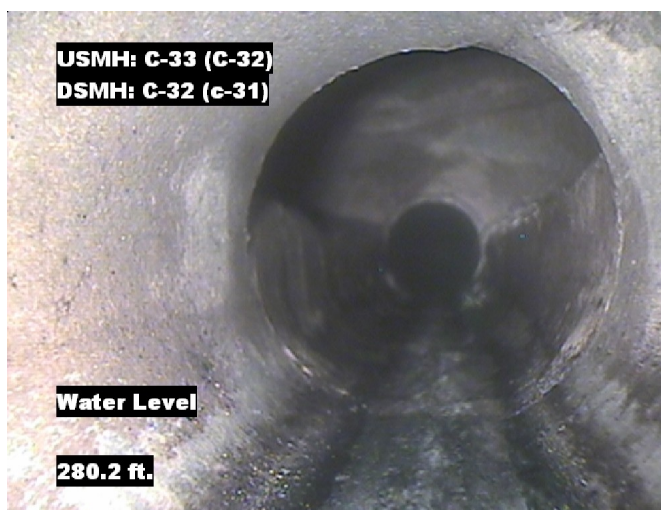
Distance: 280.2 ft. Grade: 0
Condition: Water Level
Remarks: N/A

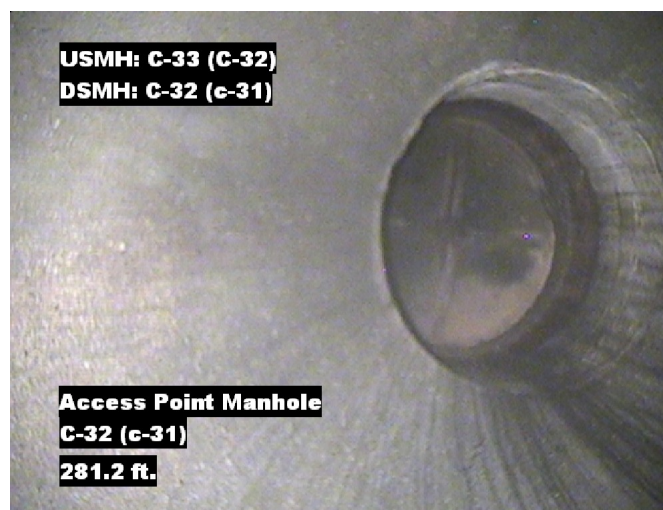
Distance: 281.2 ft. Grade: 0
Condition: Access Point Manhole
Remarks: C-32 (c-31)
