## Defect Listing

Pipe Segment Refere...	City	Street	Material	Location C...	Sewer Use
<b>C-34_C-33</b>	<b>Oliver Springs</b>	<b>Richaeds Dr</b>	<b>Concrete Pipe (non-...</b>	<b>Light High...</b>	<b>Sanitary</b>
Upstream MH	Total Length	Year Laid	Shape	Location Details	
<b>C-34</b>	<b>280.3</b>		<b>Circular</b>		
DS Manhole	Length surveyed	Year Renewed	Height	Width	Pipe Joint...
<b>C-33</b>	<b>280.3</b>		<b>8</b>	<b>8</b>	<b>4</b>

SPR	N/A	MPR	N/A	PO Number	Customer
SPRI	N/A	MPRI	N/A	<b>4397-03</b>	<b>GRW</b>
QSR	N/A	QMR	N/A	Work Order	Purpose
				<b>4397-02</b>	<b>Pre-Rehabilitation Survey</b>
OPR	Surveyed By	Direction	Date	Media label	
N/A	<b>Barry Rogers</b>	<b>Downstream</b>	<b>20150710</b>		
OPRI	Certificate Number	Pre-Cleaning	Time	Weather	
N/A	<b>U-1012-16405</b>	<b>Jetting</b>	<b>07:21</b>	<b>Dry</b>	
Date Cleaned			End Time	Additional Info	
<b>20150710</b>			<b>07:46</b>

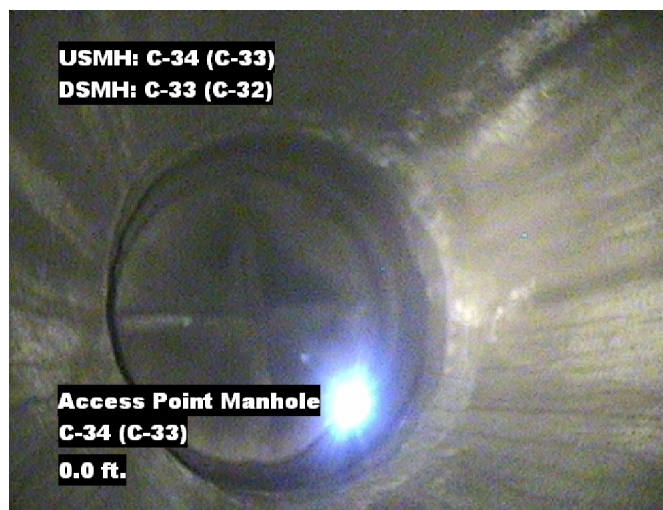
Distance: 0.0 ft. Grade: 0  
Condition: Access Point Manhole  
Remarks: C-34

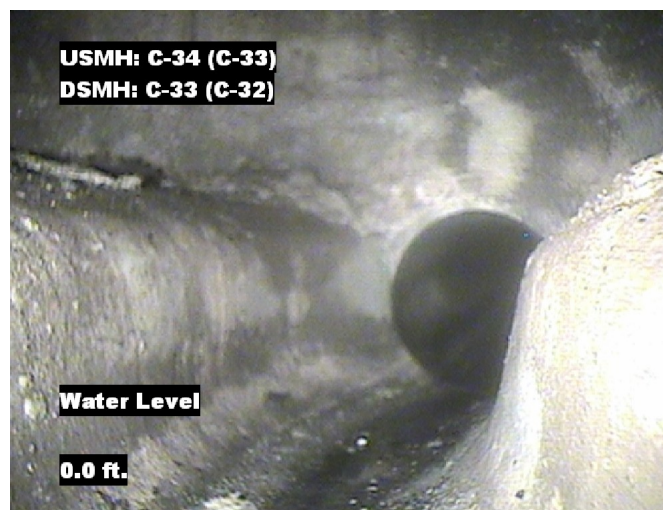
Distance: 0.0 ft. Grade: 0  
Condition: Water Level  
Remarks: N/A

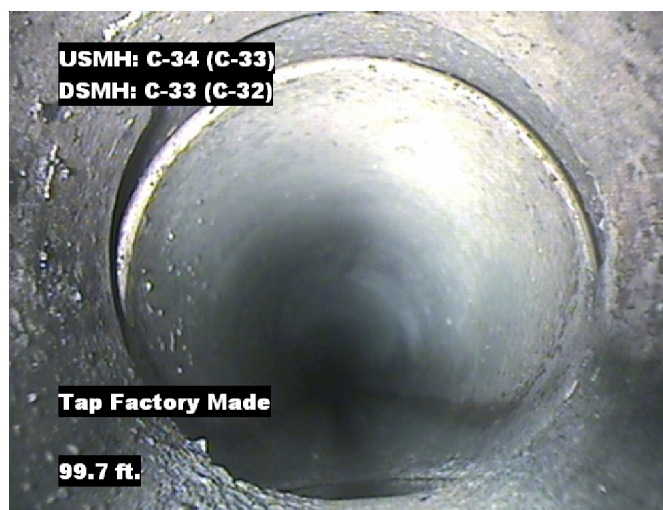
Distance: 99.7 ft. Grade: 0  
Condition: Tap Factory Made  
Remarks: N/A

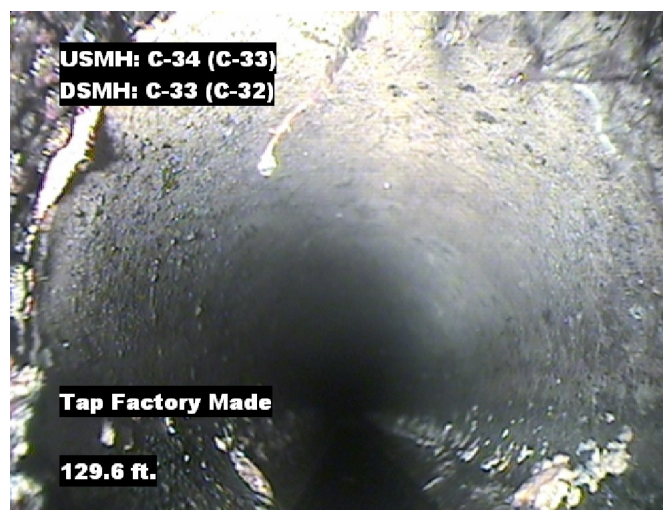
Distance: 129.6 ft. Grade: 0  
Condition: Tap Factory Made  
Remarks: N/A

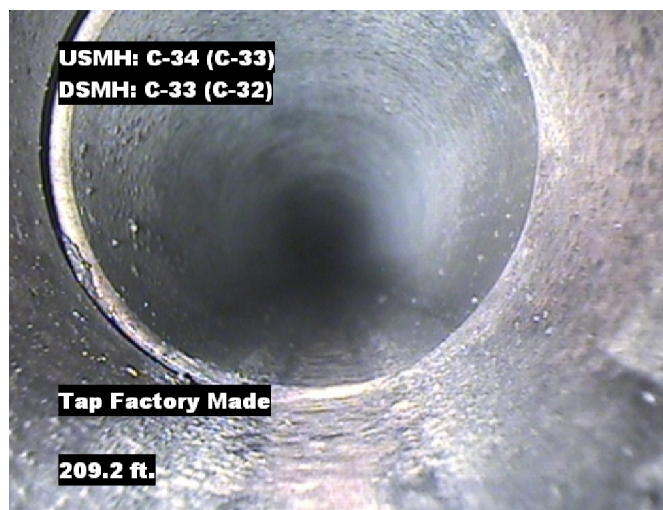
Distance: 209.2 ft. Grade: 0  
Condition: Tap Factory Made  
Remarks: N/A

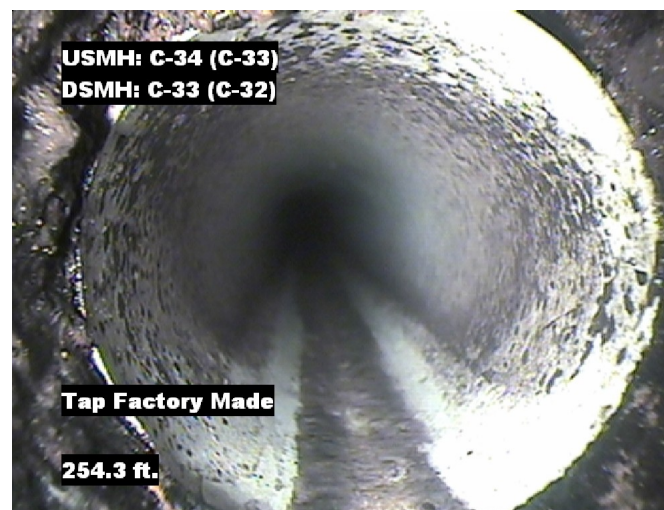
Distance: 254.3 ft. Grade: 0  
Condition: Tap Factory Made  
Remarks: N/A

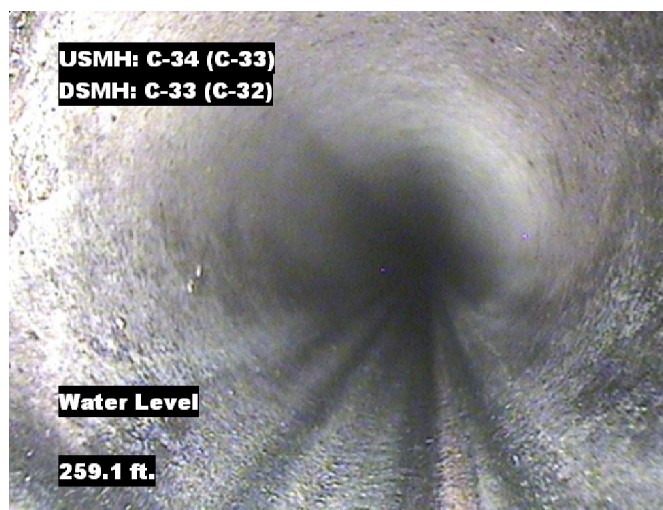
Distance: 259.1 ft. Grade: 0  
Condition: Water Level  
Remarks: N/A

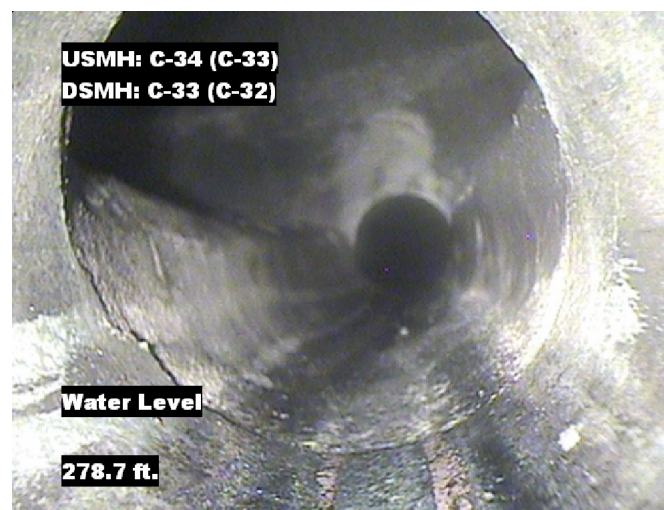
Distance: 278.7 ft. Grade: 0  
Condition: Water Level  
Remarks: N/A

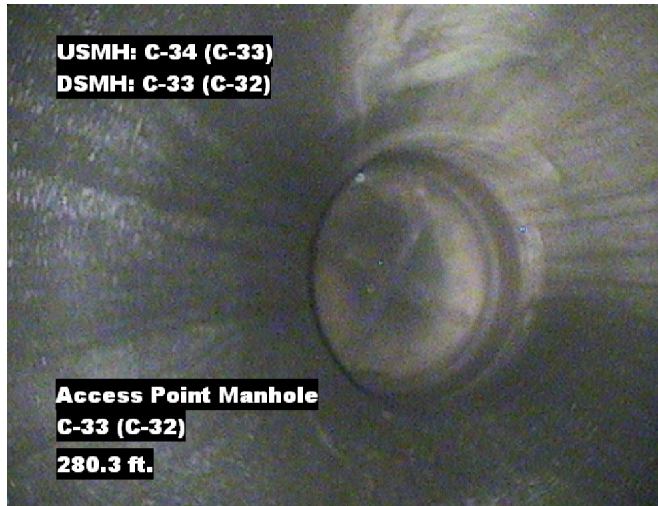
Distance: 280.3 ft. Grade: 0  
Condition: Access Point Manhole  
Remarks: C-33
