Defect Listing

Pipe Segment Refere... C-35_C-34	City Oliver Springs	Street Richards Dr	Material Concrete Pipe (non-...	Location C... Light High...	Sewer Use Sanitary
Upstream MH C-35	Total Length 149.6	Year Laid	Shape Circular	Location Details	
DS Manhole C-34	Length surveyed 149.6	Year Renewed	Height 8	Width 8	Pipe Joint... 4

SPR N/A	MPR N/A	PO Number 4397-03		Customer GRW	
SPRI N/A	MPRI N/A	Work Order 4397-02		Purpose Pre-Rehabilitation Survey	
QSR N/A	QMR N/A				
OPR N/A	Surveyed By Barry Rogers	Direction Downstream	Date 20150710	Media label	
OPRI N/A	Certificate Number U-1012-16405	Pre-Cleaning Jetting	Time 07:04	Weather Dry	
Date Cleaned 20150710			End Time 07:15	Additional Info

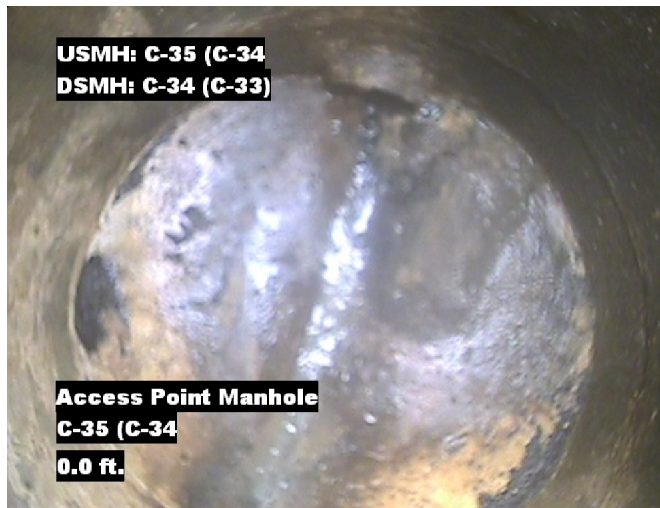
Distance: 0.0 ft. Grade: 0
Condition: Access Point Manhole
Remarks: C-35

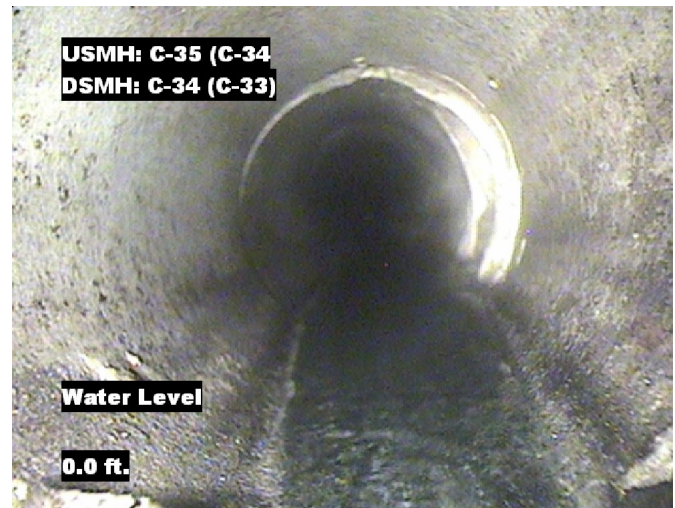
Distance: 0.0 ft. Grade: 0
Condition: Water Level
Remarks: N/A

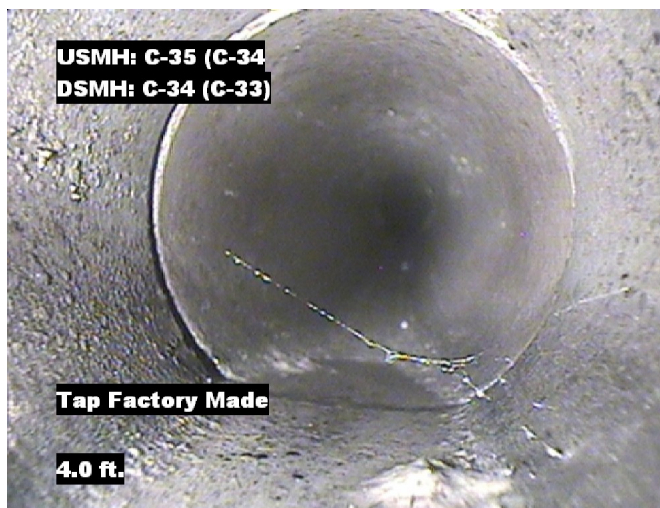
Distance: 4.0 ft. Grade: 0
Condition: Tap Factory Made
Remarks: N/A

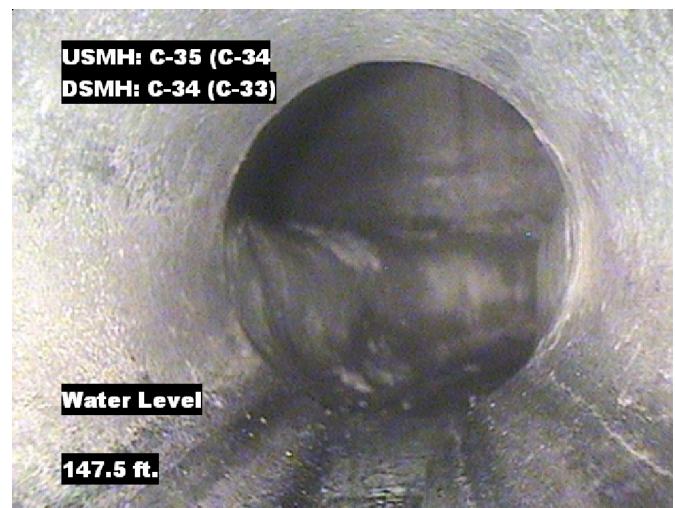
Distance: 147.5 ft. Grade: 0
Condition: Water Level
Remarks: N/A

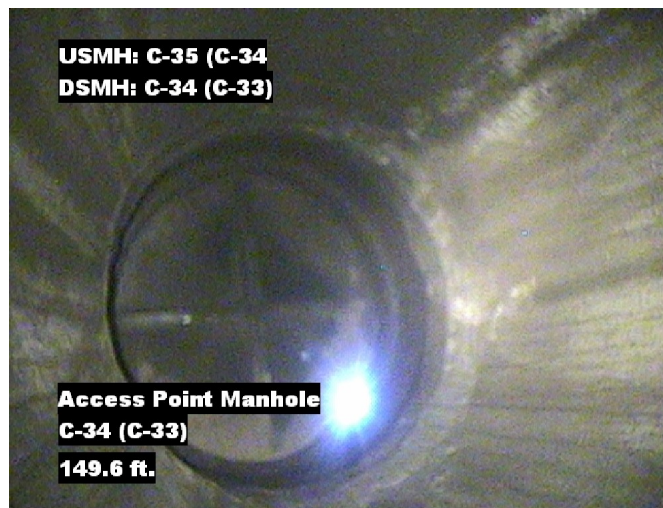
Distance: 149.6 ft. Grade: 0
Condition: Access Point Manhole
Remarks: C-34
