Defect Listing

Pipe Segment Refere... C1-1_C-1	City Oliver Springs	Street Strutt St	Material Fibreglass Reinf...	Location C... Easement/R...	Sewer Use Sanitary
Upstream MH C1-1	Total Length 115.8	Year Laid	Shape Circular	Location Details	
DS Manhole C-1	Length surveyed 115.8	Year Renewed	Height 8	Width 8	Pipe Joint... N/A

Image Report 4/Page

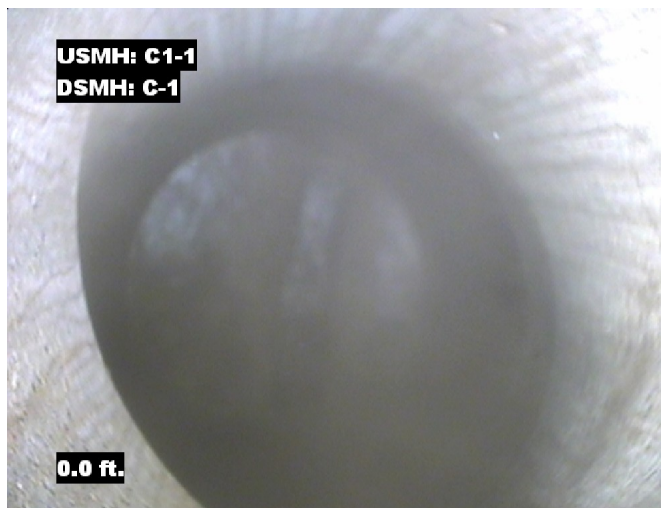
Distance: 0.0 ft. Grade: 0
Condition: Access Point Manhole
Remarks: C1-1

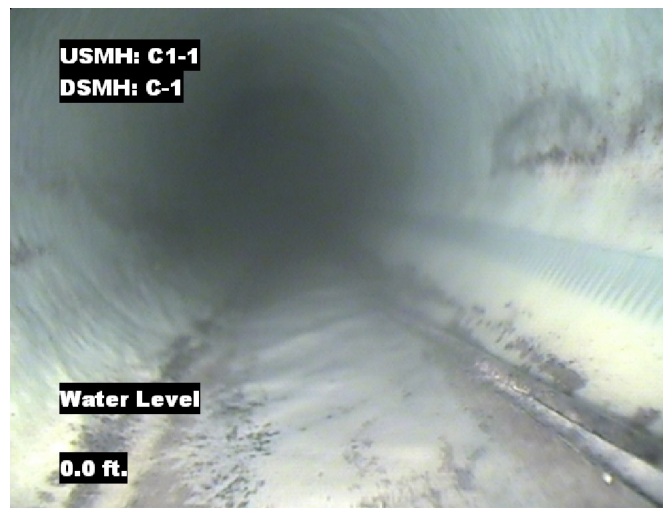
Distance: 0.0 ft. Grade: 0
Condition: Water Level
Remarks: N/A

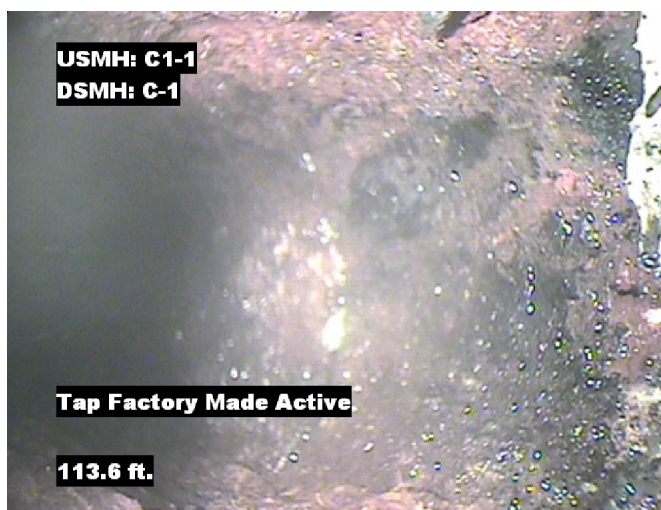
Distance: 113.6 ft. Grade: 0
Condition: Tap Factory Made Active
Remarks: N/A

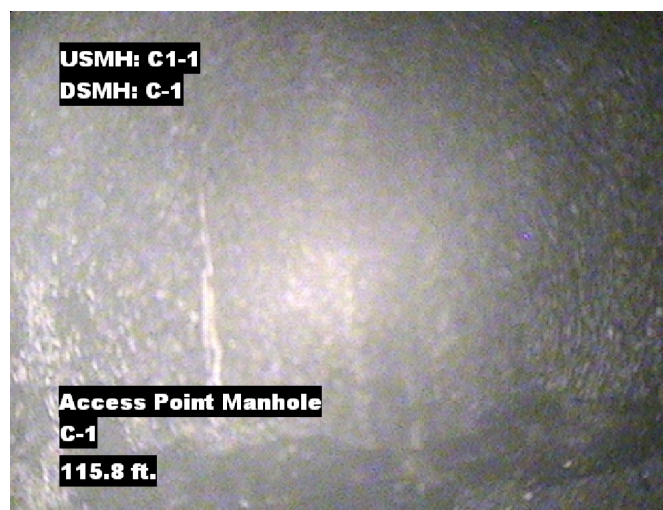
Distance: 115.8 ft. Grade: 0
Condition: Access Point Manhole
Remarks: C-1
