Defect Listing

Pipe Segment Refere... C1-2_C1-1	City Oliver Springs	Street Johnson RD	Material Fibreglass Reinforc...	Location C... Easement/R...	Sewer Use Sanitary
Upstream MH C1-2	Total Length 332.7	Year Laid	Shape Circular	Location Details	
DS Manhole C1-1	Length surveyed 332.7	Year Renewed	Height 8	Width 8	Pipe Joint... N/A

SPR 198	MPR N/A	PO Number 4397-03	Customer GRW
SPRI 3	MPRI N/A	Work Order 4397-02	Purpose Pre-Rehabilitation Survey
QSR 3L00	QMR N/A		
OPR 198	Surveyed By Barry Rogers	Direction Downstream	Date 20150724
OPRI 3	Certificate Number U-1012-16405	Pre-Cleaning Jetting	Time 10:00
	Date Cleaned 20150724	End Time 10:32	Weather Dry
		Additional Info

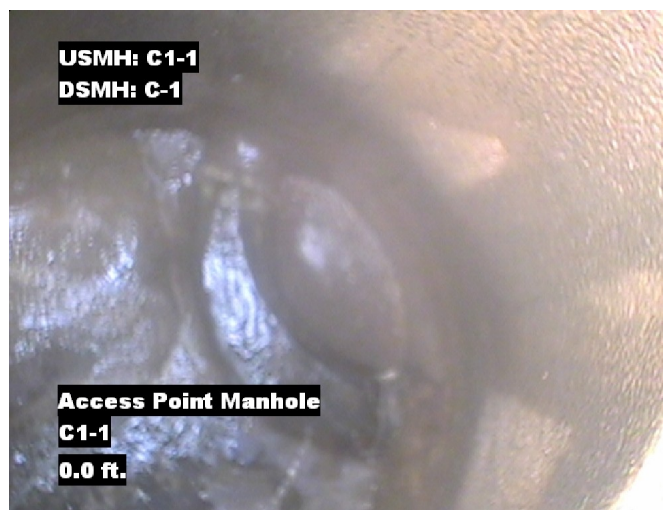
Distance: 0.0 ft. Grade: 0
Condition: Access Point Manhole
Remarks: C1-1

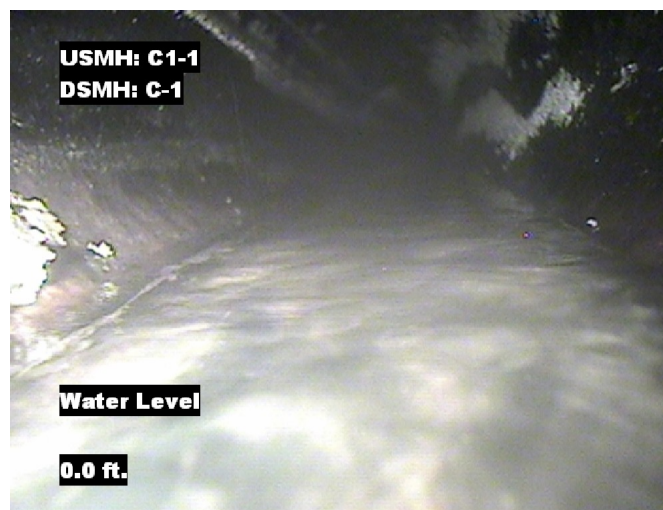
Distance: 0.0 ft. Grade: 0
Condition: Water Level
Remarks: N/A

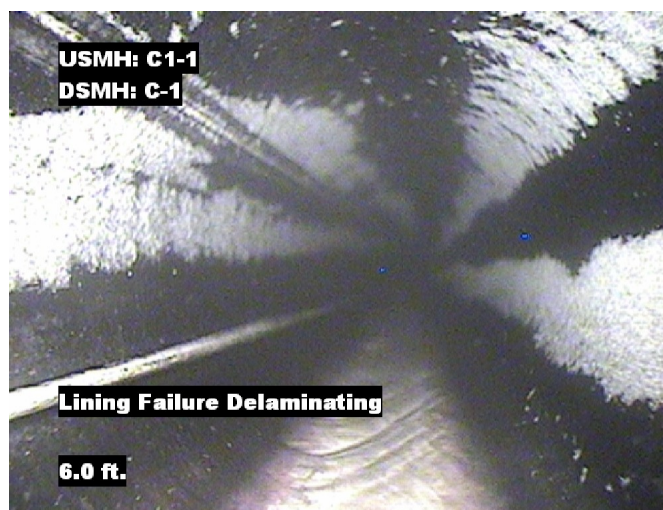
Distance: 6.0 ft. Grade: 3
Condition: Lining Failure Delaminating
Remarks: N/A

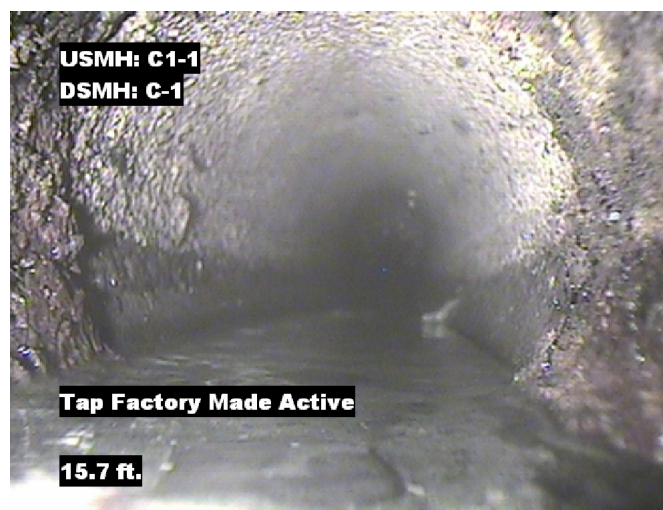
Distance: 15.7 ft. Grade: 0
Condition: Tap Factory Made Active
Remarks: N/A

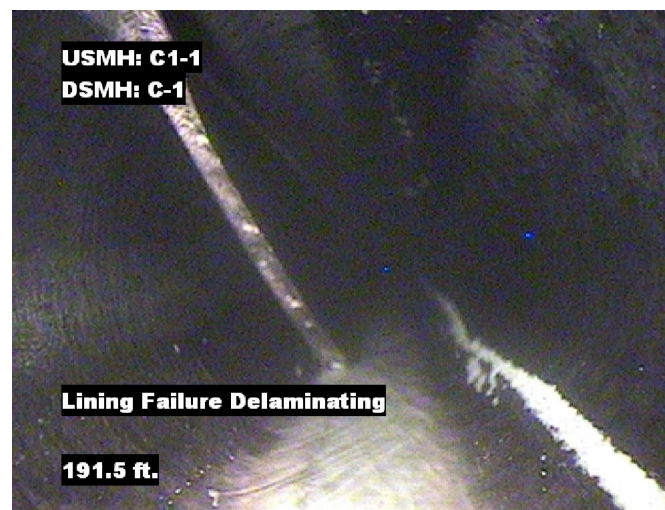
Distance: 191.5 ft. Grade: 3
Condition: Lining Failure Delaminating
Remarks: N/A

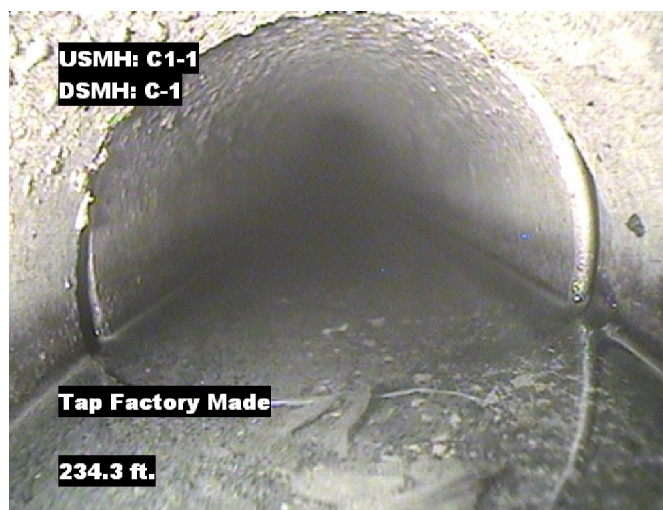
Distance: 234.3 ft. Grade: 0
Condition: Tap Factory Made
Remarks: N/A

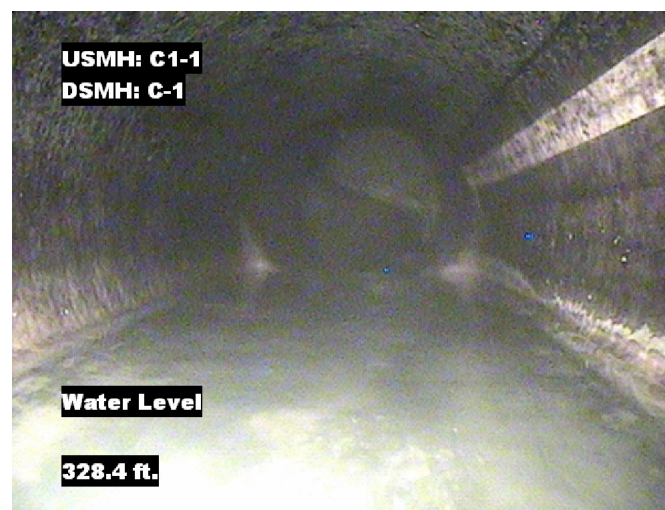
Distance: 328.4 ft. Grade: 0
Condition: Water Level
Remarks: N/A

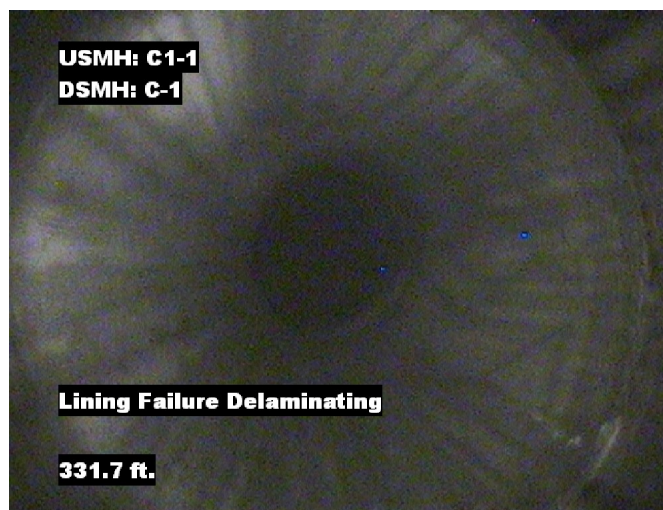
Distance: 331.7 ft. Grade: 3
Condition: Lining Failure Delaminating
Remarks: N/A

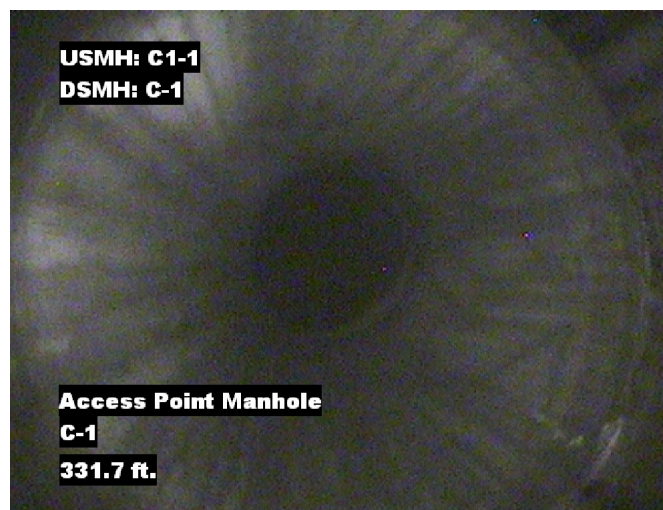
Distance: 332.7 ft. Grade: 0
Condition: Access Point Manhole
Remarks: C-1
