## Defect Listing

Pipe Segment Refere... <b>C1-3_C1-2</b>	City <b>Oliver Springs</b>	Street <b>Bennett</b>	Material <b>Fibreglass Reinforc...</b>	Location C... <b>Light High...</b>	Sewer Use <b>Sanitary</b>
Upstream MH <b>C1-3</b>	Total Length <b>261.7</b>	Year Laid	Shape <b>Circular</b>	Location Details	
DS Manhole <b>C1-2</b>	Length surveyed <b>261.7</b>	Year Renewed	Height <b>8</b>	Width <b>8</b>	Pipe Joint... <b>N/A</b>

SPR <b>N/A</b>	MPR <b>N/A</b>	PO Number <b>4397-03</b>		Customer <b>GRW</b>	
SPRI <b>N/A</b>	MPRI <b>N/A</b>	Work Order <b>4397-02</b>		Purpose <b>Pre-Rehabilitation Survey</b>	
QSR <b>N/A</b>	QMR <b>N/A</b>				
OPR <b>N/A</b>	Surveyed By <b>Barry Rogers</b>	Direction <b>Downstream</b>	Date <b>20150724</b>	Media label	
OPRI <b>N/A</b>	Certificate Number <b>U-1012-16405</b>	Pre-Cleaning <b>Jetting</b>	Time <b>09:35</b>	Weather <b>Saturated</b>	
Date Cleaned <b>20150724</b>			End Time <b>09:51</b>	Additional Info

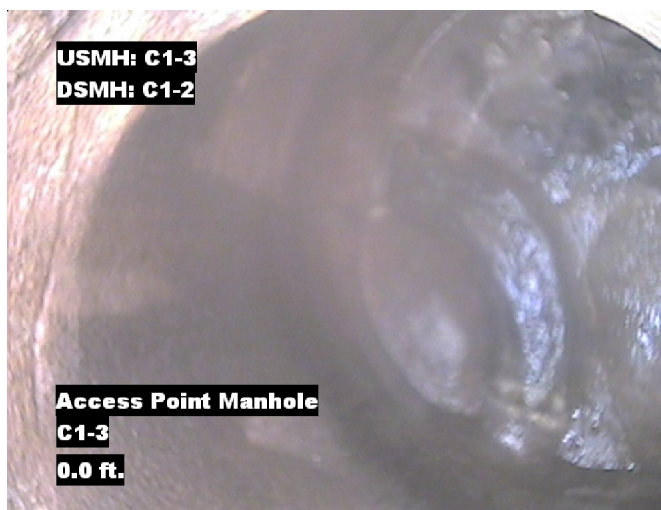
Distance: 0.0 ft. Grade: 0  
Condition: Access Point Manhole  
Remarks: C1-3

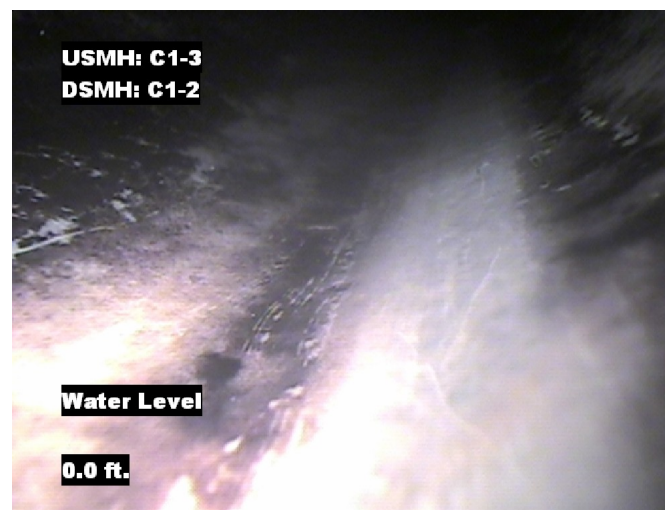
Distance: 0.0 ft. Grade: 0  
Condition: Water Level  
Remarks: N/A

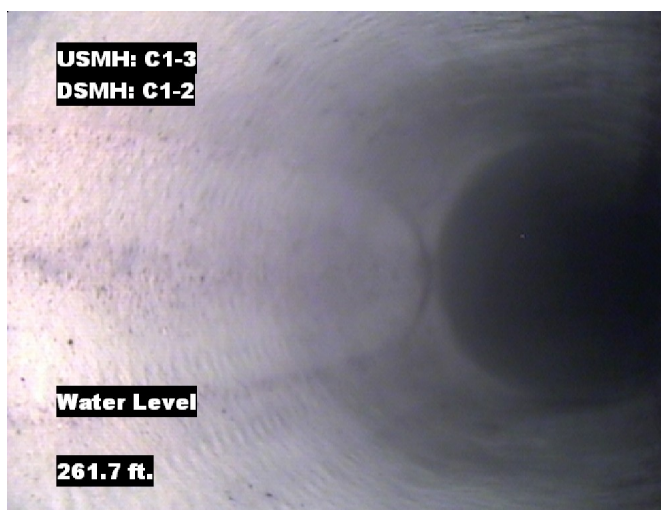
Distance: 261.7 ft. Grade: 0  
Condition: Water Level  
Remarks: N/A

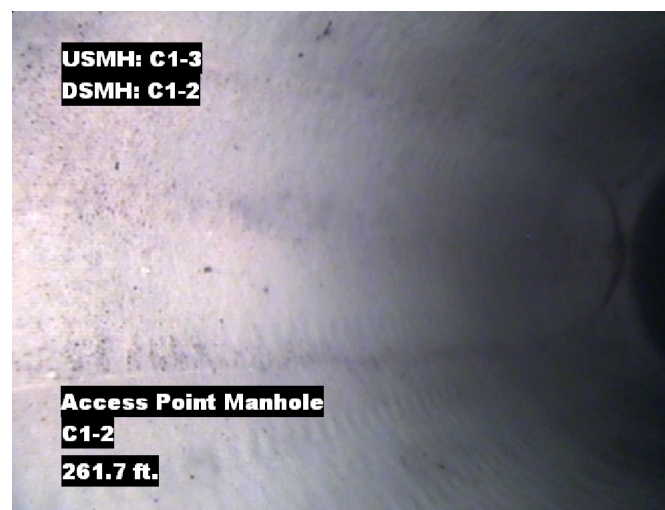
Distance: 261.7 ft. Grade: 0  
Condition: Access Point Manhole  
Remarks: C1-2
