## Defect Listing

Pipe Segment Refere... <b>C1-4_C1-3</b>	City <b>Oliver Springs</b>	Street <b>Bennett</b>	Material <b>Fibreglass Reinforc...</b>	Location C... <b>Light High...</b>	Sewer Use <b>Sanitary</b>
Upstream MH <b>C1-4</b>	Total Length <b>229.4</b>	Year Laid	Shape <b>Circular</b>	Location Details	
DS Manhole <b>C1-3</b>	Length surveyed <b>229.4</b>	Year Renewed	Height <b>8</b>	Width <b>8</b>	Pipe Joint... <b>N/A</b>

SPR <b>N/A</b>	MPR <b>N/A</b>	PO Number <b>4397-03</b>	Customer <b>GRW</b>
SPRI <b>N/A</b>	MPRI <b>N/A</b>	Work Order <b>4397-02</b>	Purpose <b>Pre-Rehabilitation Survey</b>
QSR <b>N/A</b>	QMR <b>N/A</b>		
OPR <b>N/A</b>	Surveyed By <b>Barry Rogers</b>	Direction <b>Downstream</b>	Date <b>20150724</b>
OPRI <b>N/A</b>	Certificate Number <b>U-1012-16405</b>	Pre-Cleaning <b>Jetting</b>	Time <b>09:12</b>
	Date Cleaned <b>20150724</b>	End Time <b>09:21</b>	Weather <b>Saturated</b>
			Additional Info <b>Mh C1-3 has been li...</b>

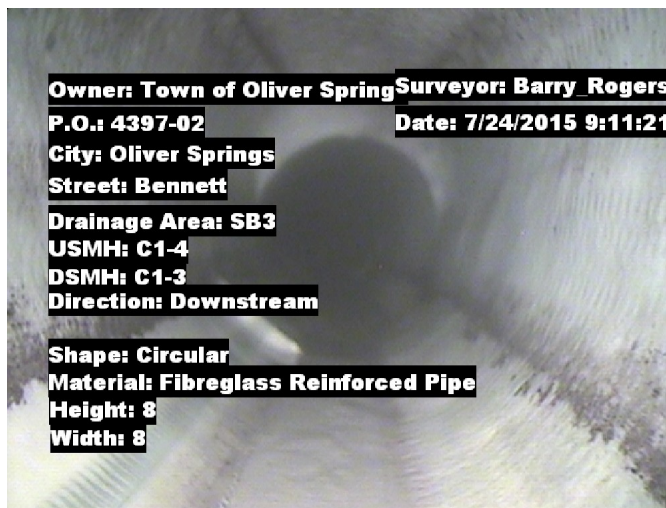
Distance: 0.0 ft. Grade: 0  
Condition: Access Point Manhole  
Remarks: C1-4

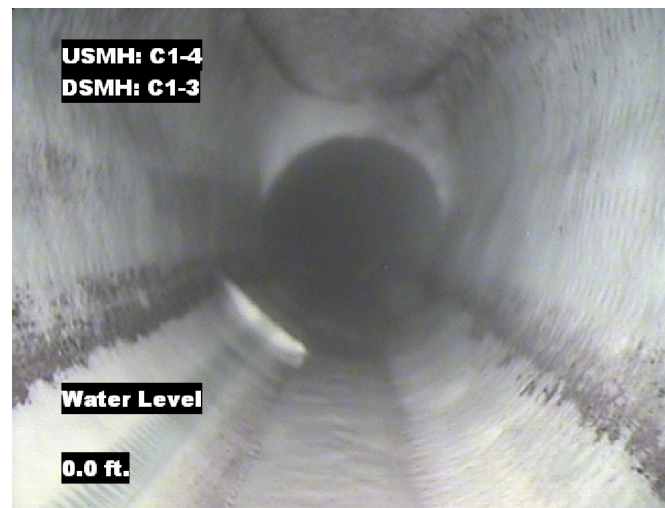
Distance: 0.0 ft. Grade: 0  
Condition: Water Level  
Remarks: N/A

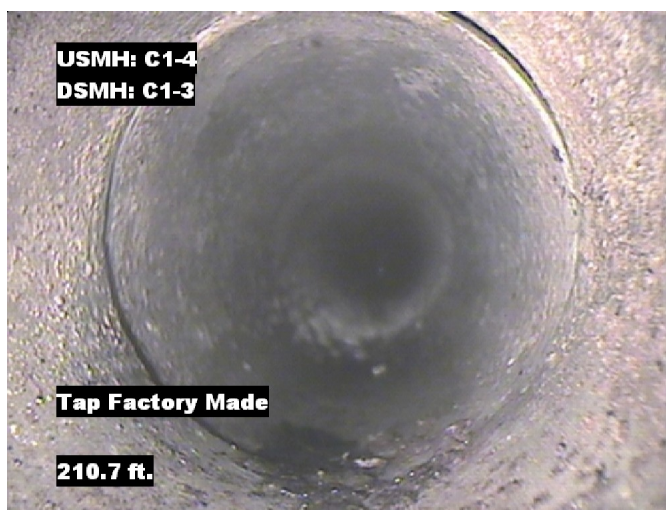
Distance: 210.7 ft. Grade: 0  
Condition: Tap Factory Made  
Remarks: N/A

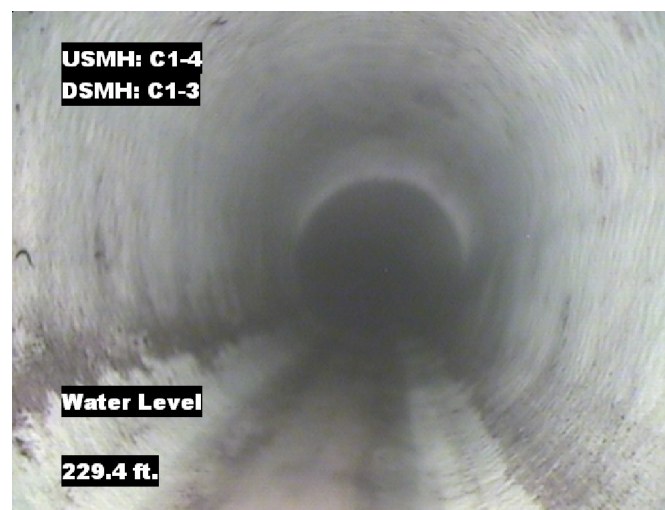
Distance: 229.4 ft. Grade: 0  
Condition: Water Level  
Remarks: N/A

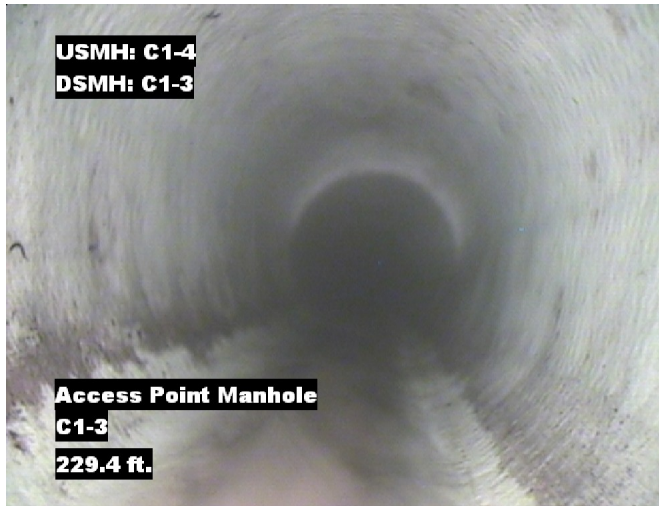
Distance: 229.4 ft. Grade: 0  
Condition: Access Point Manhole  
Remarks: C1-3
