## Defect Listing

Pipe Segment Refere... <b>C1-5_C1-4</b>	City <b>Oliver Springs</b>	Street <b>Bennett dr</b>	Material <b>Fibreglass Reinforc...</b>	Location C... <b>Light High...</b>	Sewer Use <b>Sanitary</b>
Upstream MH <b>C1-5</b>	Total Length <b>174.6</b>	Year Laid	Shape <b>Circular</b>	Location Details	
DS Manhole <b>C1-4</b>	Length surveyed <b>174.6</b>	Year Renewed	Height <b>8</b>	Width <b>8</b>	Pipe Joint... <b>N/A</b>

SPR <b>N/A</b>	MPR <b>N/A</b>	PO Number <b>4397-03</b>	Customer <b>GRW</b>
SPRI <b>N/A</b>	MPRI <b>N/A</b>	Work Order <b>4397-02</b>	Purpose <b>Pre-Rehabilitation Survey</b>
QSR <b>N/A</b>	QMR <b>N/A</b>		
OPR <b>N/A</b>	Surveyed By <b>Barry Rogers</b>	Direction <b>Downstream</b>	Date <b>20150724</b>
OPRI <b>N/A</b>	Certificate Number <b>U-1012-16405</b>	Pre-Cleaning <b>Jetting</b>	Time <b>08:57</b>
	Date Cleaned <b>20150724</b>	End Time <b>09:08</b>	Weather <b>Saturated</b>
		Additional Info <b>Mh C1-4 has liner t...</b>

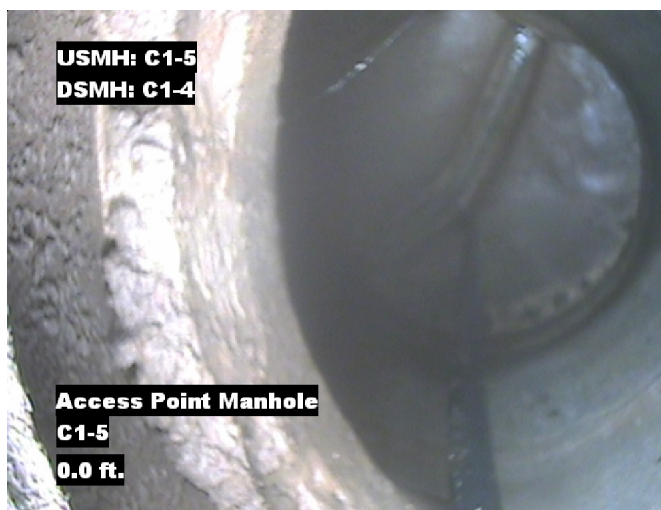
Distance: 0.0 ft. Grade: 0  
Condition: Access Point Manhole  
Remarks: C1-5

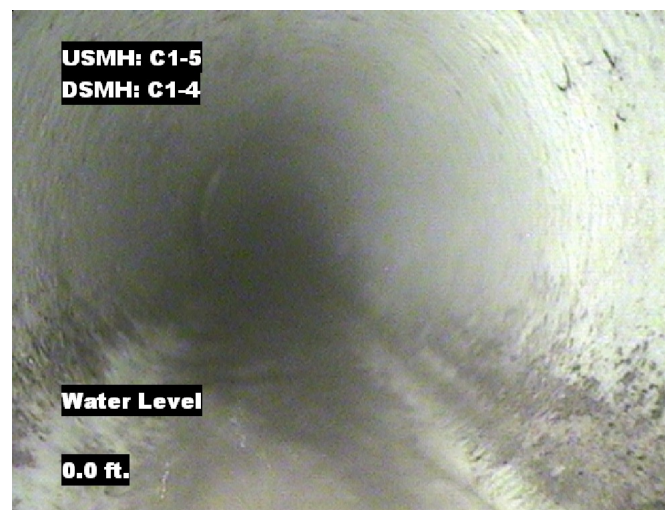
Distance: 0.0 ft. Grade: 0  
Condition: Water Level  
Remarks: N/A

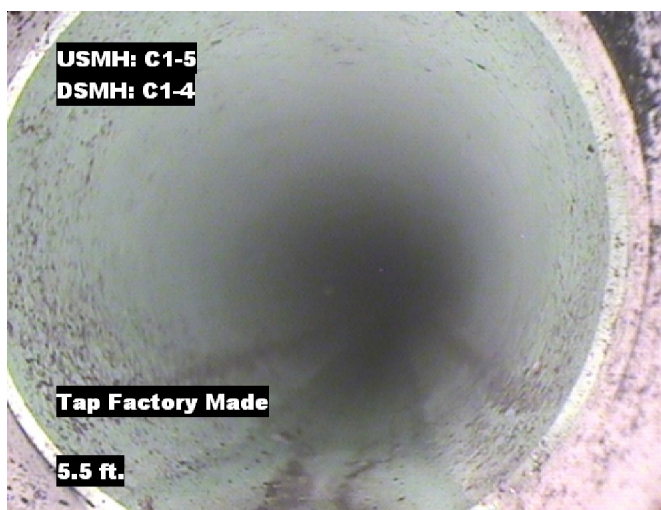
Distance: 5.5 ft. Grade: 0  
Condition: Tap Factory Made  
Remarks: N/A

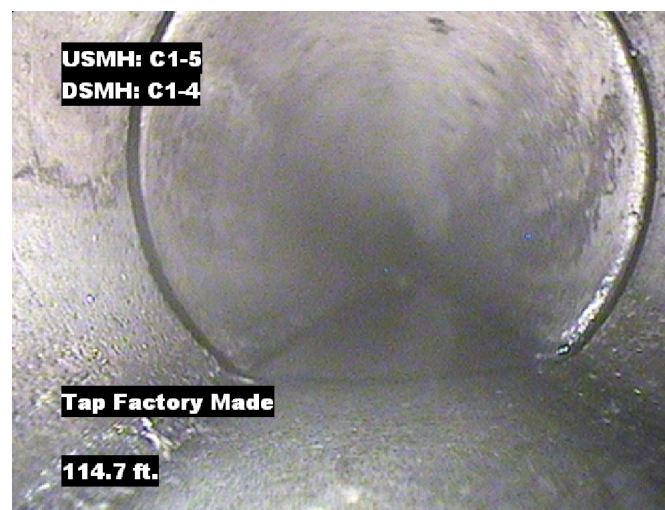
Distance: 114.7 ft. Grade: 0  
Condition: Tap Factory Made  
Remarks: N/A

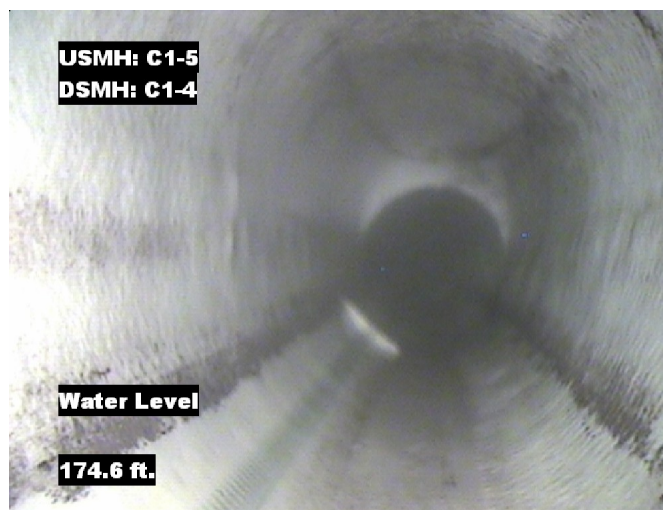
Distance: 174.6 ft.      Grade: 0  
Condition: Water Level  
Remarks: N/A

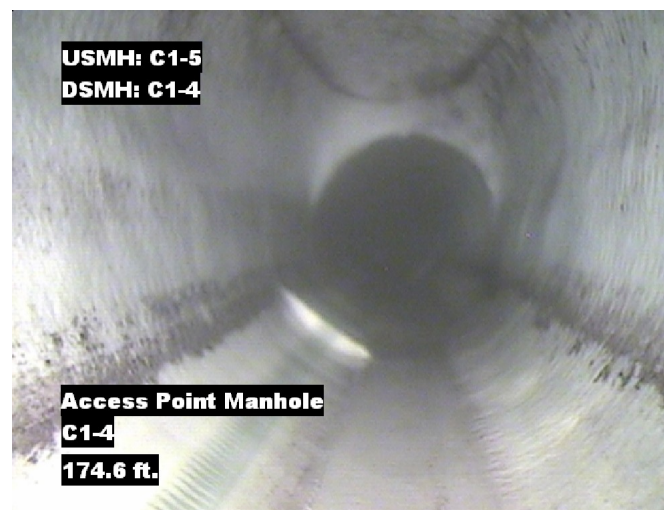
Distance: 174.6 ft.      Grade: 0  
Condition: Access Point Manhole  
Remarks: C1-4
