Defect Listing

Pipe Segment Refere... C10-2_C-18	City Oliver Springs	Street maples ave	Material Fibreglass Reinforc...	Location C... Light High...	Sewer Use Sanitary
Upstream MH C10-2	Total Length 240.5	Year Laid	Shape Circular	Location Details	
DS Manhole C-18	Length surveyed 240.5	Year Renewed	Height 8	Width 8	Pipe Joint... N/A

Image Report 4/Page

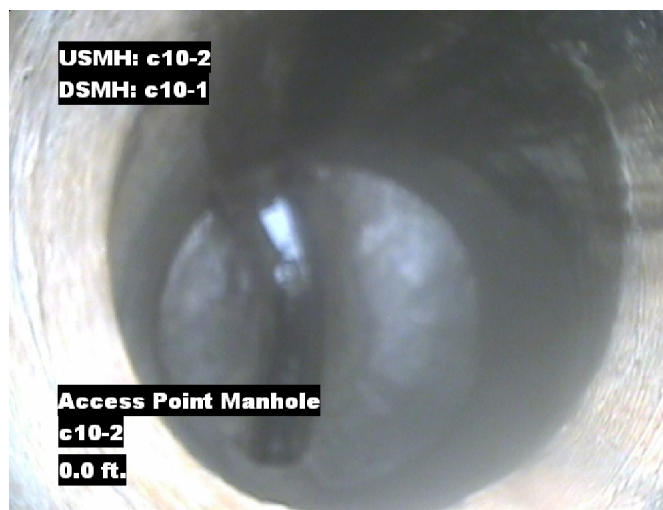
Distance: 0.0 ft. Grade: 0
Condition: Access Point Manhole
Remarks: c10-2

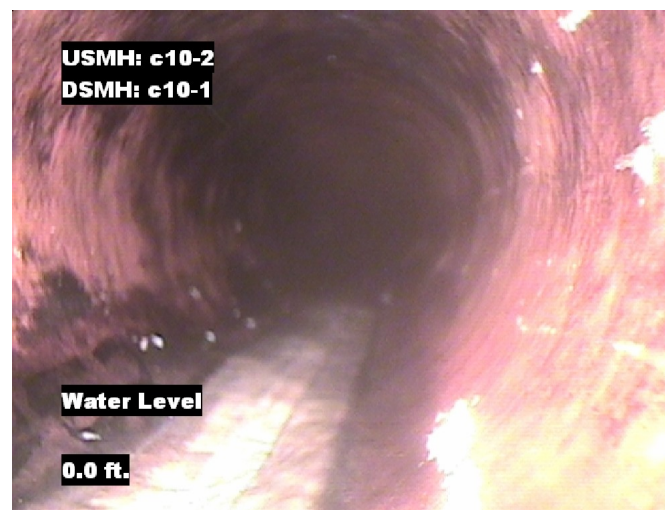
Distance: 0.0 ft. Grade: 0
Condition: Water Level
Remarks: N/A

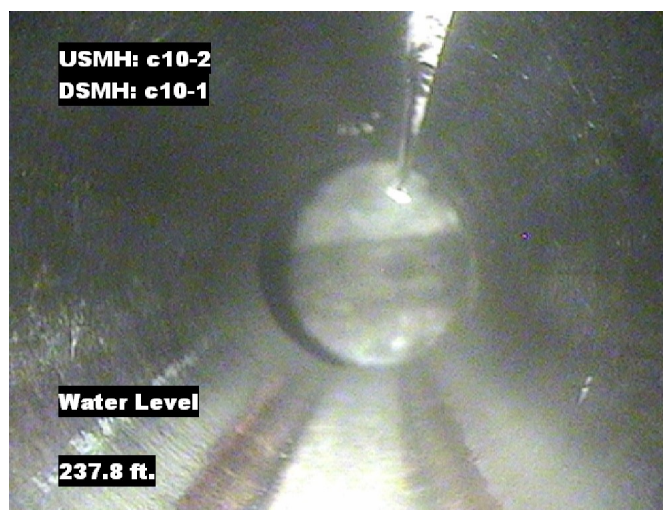
Distance: 237.8 ft. Grade: 0
Condition: Water Level
Remarks: N/A

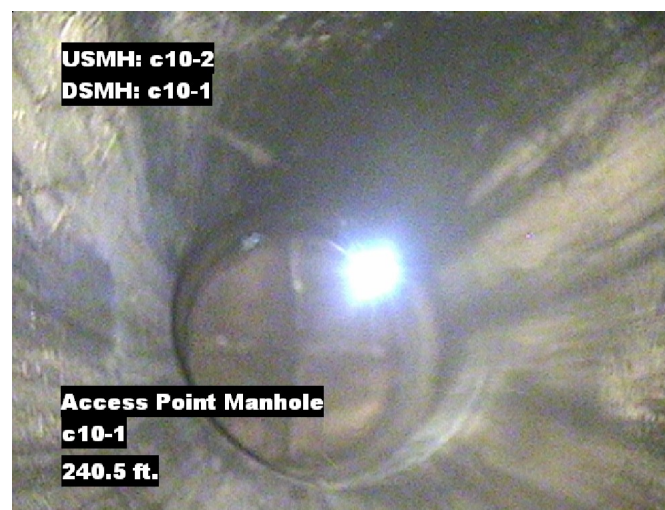
Distance: 240.5 ft. Grade: 0
Condition: Access Point Manhole
Remarks: C-18
