Defect Listing

Pipe Segment Refere... C10-3_C10-2	City Oliver Springs	Street male ave	Material Concrete Pipe (non-...	Location C... Light High...	Sewer Use Sanitary
Upstream MH C10-3	Total Length 162.2	Year Laid	Shape Circular	Location Details	
DS Manhole C10-2	Length surveyed 162.2	Year Renewed	Height 8	Width 8	Pipe Joint... 4

SPR N/A	MPR 4	PO Number 4397-03	Customer GRW
SPRI N/A	MPRI 2	Work Order 4397-02	Purpose Pre-Rehabilitation Survey
QSR N/A	QMR 2200		
OPR 4	Surveyed By Barry Rogers	Direction Downstream	Date 20150717
OPRI 2	Certificate Number U-1012-16405	Pre-Cleaning Jetting	Time 10:05
	Date Cleaned 20150717	End Time 10:18	Weather Dry
		Additional Info

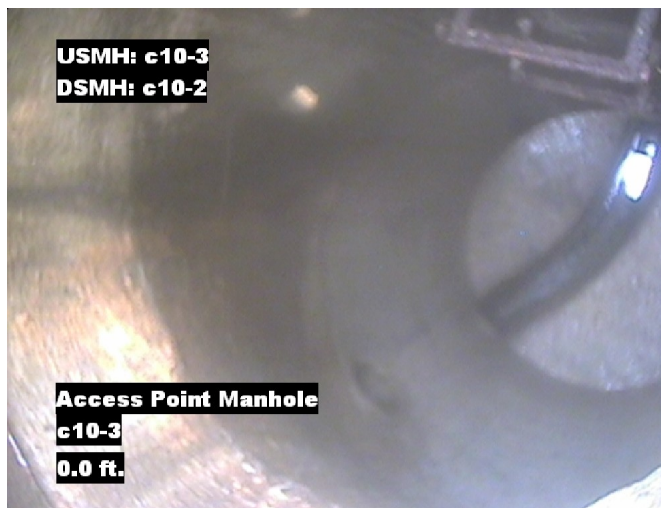
Distance: 0.0 ft. Grade: 0
Condition: Access Point Manhole
Remarks: c10-3

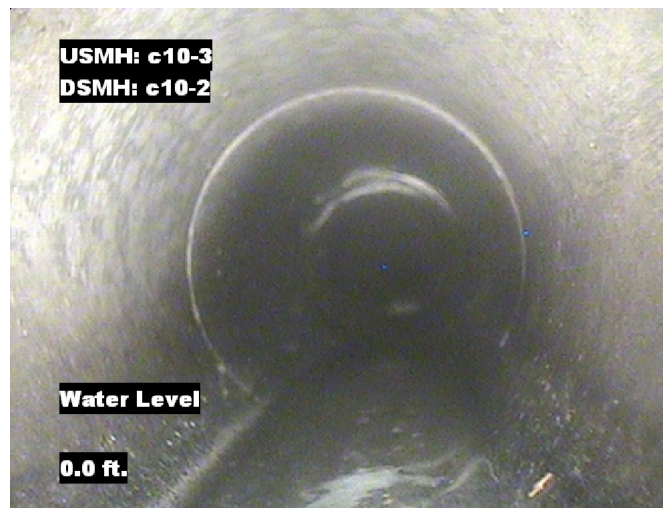
Distance: 0.0 ft. Grade: 0
Condition: Water Level
Remarks: N/A

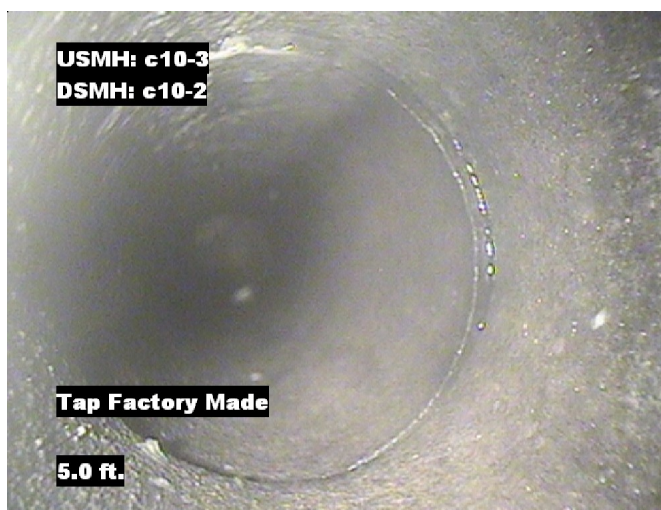
Distance: 5.0 ft. Grade: 0
Condition: Tap Factory Made
Remarks: N/A

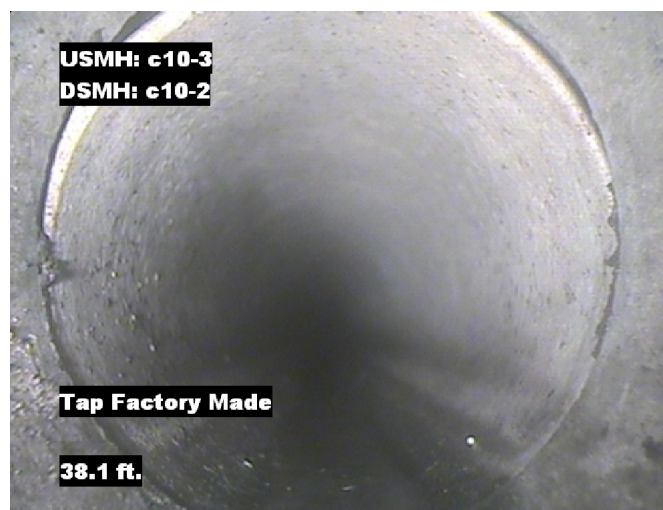
Distance: 38.1 ft. Grade: 0
Condition: Tap Factory Made
Remarks: N/A

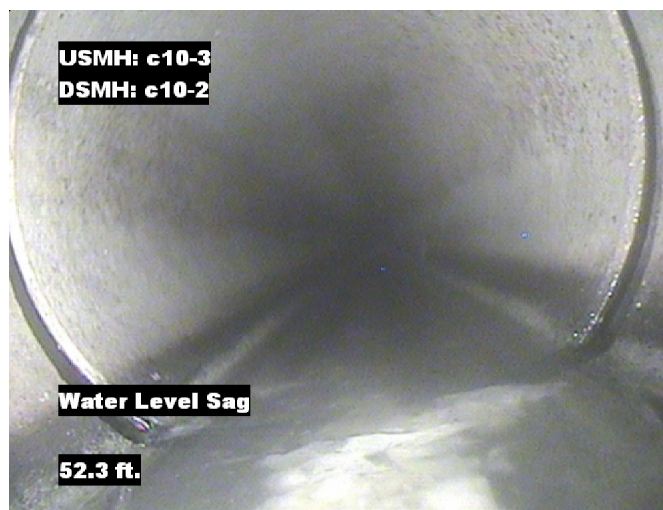
Distance: 52.3 ft. Grade: 2
Condition: Water Level Sag
Remarks: N/A

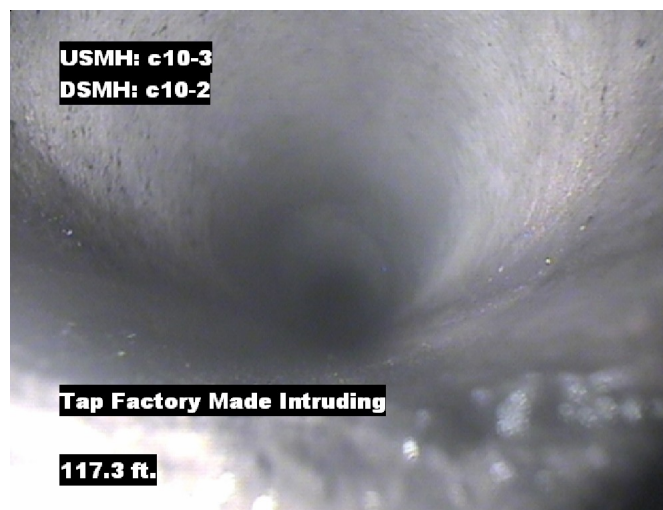
Distance: 117.3 ft. Grade: 2
Condition: Tap Factory Made Intruding
Remarks: N/A

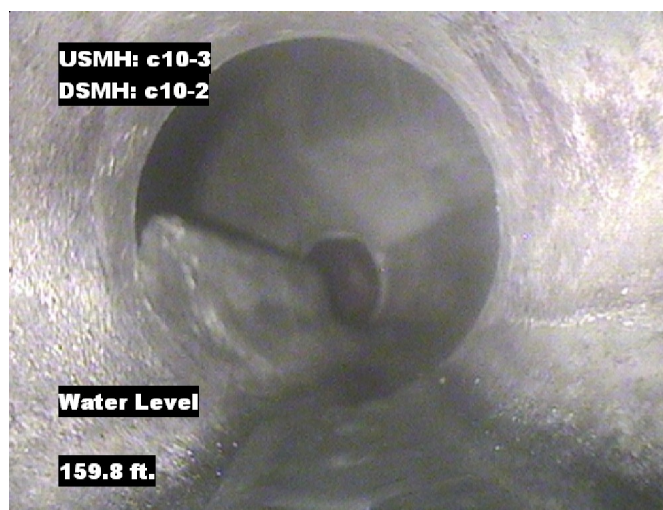
Distance: 159.8 ft. Grade: 0
Condition: Water Level
Remarks: N/A

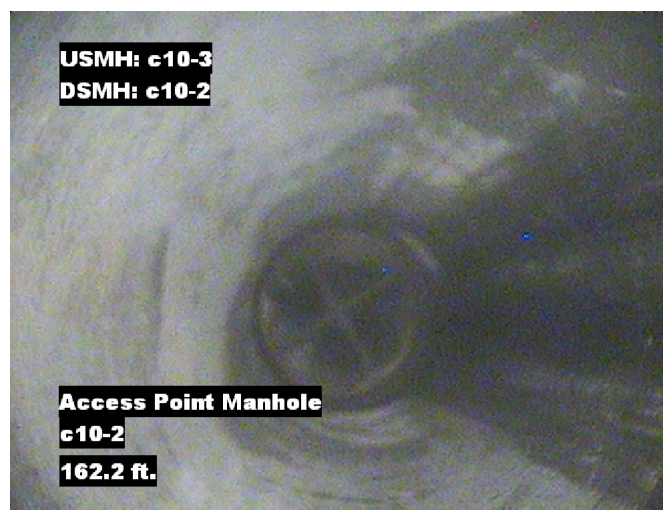
Distance: 162.2 ft. Grade: 0
Condition: Access Point Manhole
Remarks: c10-2
