## Defect Listing

Pipe Segment Refere... <b>C10-4_C10-3</b>	City <b>Oliver Springs</b>	Street <b>maple ave</b>	Material <b>Concrete Pipe (non-...</b>	Location C... <b>Light High...</b>	Sewer Use <b>Sanitary</b>
Upstream MH <b>C10-4</b>	Total Length <b>199.6</b>	Year Laid	Shape <b>Circular</b>	Location Details	
DS Manhole <b>C10-3</b>	Length surveyed <b>199.6</b>	Year Renewed	Height <b>8</b>	Width <b>8</b>	Pipe Joint... <b>4</b>

SPR <b>N/A</b>	MPR <b>N/A</b>	PO Number <b>4397-03</b>	Customer <b>GRW</b>
SPRI <b>N/A</b>	MPRI <b>N/A</b>	Work Order <b>4397-02</b>	Purpose <b>Pre-Rehabilitation Survey</b>
QSR <b>N/A</b>	QMR <b>N/A</b>		
OPR <b>N/A</b>	Surveyed By <b>Barry Rogers</b>	Direction <b>Downstream</b>	Date <b>20150717</b>
OPRI <b>N/A</b>	Certificate Number <b>U-1012-16405</b>	Pre-Cleaning <b>Jetting</b>	Time <b>09:39</b>
	Date Cleaned <b>20150717</b>	End Time <b>09:56</b>	Weather <b>Dry</b>
			Additional Info

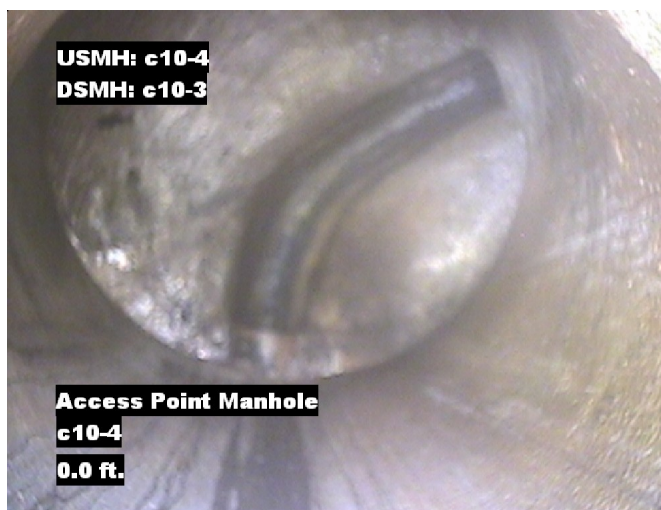
Distance: 0.0 ft. Grade: 0  
Condition: Access Point Manhole  
Remarks: c10-4

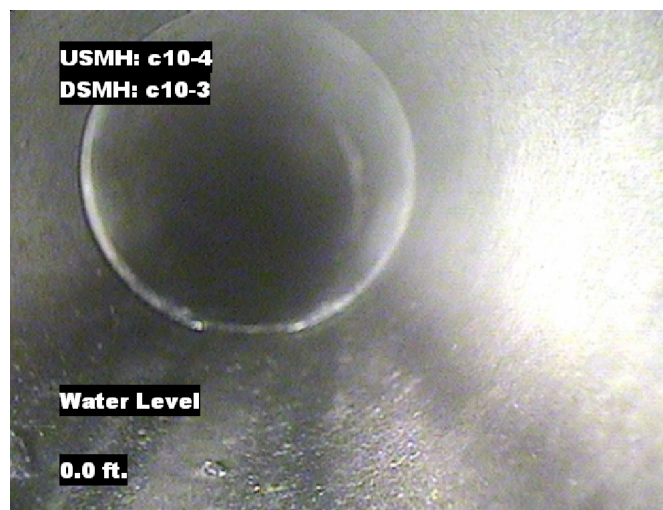
Distance: 0.0 ft. Grade: 0  
Condition: Water Level  
Remarks: N/A

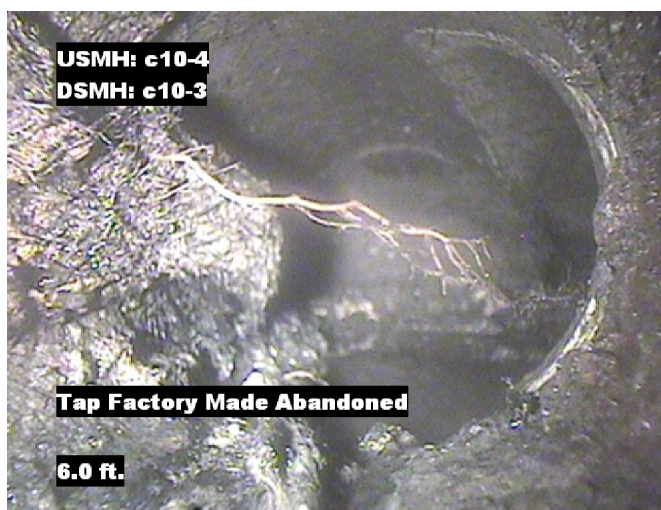
Distance: 6.0 ft. Grade: 0  
Condition: Tap Factory Made Abandoned  
Remarks: N/A

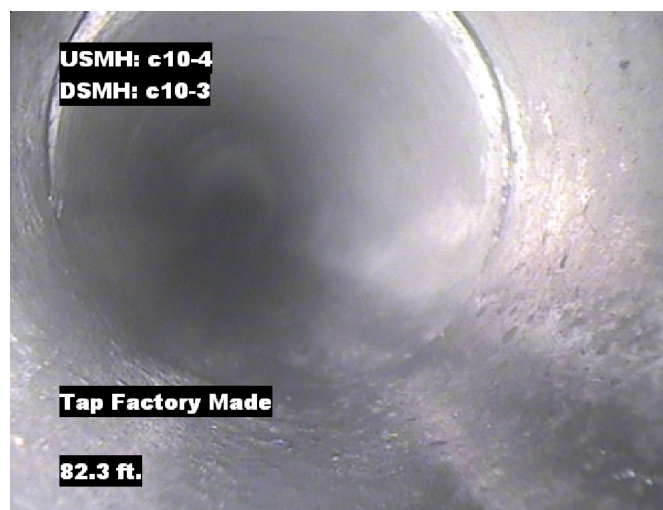
Distance: 82.3 ft. Grade: 0  
Condition: Tap Factory Made  
Remarks: N/A

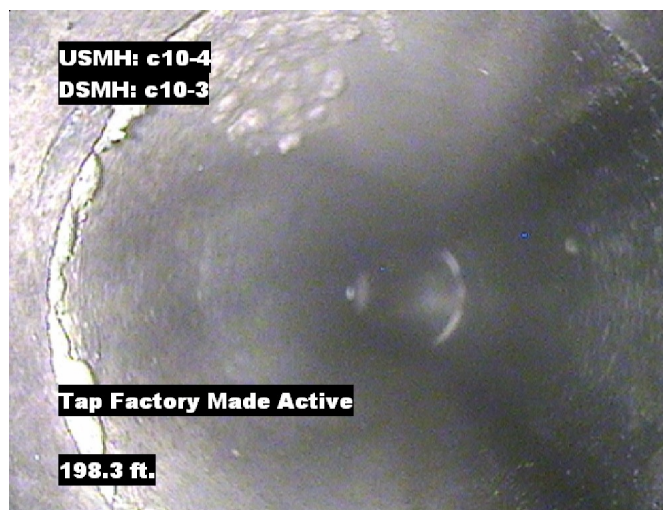
Distance: 198.3 ft. Grade: 0  
Condition: Tap Factory Made Active  
Remarks: N/A

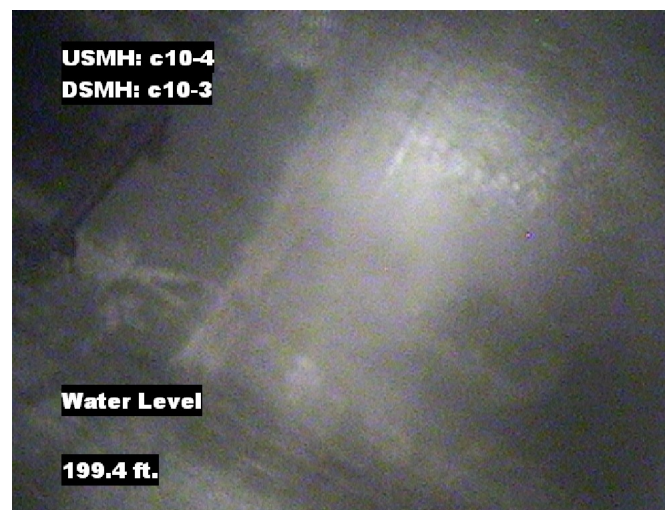
Distance: 199.4 ft. Grade: 0  
Condition: Water Level  
Remarks: N/A

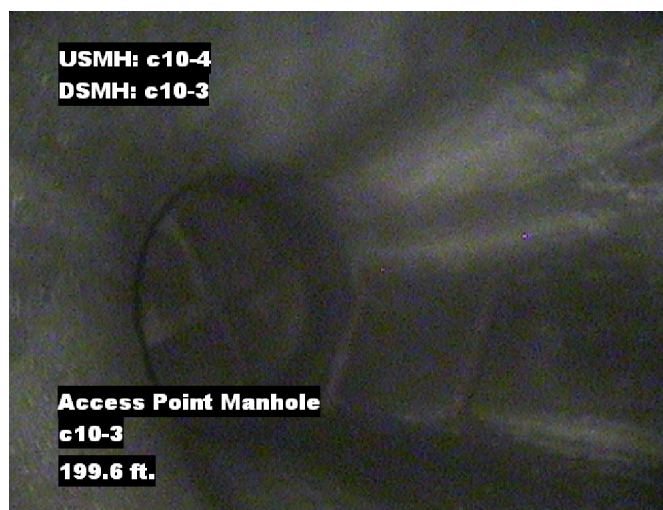
Distance: 199.6 ft. Grade: 0  
Condition: Access Point Manhole  
Remarks: c10-3
