Defect Listing

Pipe Segment Refere... C11-1_C-20	City Oliver Springs	Street Hwy 62	Material Concrete Pipe (non-...	Location C... Main Highw...	Sewer Use Sanitary
Upstream MH C11-1	Total Length 341.7	Year Laid	Shape Circular	Location Details	
DS Manhole C-20	Length surveyed 341.7	Year Renewed	Height 8	Width 8	Pipe Joint... 4

SPR N/A	MPR N/A	PO Number 4397-03		Customer GRW	
SPRI N/A	MPRI N/A	Work Order 4397-02		Purpose Pre-Rehabilitation Survey	
QSR N/A	QMR N/A				
OPR N/A	Surveyed By Barry Rogers	Direction Upstream	Date 20150727	Media label	
OPRI N/A	Certificate Number U-1012-16405	Pre-Cleaning Jetting	Time 08:02	Weather Dry	
Date Cleaned 20150727			End Time 08:18	Additional Info

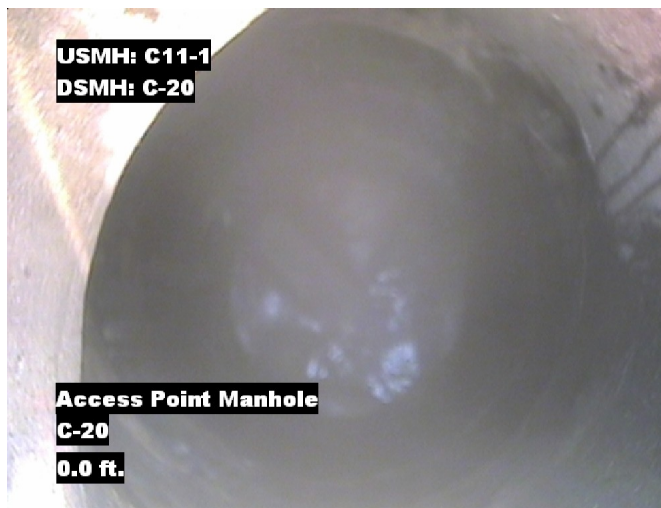
Distance: 0.0 ft. Grade: 0
Condition: Access Point Manhole
Remarks: C-20

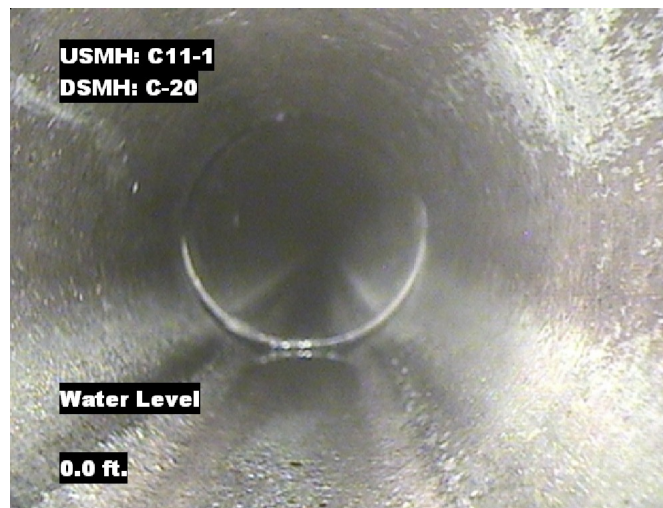
Distance: 0.0 ft. Grade: 0
Condition: Water Level
Remarks: N/A

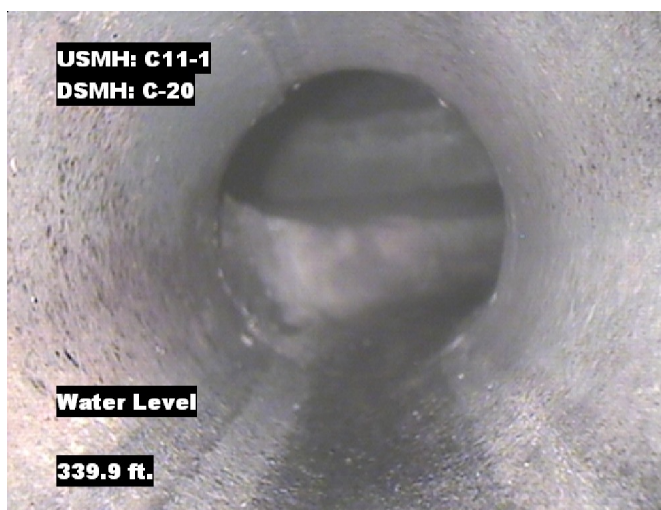
Distance: 339.9 ft. Grade: 0
Condition: Water Level
Remarks: N/A

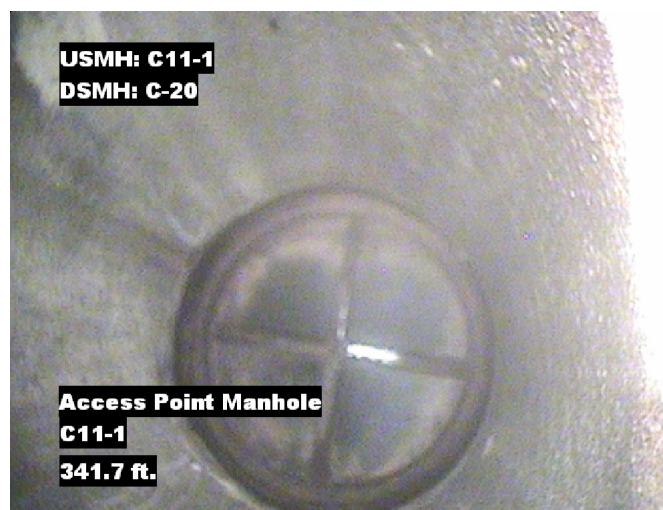
Distance: 341.7 ft. Grade: 0
Condition: Access Point Manhole
Remarks: C11-1
