## Defect Listing

Pipe Segment Refere... <b>C12-1_C12-1A</b>	City <b>Oliver Springs</b>	Street <b>hannah dr</b>	Material <b>Concrete Pipe (non-...</b>	Location C... <b>Easement/R...</b>	Sewer Use <b>Sanitary</b>
Upstream MH <b>C12-1</b>	Total Length <b>61.3</b>	Year Laid	Shape <b>Circular</b>	Location Details	
DS Manhole <b>C12-1A</b>	Length surveyed <b>61.3</b>	Year Renewed	Height <b>8</b>	Width <b>8</b>	Pipe Joint... <b>4</b>

SPR <b>N/A</b>	MPR <b>N/A</b>	PO Number <b>4397-03</b>		Customer <b>GRW</b>	
SPRI <b>N/A</b>	MPRI <b>N/A</b>	Work Order <b>4397-02</b>		Purpose <b>Pre-Rehabilitation Survey</b>	
QSR <b>N/A</b>	QMR <b>N/A</b>				
OPR <b>N/A</b>	Surveyed By <b>Barry Rogers</b>	Direction <b>Downstream</b>	Date <b>20150716</b>	Media label	
OPRI <b>N/A</b>	Certificate Number <b>U-1012-16405</b>	Pre-Cleaning <b>Jetting</b>	Time <b>14:34</b>	Weather <b>Dry</b>	
Date Cleaned <b>20150716</b>			End Time <b>14:48</b>	Additional Info

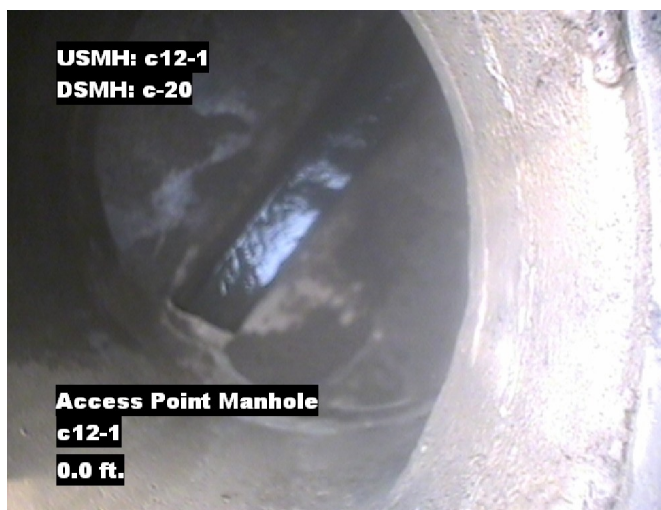
Distance: 0.0 ft. Grade: 0  
Condition: Access Point Manhole  
Remarks: c12-1

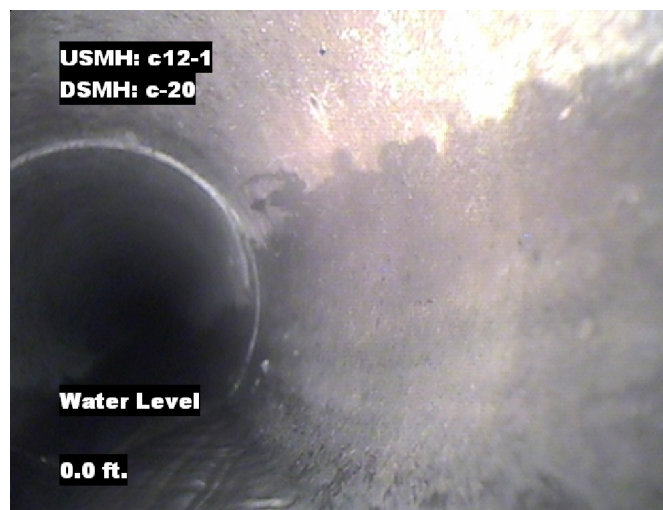
Distance: 0.0 ft. Grade: 0  
Condition: Water Level  
Remarks: N/A

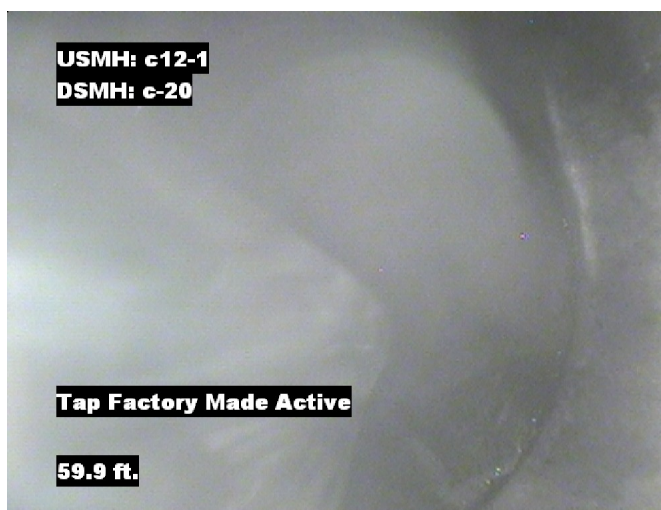
Distance: 59.9 ft. Grade: 0  
Condition: Tap Factory Made Active  
Remarks: N/A

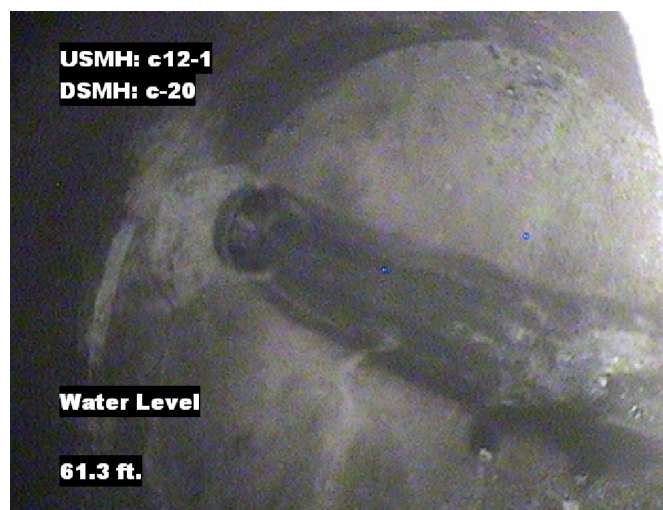
Distance: 61.3 ft. Grade: 0  
Condition: Water Level  
Remarks: N/A

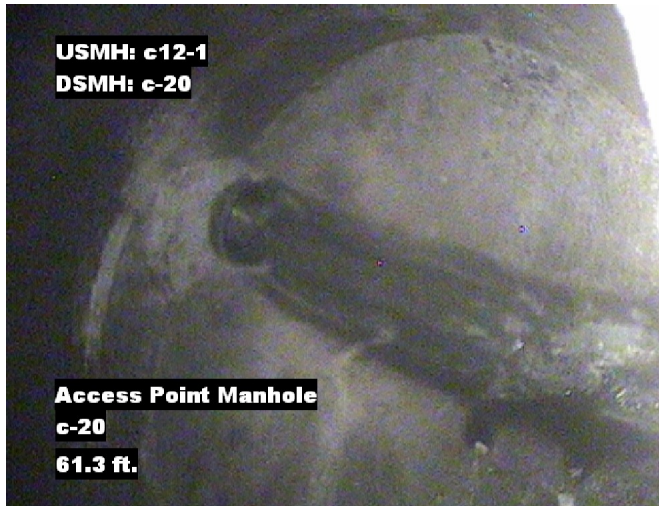
Distance: 61.3 ft. Grade: 0  
Condition: Access Point Manhole  
Remarks: C12-1A
