## Defect Listing

Pipe Segment Refere... <b>C12-1A_C-20</b>	City <b>Oliver Springs</b>	Street <b>Maple Ave</b>	Material <b>Concrete Pipe (non-...</b>	Location C... <b>Railway</b>	Sewer Use <b>Sanitary</b>
Upstream MH <b>C12-1A</b>	Total Length <b>243.5</b>	Year Laid	Shape <b>Circular</b>	Location Details <b>Runs under RailRoad</b>	
DS Manhole <b>C-20</b>	Length surveyed <b>243.5</b>	Year Renewed	Height <b>8</b>	Width <b>8</b>	Pipe Joint... <b>4</b>

SPR <b>3</b>	MPR <b>8</b>	PO Number <b>4397-03</b>	Customer <b>GRW</b>
SPRI <b>3</b>	MPRI <b>4</b>	Work Order <b>4397-02</b>	Purpose <b>Pre-Rehabilitation Survey</b>
QSR <b>3100</b>	QMR <b>4200</b>		
OPR <b>11</b>	Surveyed By <b>Barry Rogers</b>	Direction <b>Upstream</b>	Date <b>20150716</b>
OPRI <b>3.7</b>	Certificate Number <b>U-1012-16405</b>	Pre-Cleaning <b>Jetting</b>	Time <b>15:08</b>
	Date Cleaned <b>20150716</b>	End Time <b>15:18</b>	Weather <b>Dry</b>
			Media label
			Additional Info

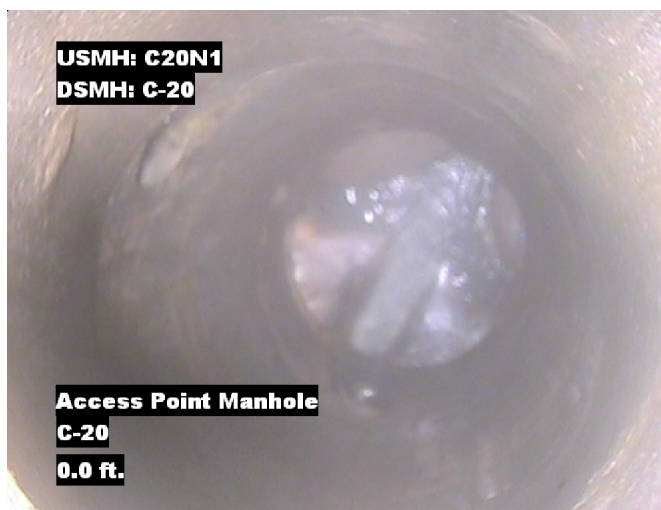
Distance: 0.0 ft. Grade: 0  
Condition: Access Point Manhole  
Remarks: C-20

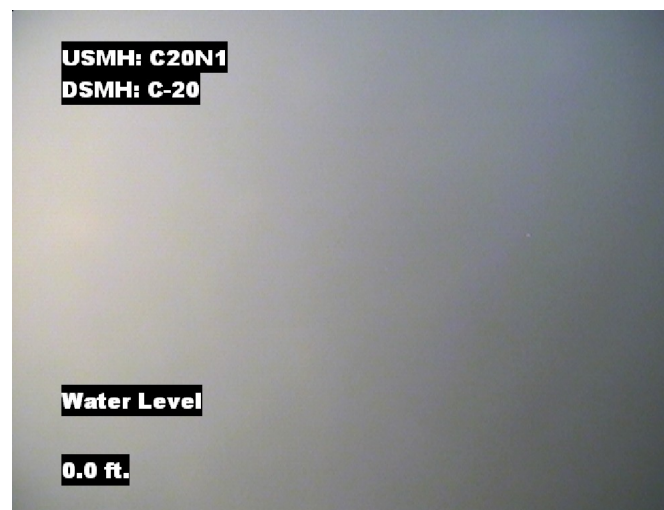
Distance: 0.0 ft. Grade: 0  
Condition: Water Level  
Remarks: N/A

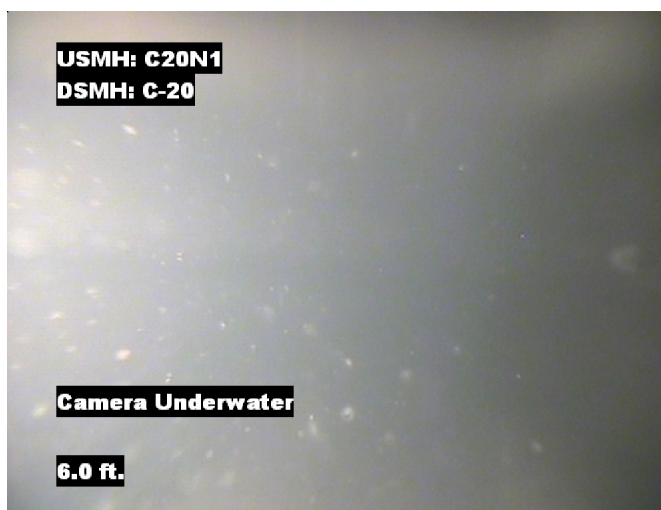
Distance: 6.0 ft. Grade: 4  
Condition: Camera Underwater  
Remarks: N/A

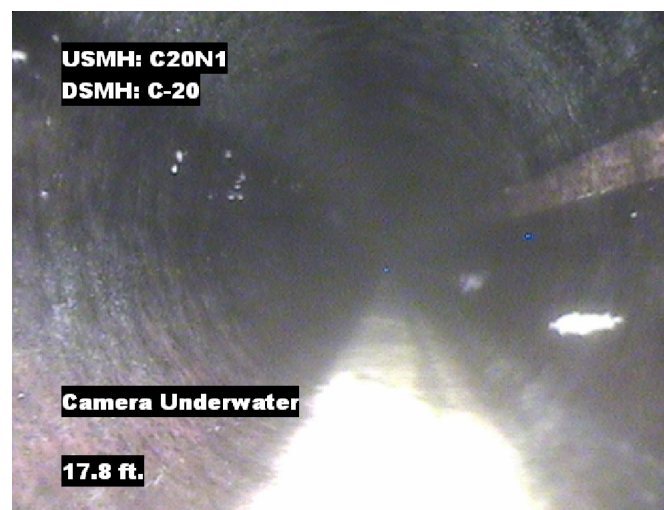
Distance: 17.8 ft. Grade: 4  
Condition: Camera Underwater  
Remarks: N/A

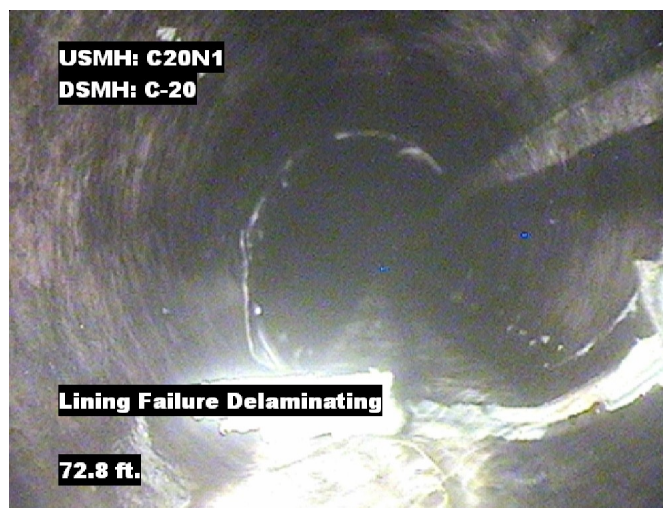
Distance: 72.8 ft. Grade: 3  
Condition: Lining Failure Delaminating  
Remarks: N/A

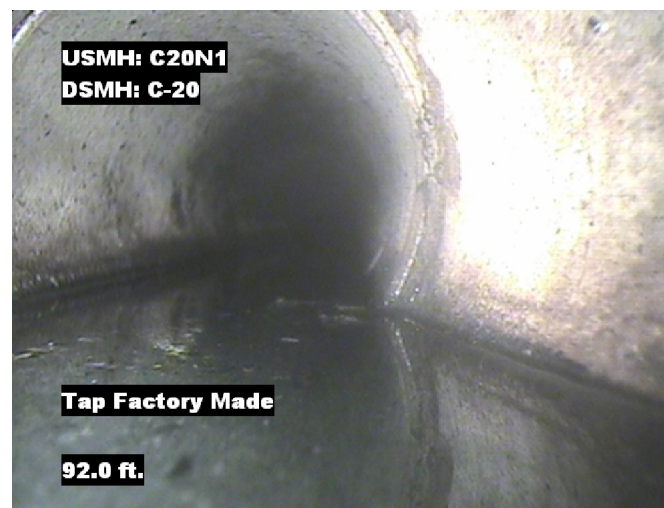
Distance: 92.0 ft. Grade: 0  
Condition: Tap Factory Made  
Remarks: N/A

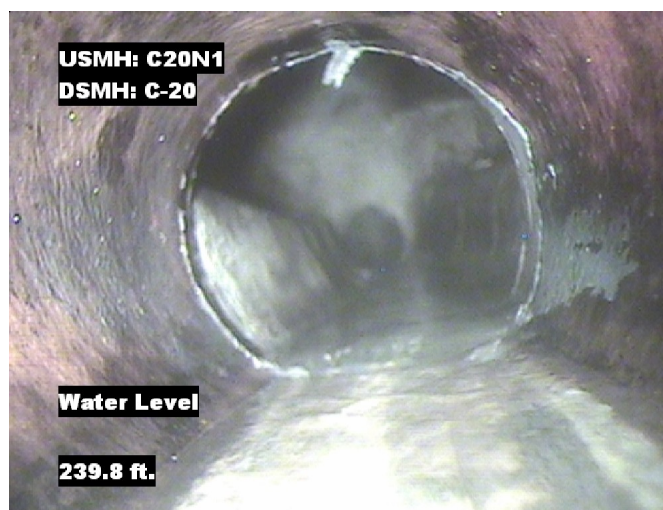
Distance: 239.8 ft. Grade: 0  
Condition: Water Level  
Remarks: N/A

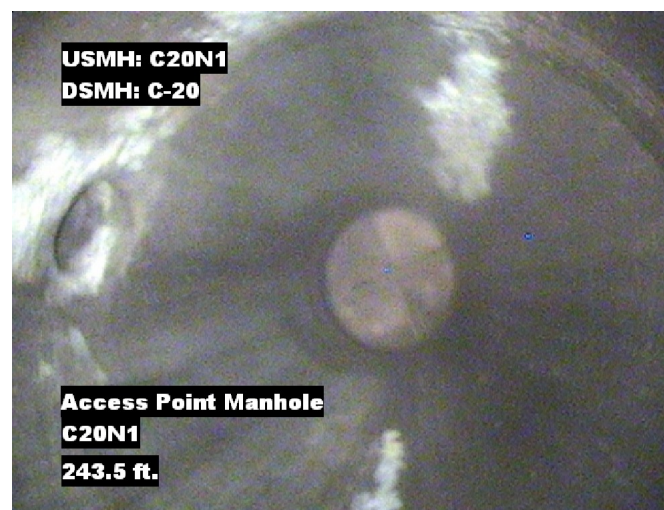
Distance: 243.5 ft. Grade: 0  
Condition: Access Point Manhole  
Remarks: C12-1A
