## Defect Listing

Pipe Segment Refere... <b>C12-2_C12-1</b>	City <b>Oliver Springs</b>	Street <b>hannah dr</b>	Material <b>Concrete Pipe (non-...</b>	Location C... <b>Light High...</b>	Sewer Use <b>Sanitary</b>
Upstream MH <b>C12-2</b>	Total Length <b>191.2</b>	Year Laid	Shape <b>Circular</b>	Location Details	
DS Manhole <b>C12-1</b>	Length surveyed <b>191.2</b>	Year Renewed	Height <b>8</b>	Width <b>8</b>	Pipe Joint... <b>4</b>

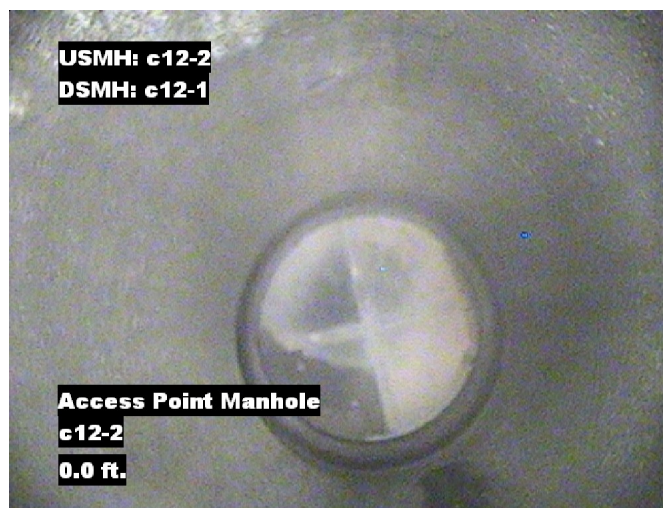
Distance: 0.0 ft. Grade: 0  
Condition: Access Point Manhole  
Remarks: c12-2

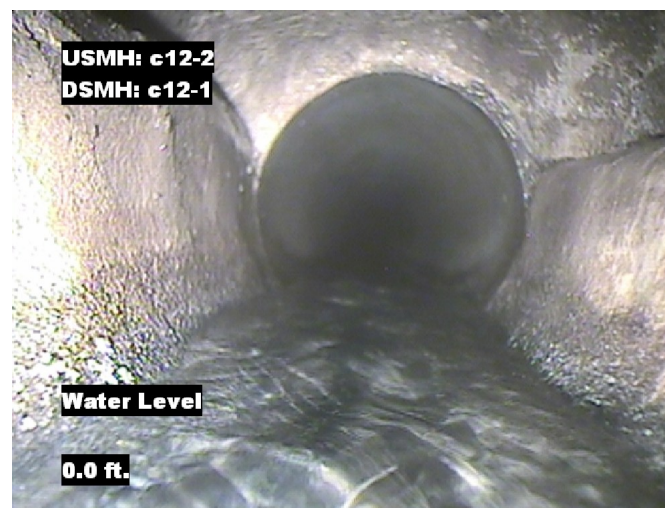
Distance: 0.0 ft. Grade: 0  
Condition: Water Level  
Remarks: N/A

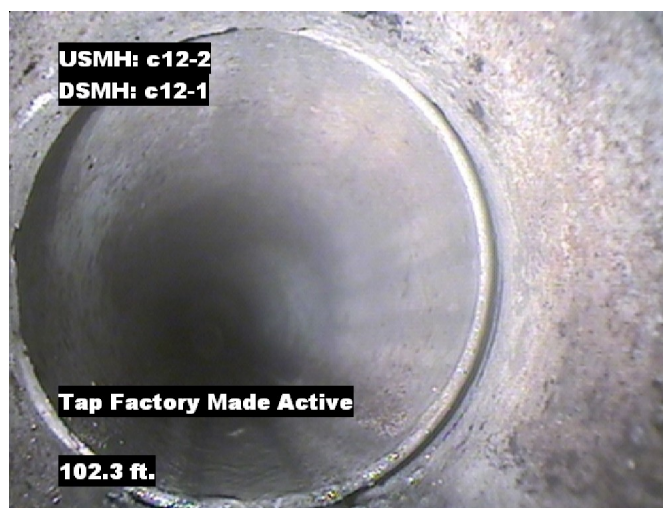
Distance: 102.3 ft. Grade: 0  
Condition: Tap Factory Made Active  
Remarks: N/A

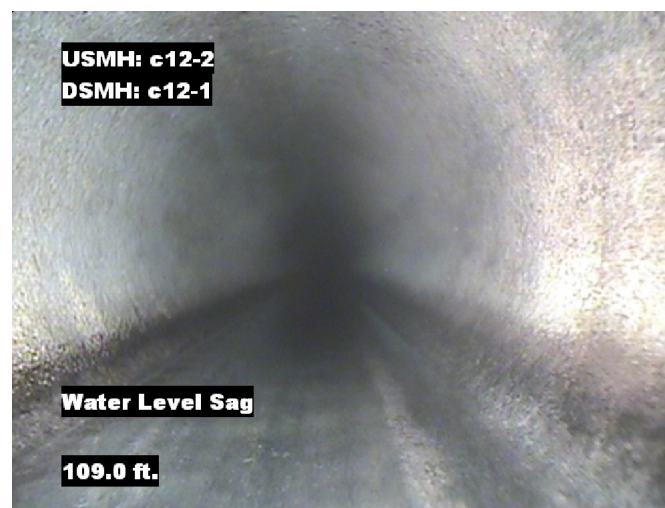
Distance: 109.0 ft. Grade: 2  
Condition: Water Level Sag  
Remarks: N/A

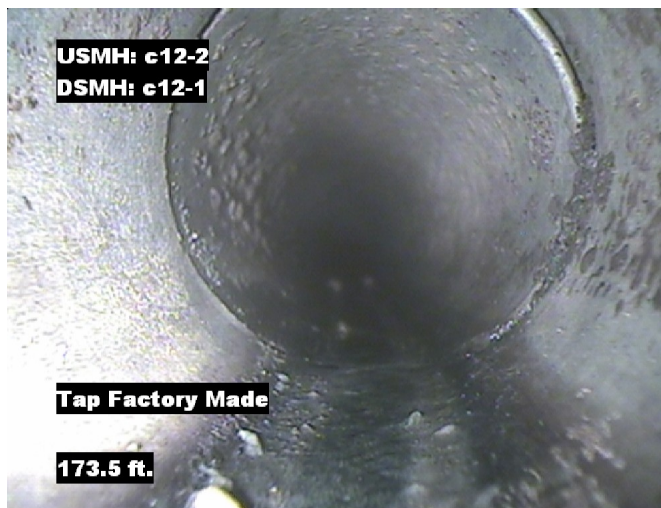
Distance: 173.5 ft. Grade: 0  
Condition: Tap Factory Made  
Remarks: N/A

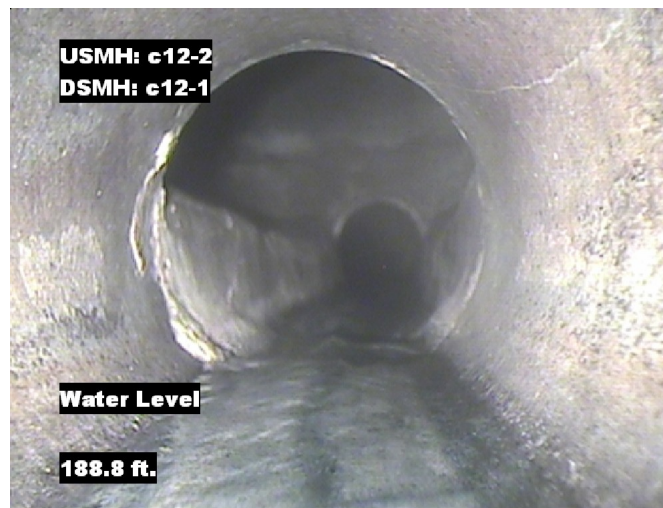
Distance: 188.8 ft. Grade: 0  
Condition: Water Level  
Remarks: N/A

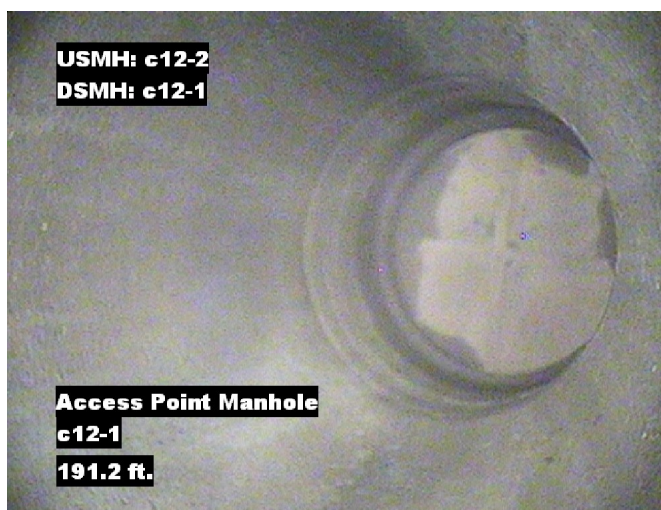
Distance: 191.2 ft. Grade: 0  
Condition: Access Point Manhole  
Remarks: c12-1
