## Defect Listing

Pipe Segment Refere... <b>C12-3_C12-2</b>	City <b>Oliver Springs</b>	Street <b>hannah dr</b>	Material <b>Concrete Pipe (non-...</b>	Location C... <b>Light High...</b>	Sewer Use <b>Sanitary</b>
Upstream MH <b>C12-3</b>	Total Length <b>212.9</b>	Year Laid	Shape <b>Circular</b>	Location Details	
DS Manhole <b>C12-2</b>	Length surveyed <b>212.9</b>	Year Renewed	Height <b>8</b>	Width <b>8</b>	Pipe Joint... <b>4</b>

SPR <b>N/A</b>	MPR <b>N/A</b>	PO Number <b>4397-03</b>	Customer <b>GRW</b>
SPRI <b>N/A</b>	MPRI <b>N/A</b>	Work Order <b>4397-02</b>	Purpose <b>Pre-Rehabilitation Survey</b>
QSR <b>N/A</b>	QMR <b>N/A</b>		
OPR <b>N/A</b>	Surveyed By <b>Barry Rogers</b>	Direction <b>Downstream</b>	Date <b>20150715</b>
OPRI <b>N/A</b>	Certificate Number <b>U-1012-16405</b>	Pre-Cleaning <b>Jetting</b>	Time <b>14:33</b>
	Date Cleaned <b>20150715</b>	End Time <b>14:52</b>	Weather <b>Dry</b>
			Additional Info

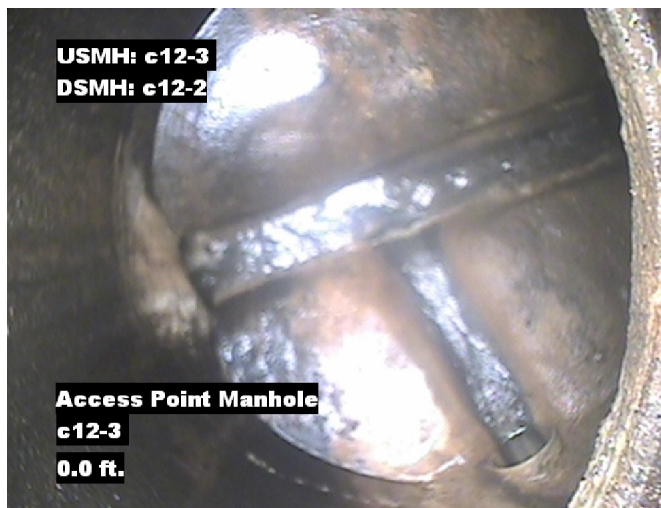
Distance: 0.0 ft. Grade: 0  
Condition: Access Point Manhole  
Remarks: c12-3

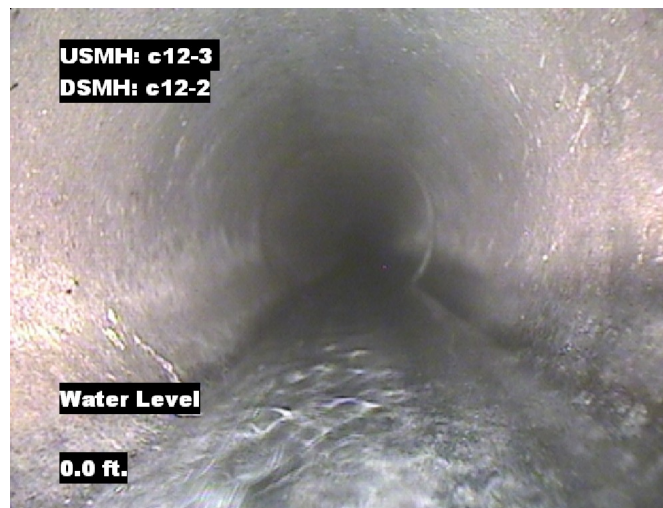
Distance: 0.0 ft. Grade: 0  
Condition: Water Level  
Remarks: N/A

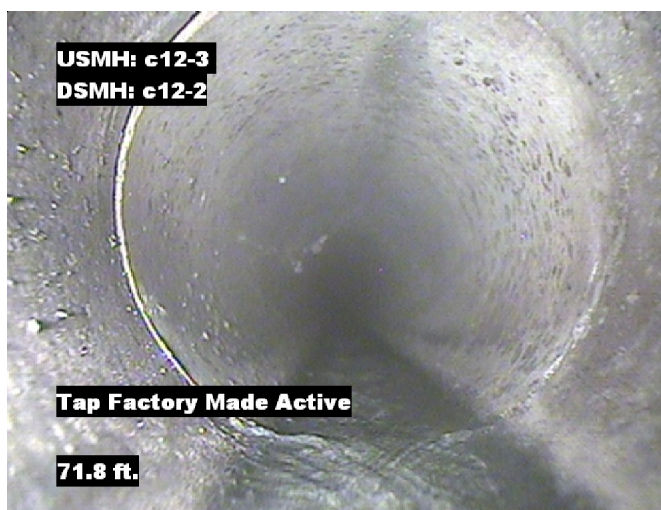
Distance: 71.8 ft. Grade: 0  
Condition: Tap Factory Made Active  
Remarks: N/A

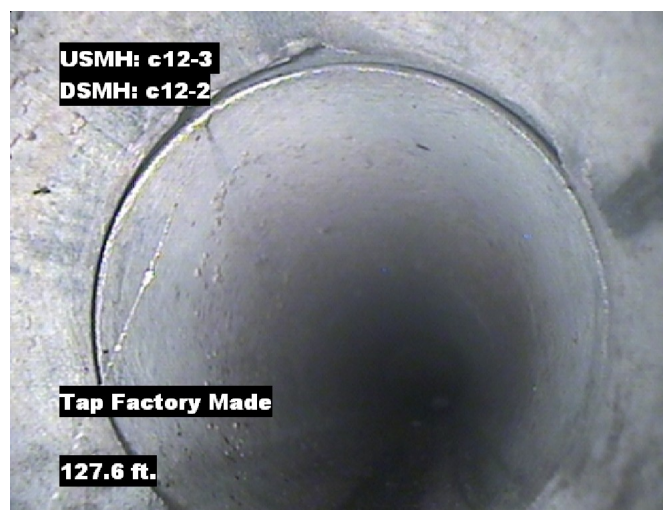
Distance: 127.6 ft. Grade: 0  
Condition: Tap Factory Made  
Remarks: N/A

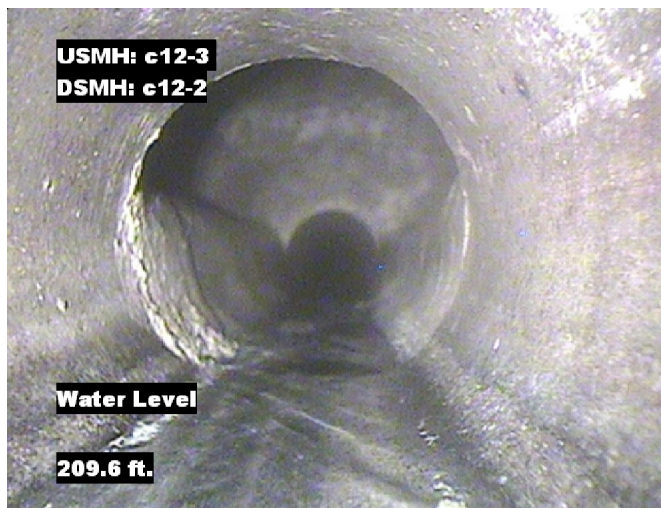
Distance: 209.6 ft.      Grade: 0  
Condition: Water Level  
Remarks: N/A

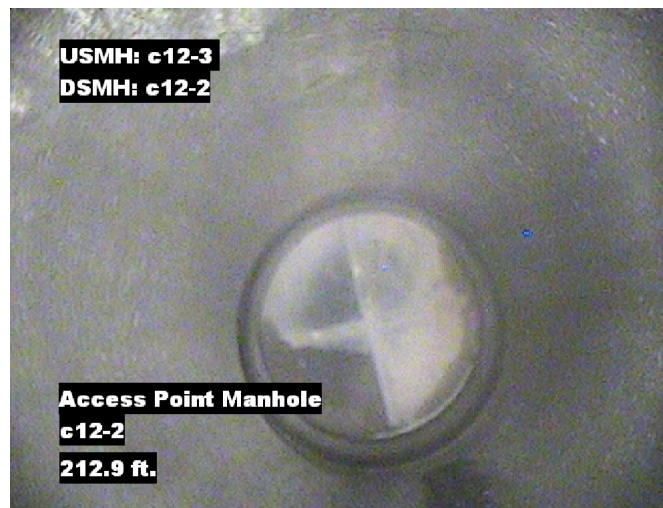
Distance: 212.9 ft.      Grade: 0  
Condition: Access Point Manhole  
Remarks: c12-2
