Defect Listing

Pipe Segment Refere... C12-4_C12-3	City Oliver Springs	Street hannah dr	Material Concrete Pipe (non-...	Location C... Light High...	Sewer Use Sanitary
Upstream MH C12-4	Total Length 359.5	Year Laid	Shape Circular	Location Details	
DS Manhole C12-3	Length surveyed 359.5	Year Renewed	Height 8	Width 8	Pipe Joint... 4

Image Report 4/Page

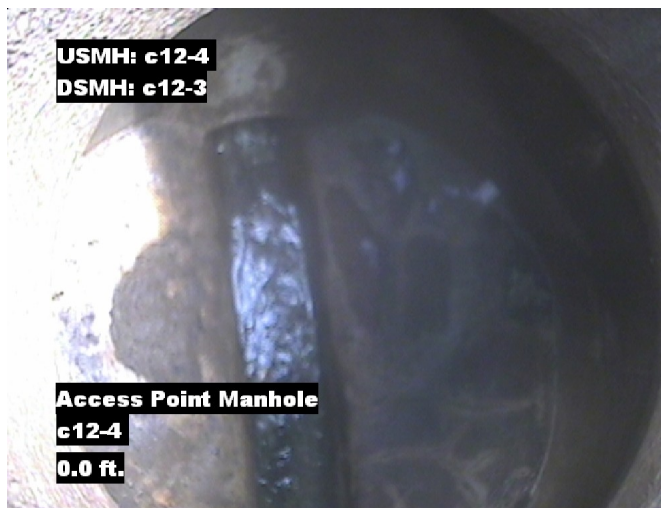
Distance: 0.0 ft. Grade: 0
Condition: Access Point Manhole
Remarks: c12-4

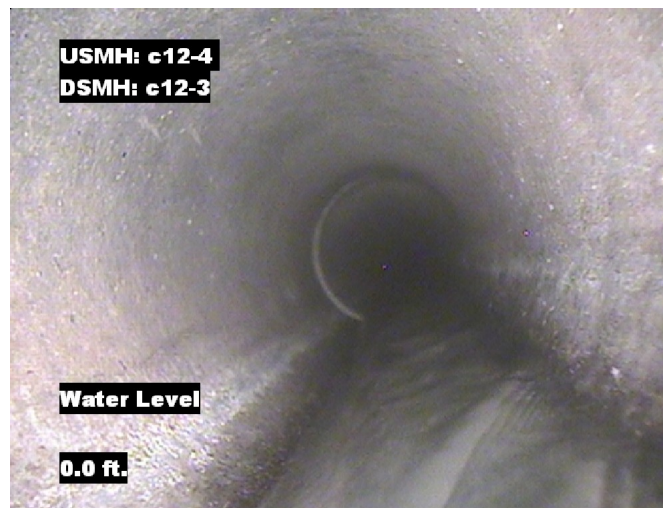
Distance: 0.0 ft. Grade: 0
Condition: Water Level
Remarks: N/A

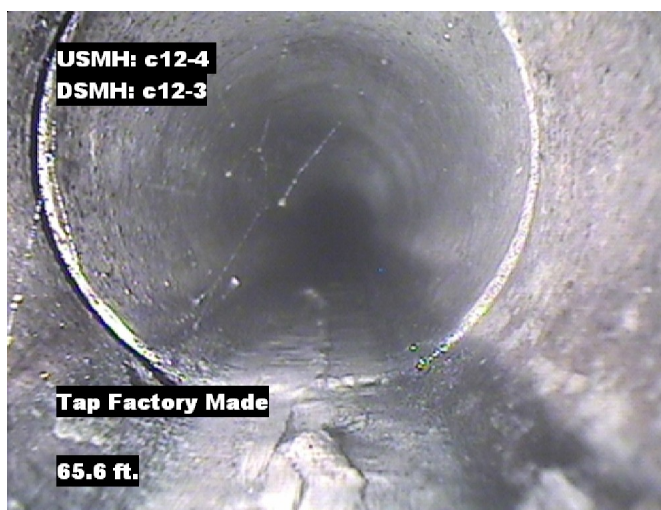
Distance: 65.6 ft. Grade: 0
Condition: Tap Factory Made
Remarks: N/A

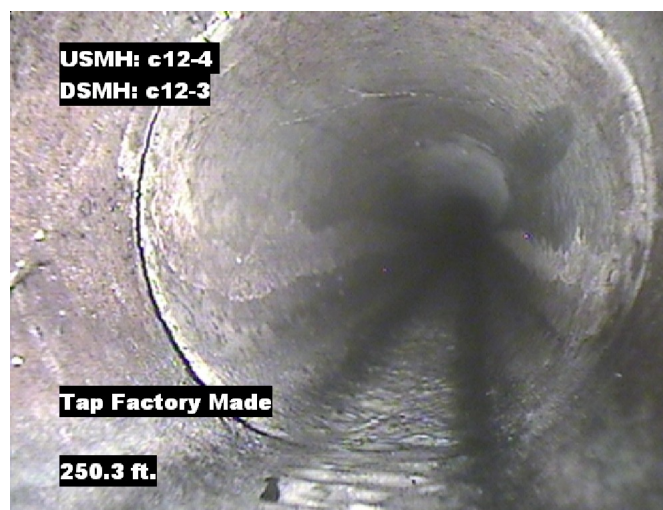
Distance: 250.3 ft. Grade: 0
Condition: Tap Factory Made
Remarks: N/A

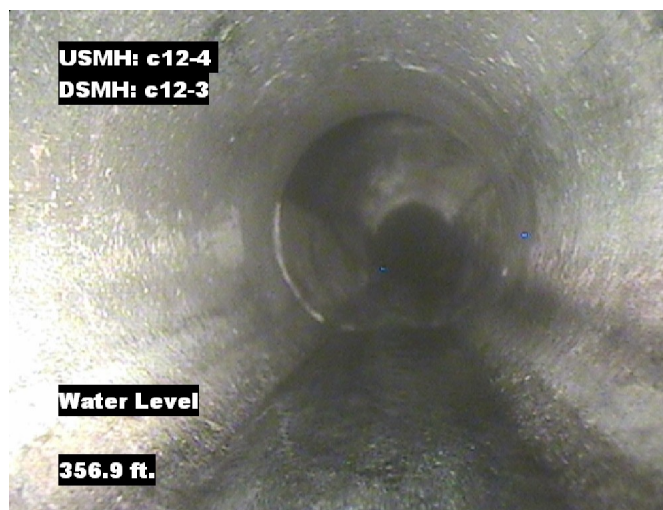
Distance: 356.9 ft. Grade: 0
Condition: Water Level
Remarks: N/A

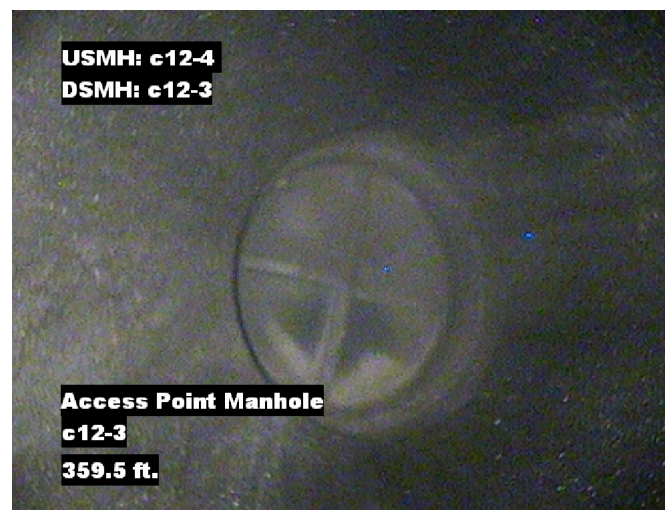
Distance: 359.5 ft. Grade: 0
Condition: Access Point Manhole
Remarks: c12-3
