# **Defect Listing**

#### **Image Report 4/Page**

Pipe Segment Refere	City	Street	Material		Location C	Sewer Use
C12-5_C12-4	Oliver Springs	Hannah Dr	Concrete Pipe (non		Light High	Sanitary
Upstream MH	Total Length	Year Laid	Shape		Location	Details
C12-5	338.4		Circular			
DS Manhole	Length surveyed	Year Renewed	Height	Width	Pipe Joint	
C12-4	338.4		8	8	4

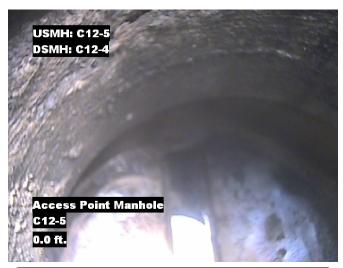
Distance: 0.0 ft. Grade: (

Condition: Access Point Manhole

Remarks: C12-5

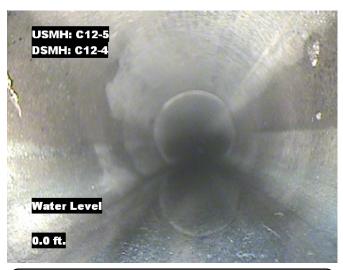
Distance: 0.0 ft. Grade: 0

Condition: Water Level

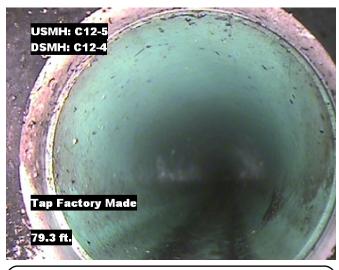
Distance: 79.3 ft. Grade: 0

Condition: Tap Factory Made

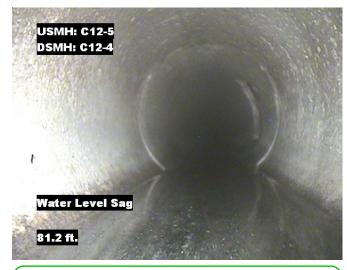
Distance: 81.2 ft. Grade: 2

Condition: Water Level Sag

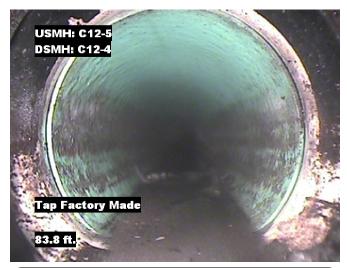
Distance: 83.8 ft. Grade: 0

Condition: Tap Factory Made

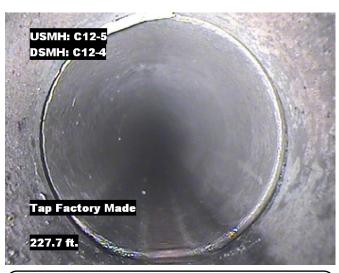
Distance: 227.7 ft. Grade: 0

Condition: Tap Factory Made

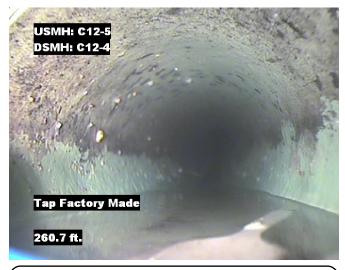
Distance: 260.7 ft. Grade: 0

Condition: Tap Factory Made

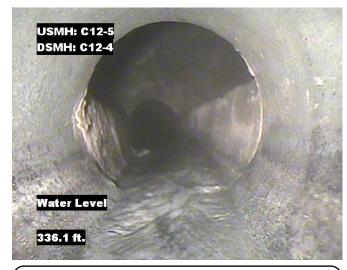
Distance: 336.1 ft. Grade: 0

Condition: Water Level

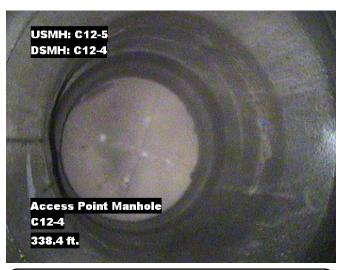
Distance: 338.4 ft. Grade: 0

Condition: Access Point Manhole

Remarks: C12-4
