## Defect Listing

Pipe Segment Refere... <b>C12-6_C12-5</b>	City <b>Oliver Springs</b>	Street <b>Hannah Dr</b>	Material <b>Concrete Pipe (non-...</b>	Location C... <b>Light High...</b>	Sewer Use <b>Sanitary</b>
Upstream MH <b>C12-6</b>	Total Length <b>184.2</b>	Year Laid	Shape <b>Circular</b>	Location Details	
DS Manhole <b>C12-5</b>	Length surveyed <b>184.2</b>	Year Renewed	Height <b>8</b>	Width <b>8</b>	Pipe Joint... <b>4</b>

SPR <b>N/A</b>	MPR <b>2</b>	PO Number <b>4397-03</b>	Customer <b>GRW</b>
SPRI <b>N/A</b>	MPRI <b>2</b>	Work Order <b>4397-02</b>	Purpose <b>Pre-Rehabilitation Survey</b>
QSR <b>N/A</b>	QMR <b>2100</b>		
OPR <b>2</b>	Surveyed By <b>Barry Rogers</b>	Direction <b>Downstream</b>	Date <b>20150715</b>
OPRI <b>2</b>	Certificate Number <b>U-1012-16405</b>	Pre-Cleaning <b>Jetting</b>	Time <b>10:44</b>
	Date Cleaned <b>20150715</b>	End Time <b>10:57</b>	Weather <b>Dry</b>
		Additional Info

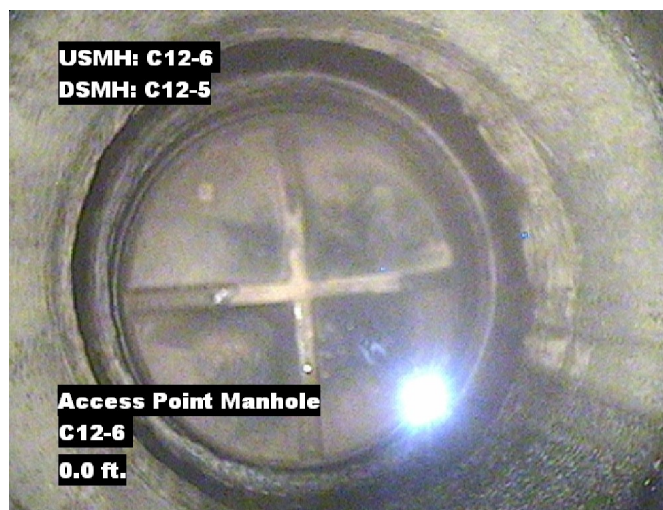
Distance: 0.0 ft. Grade: 0  
Condition: Access Point Manhole  
Remarks: C12-6

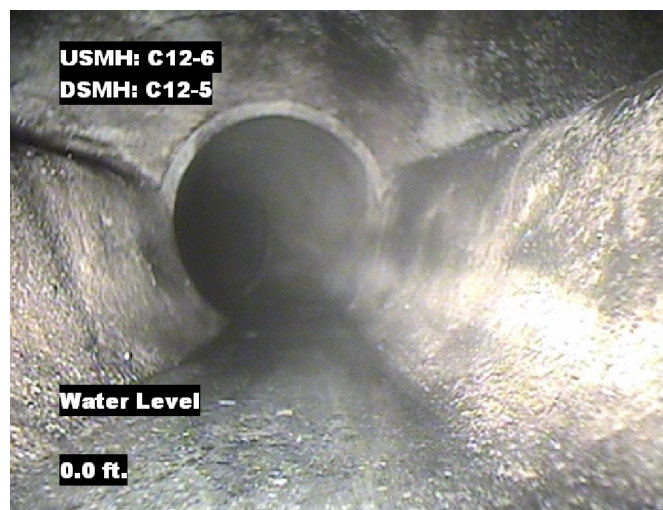
Distance: 0.0 ft. Grade: 0  
Condition: Water Level  
Remarks: N/A

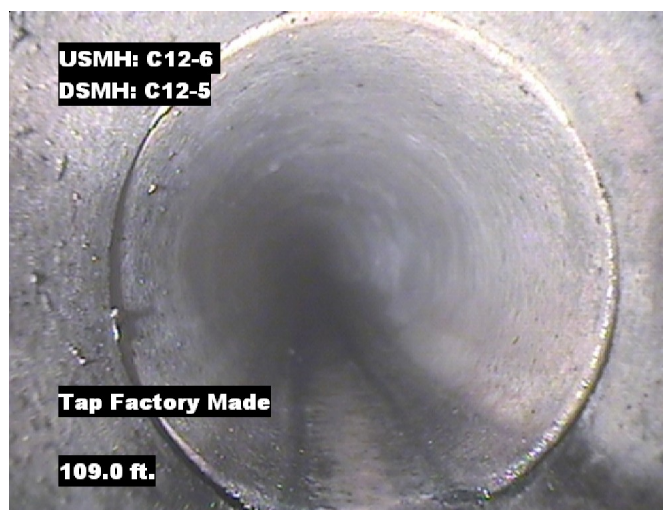
Distance: 109.0 ft. Grade: 0  
Condition: Tap Factory Made  
Remarks: N/A

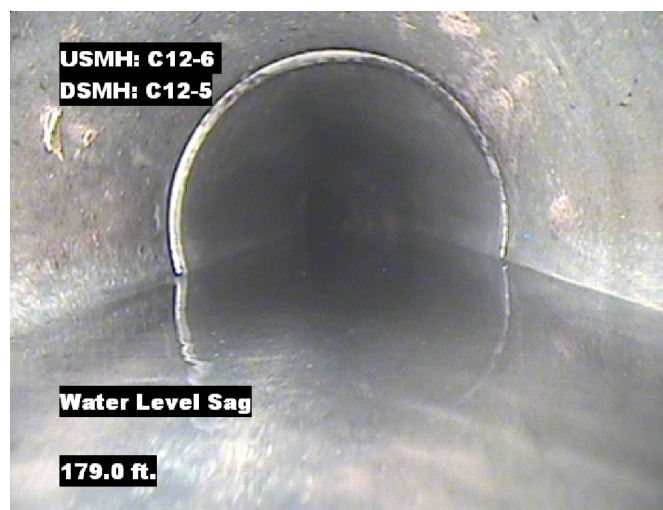
Distance: 179.0 ft. Grade: 2  
Condition: Water Level Sag  
Remarks: N/A

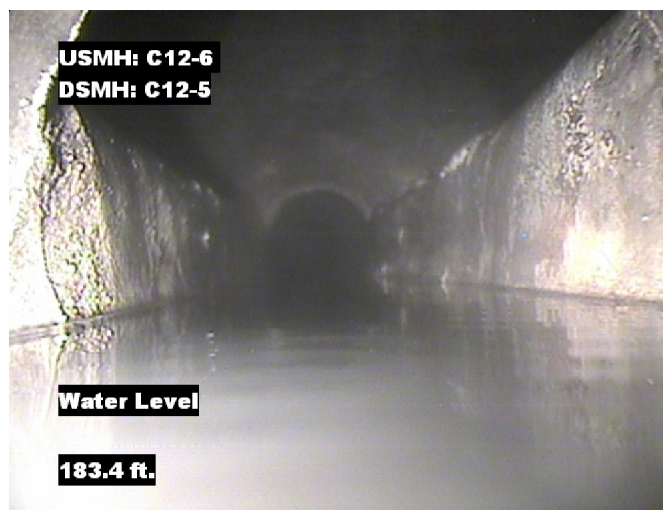
Distance: 183.4 ft.      Grade: 0  
Condition: Water Level  
Remarks: N/A

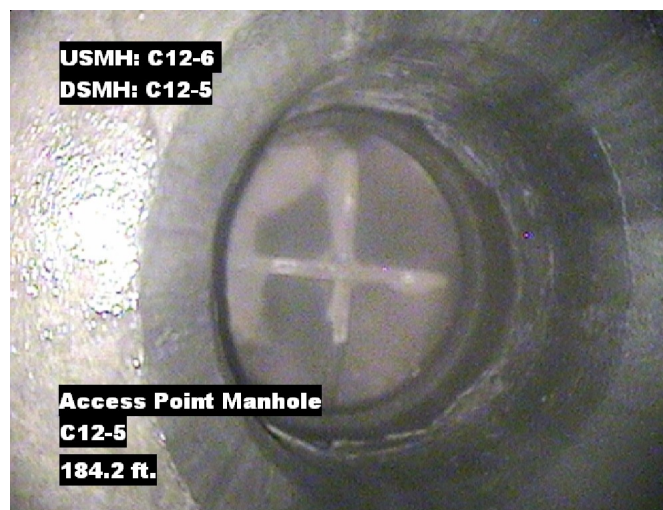
Distance: 184.2 ft.      Grade: 0  
Condition: Access Point Manhole  
Remarks: C12-5
