Defect Listing

Pipe Segment Refere... C12-7_C12-6	City Oliver Springs	Street Hannah Dr	Material Concrete Pipe (non-...	Location C... Light High...	Sewer Use Sanitary
Upstream MH C12-7	Total Length 289.5	Year Laid	Shape Circular	Location Details	
DS Manhole C12-6	Length surveyed 289.5	Year Renewed	Height 8	Width 8	Pipe Joint... 4

SPR 1	MPR N/A	PO Number 4397-03	Customer GRW
SPRI 1	MPRI N/A	Work Order 4397-02	Purpose Pre-Rehabilitation Survey
QSR 1100	QMR N/A		
OPR 1	Surveyed By Barry Rogers	Direction Downstream	Date 20150715
OPRI 1	Certificate Number U-1012-16405	Pre-Cleaning Jetting	Time 10:18
	Date Cleaned 20150715	End Time 10:40	Weather Dry
			Additional Info

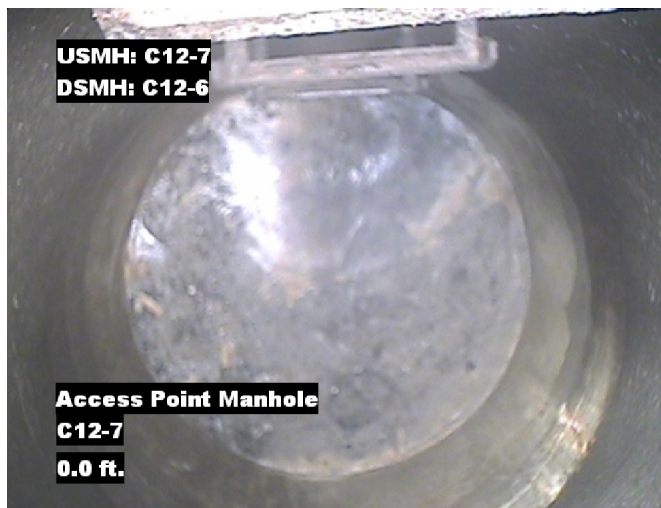
Distance: 0.0 ft. Grade: 0
Condition: Access Point Manhole
Remarks: C12-7

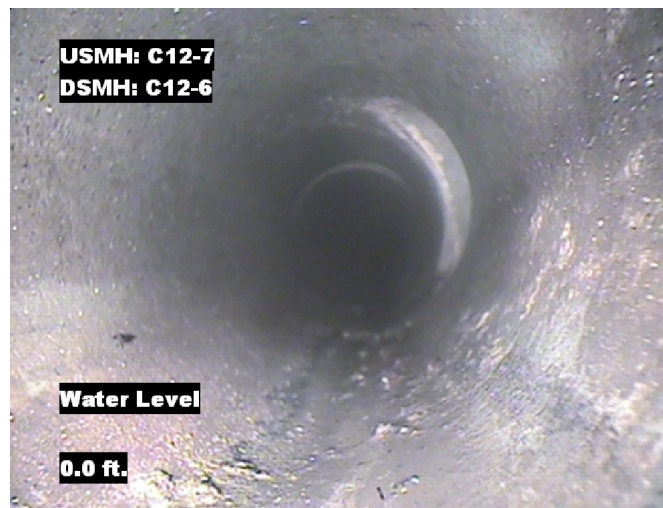
Distance: 0.0 ft. Grade: 0
Condition: Water Level
Remarks: N/A

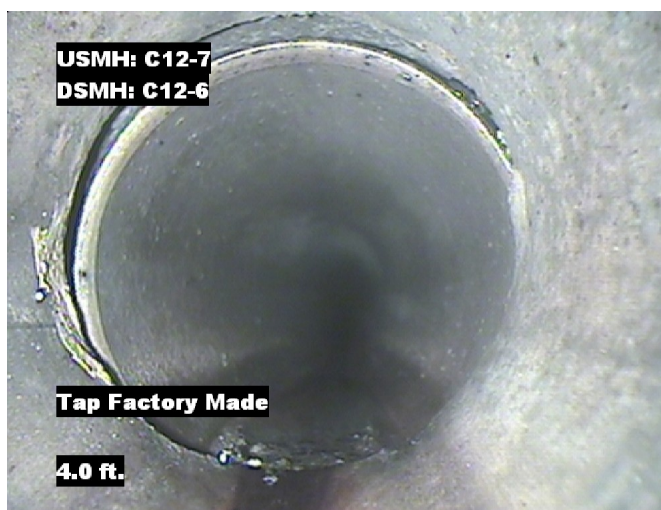
Distance: 4.0 ft. Grade: 0
Condition: Tap Factory Made
Remarks: N/A

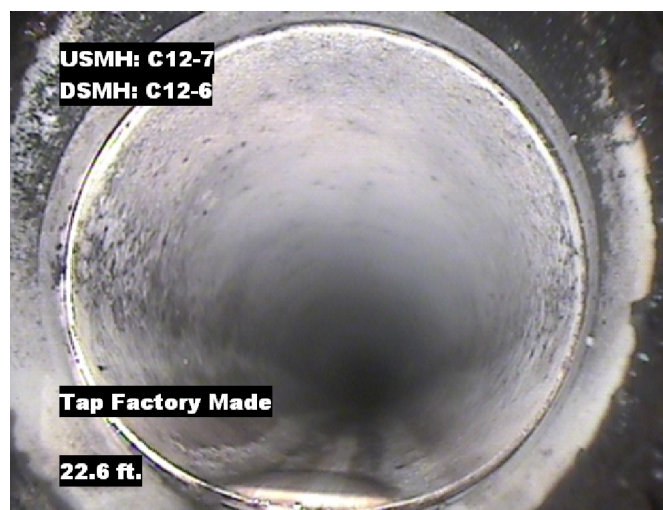
Distance: 22.6 ft. Grade: 0
Condition: Tap Factory Made
Remarks: N/A

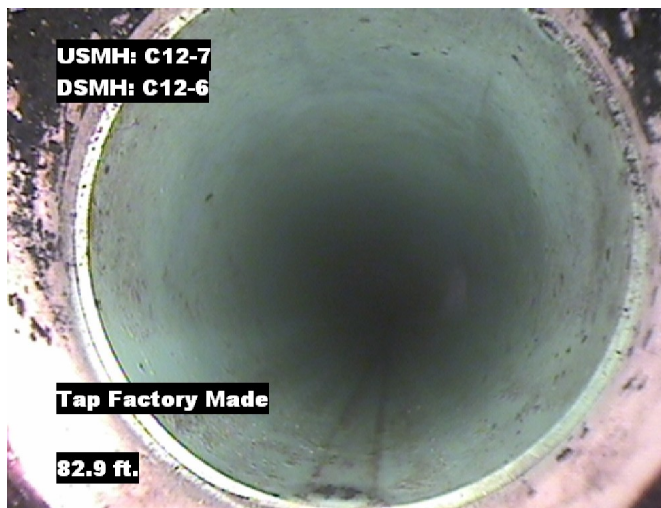
Distance: 82.9 ft. Grade: 0
Condition: Tap Factory Made
Remarks: N/A

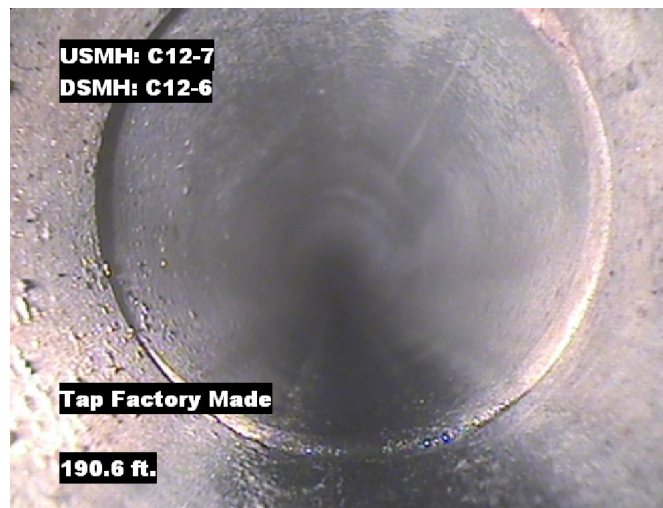
Distance: 190.6 ft. Grade: 0
Condition: Tap Factory Made
Remarks: N/A

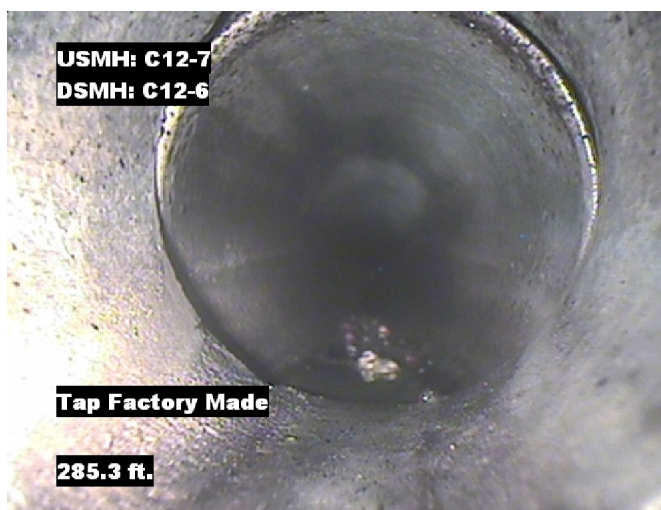
Distance: 285.3 ft. Grade: 0
Condition: Tap Factory Made
Remarks: N/A

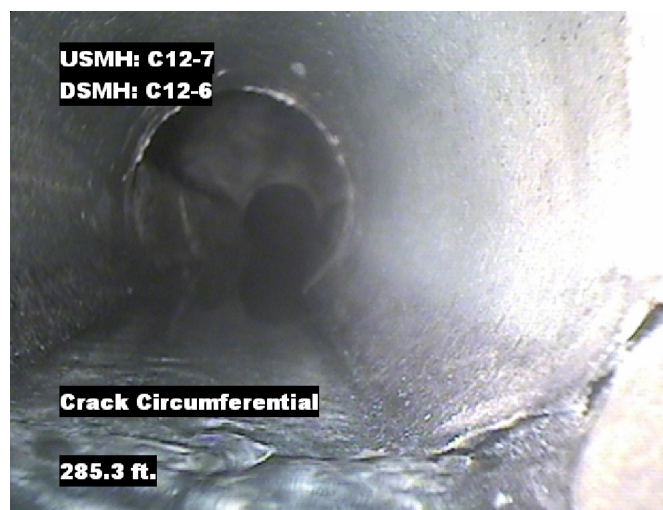
Distance: 285.3 ft. Grade: 1
Condition: Crack Circumferential
Remarks: N/A

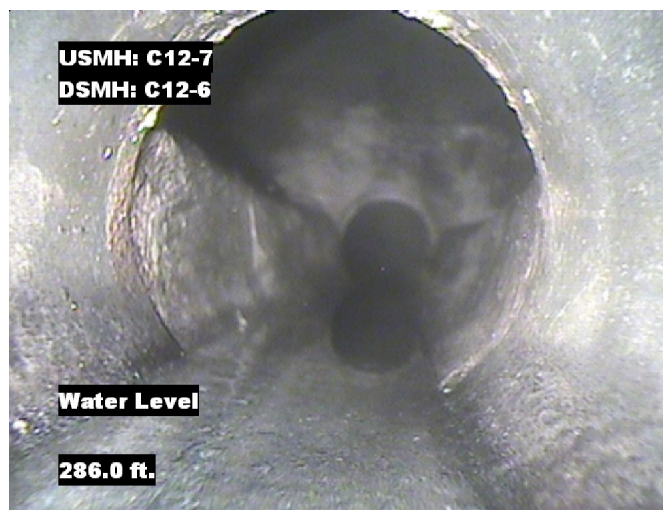
Distance: 286.0 ft. Grade: 0
Condition: Water Level
Remarks: N/A

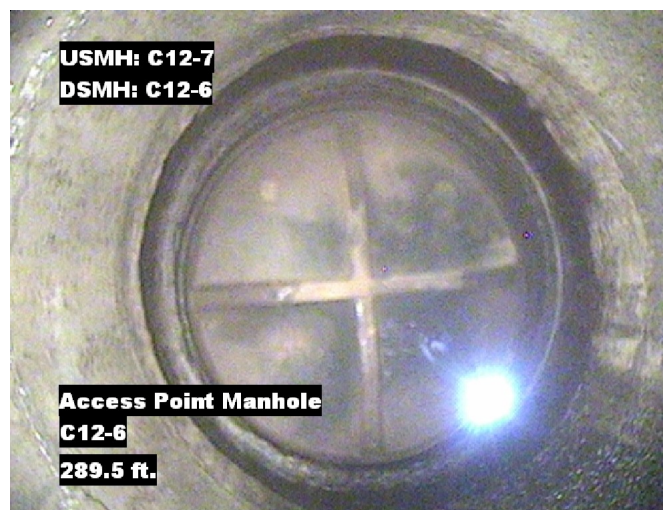
Distance: 289.5 ft. Grade: 0
Condition: Access Point Manhole
Remarks: C12-6
