## Defect Listing

Pipe Segment Refere... <b>C13-1_C-21</b>	City <b>Oliver Springs</b>	Street <b>Browder Cir</b>	Material <b>Concrete Pipe (non-...</b>	Location C... <b>Light High...</b>	Sewer Use <b>Sanitary</b>
Upstream MH <b>C13-1</b>	Total Length <b>215.3</b>	Year Laid	Shape <b>Circular</b>	Location Details	
DS Manhole <b>C-21</b>	Length surveyed <b>215.3</b>	Year Renewed	Height <b>8</b>	Width <b>8</b>	Pipe Joint... <b>4</b>

SPR <b>N/A</b>	MPR <b>7</b>	PO Number <b>4397-03</b>	Customer <b>GRW</b>
SPRI <b>N/A</b>	MPRI <b>3.5</b>	Work Order <b>4397-02</b>	Purpose <b>Pre-Rehabilitation Survey</b>
QSR <b>N/A</b>	QMR <b>4131</b>		
OPR <b>7</b>	Surveyed By <b>Barry Rogers</b>	Direction <b>Downstream</b>	Date <b>20150715</b>
OPRI <b>3.5</b>	Certificate Number <b>U-1012-16405</b>	Pre-Cleaning <b>Jetting</b>	Time <b>09:52</b>
	Date Cleaned <b>20150715</b>	End Time <b>10:06</b>	Weather <b>Damp</b>
			Additional Info

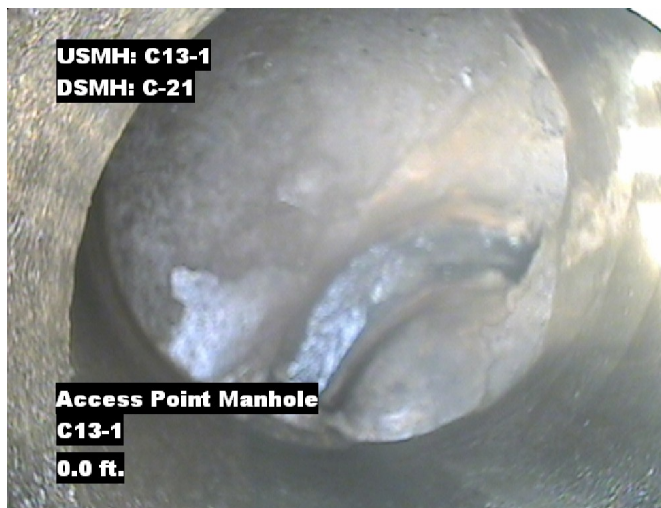
Distance: 0.0 ft. Grade: 0  
Condition: Access Point Manhole  
Remarks: C13-1

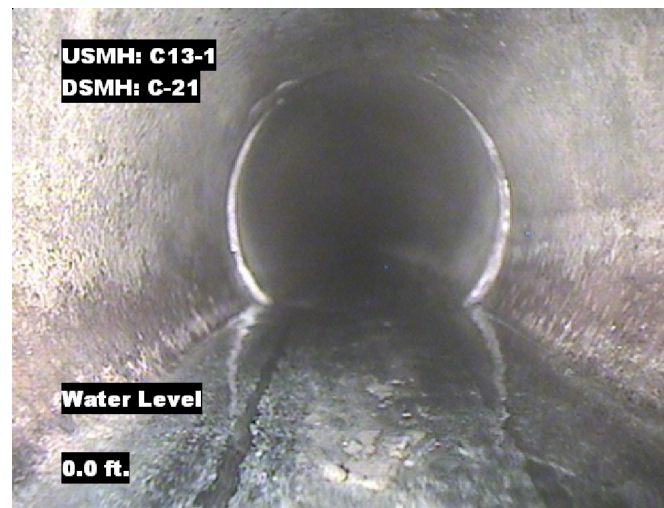
Distance: 0.0 ft. Grade: 0  
Condition: Water Level  
Remarks: N/A

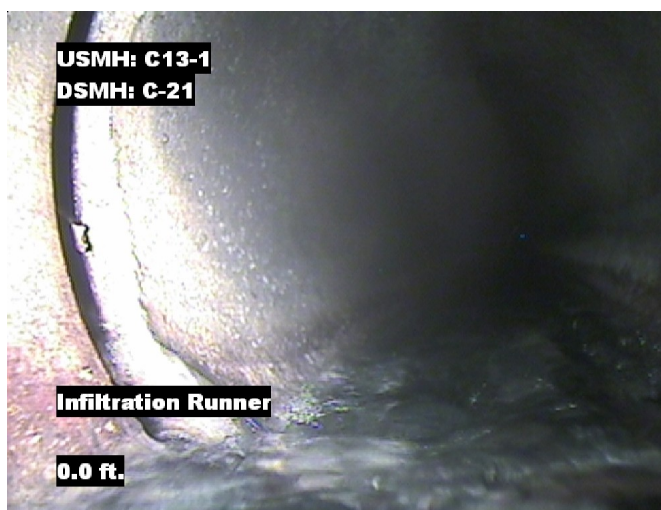
Distance: 5.0 ft. Grade: 4  
Condition: Infiltration Runner  
Remarks: N/A

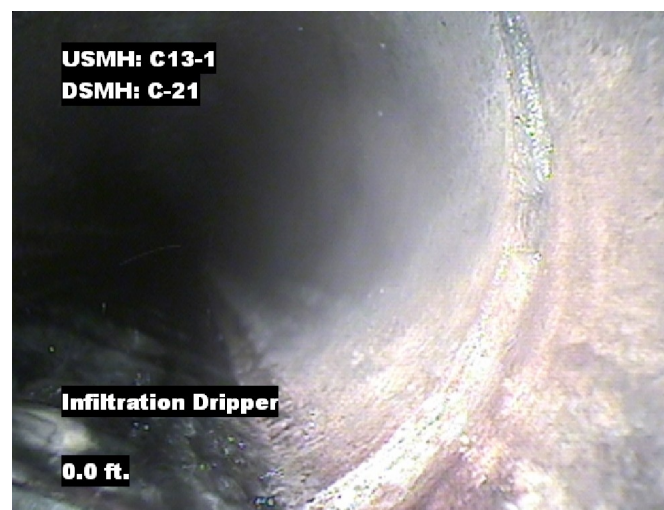
Distance: 5.0 ft. Grade: 3  
Condition: Infiltration Dripper  
Remarks: N/A

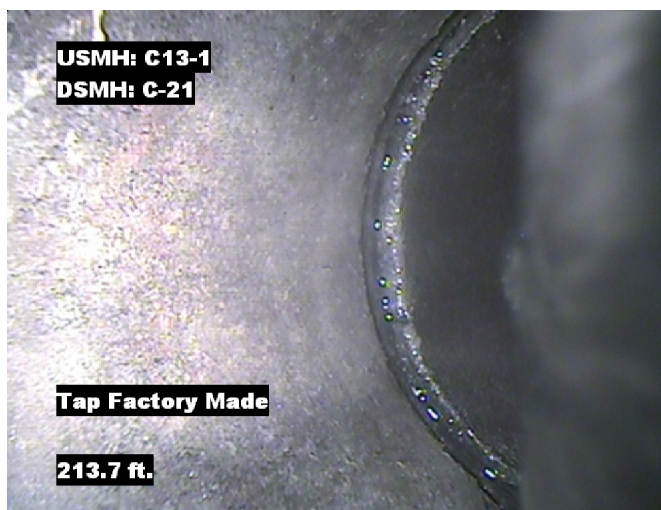
Distance: 213.7 ft. Grade: 0  
Condition: Tap Factory Made  
Remarks: N/A

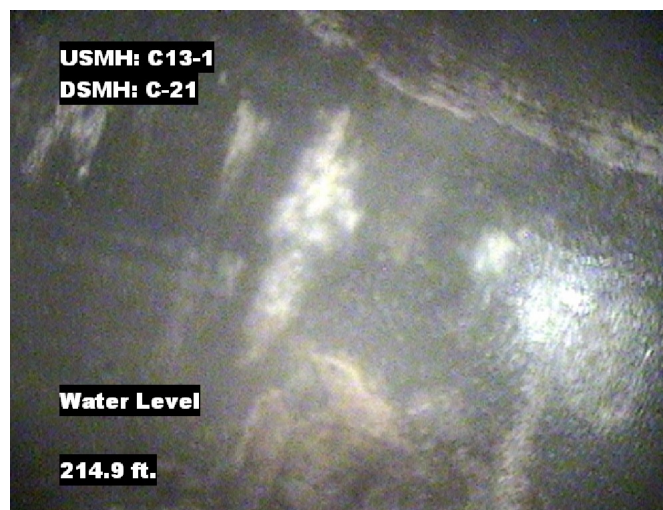
Distance: 214.9 ft. Grade: 0  
Condition: Water Level  
Remarks: N/A

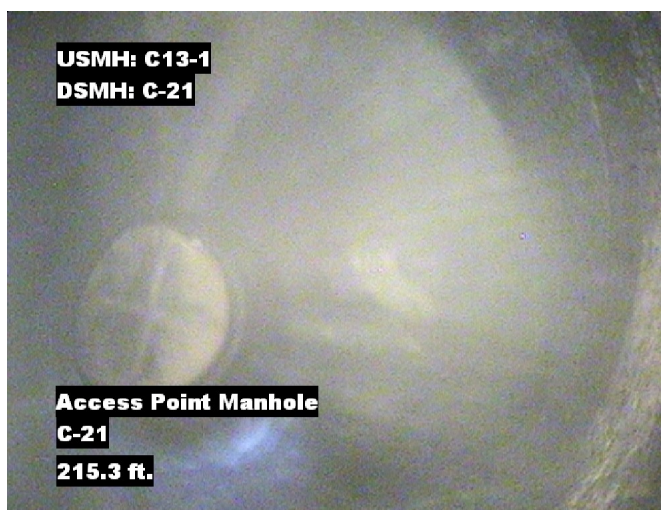
Distance: 215.3 ft. Grade: 0  
Condition: Access Point Manhole  
Remarks: C-21
