Defect Listing

Pipe Segment Refere... C13-2_C13-1	City Oliver Springs	Street Browder Cir	Material Concrete Pipe (non-...	Location C... Light High...	Sewer Use Sanitary
Upstream MH C13-2	Total Length 105.5	Year Laid	Shape Circular	Location Details	
DS Manhole C13-1	Length surveyed 105.5	Year Renewed	Height 8	Width 8	Pipe Joint... 4

SPR N/A	MPR N/A	PO Number 4397-03	Customer GRW
SPRI N/A	MPRI N/A	Work Order 4397-02	Purpose Pre-Rehabilitation Survey
QSR N/A	QMR N/A		
OPR N/A	Surveyed By Barry Rogers	Direction Downstream	Date 20150715
OPRI N/A	Certificate Number U-1012-16405	Pre-Cleaning Jetting	Time 09:34
	Date Cleaned 20150715	End Time 09:42	Weather Damp
			Additional Info

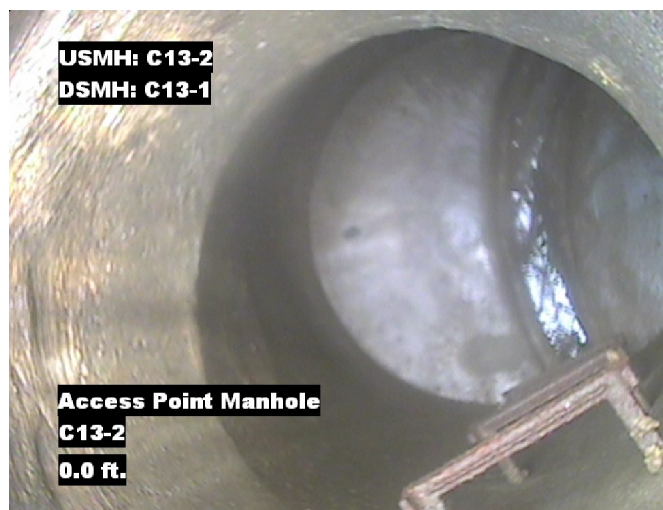
Distance: 0.0 ft. Grade: 0
Condition: Access Point Manhole
Remarks: C13-2

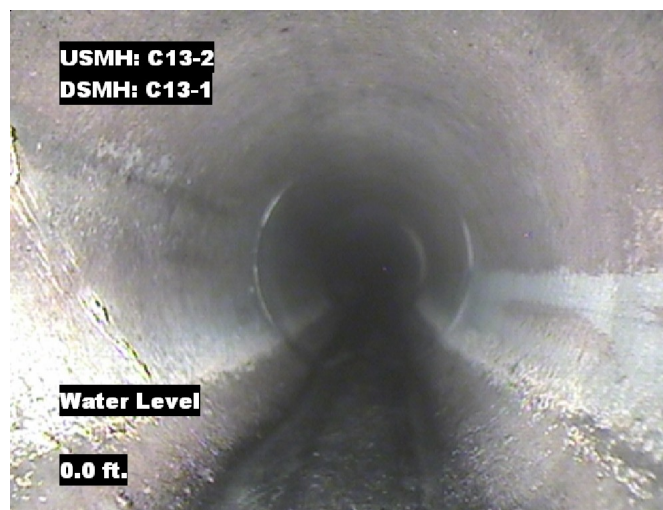
Distance: 0.0 ft. Grade: 0
Condition: Water Level
Remarks: N/A

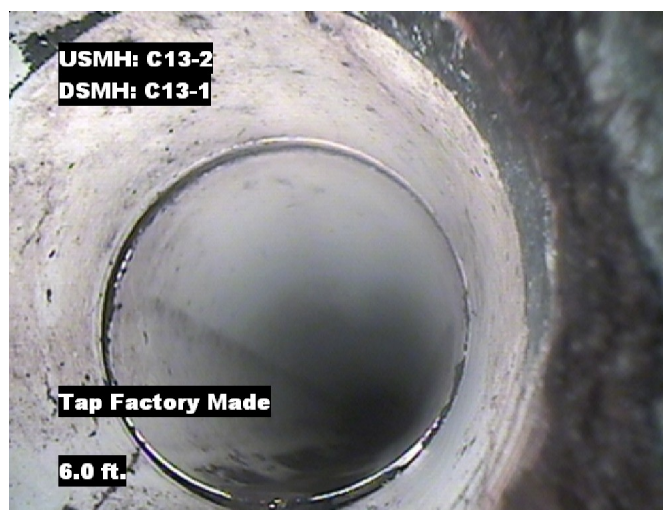
Distance: 6.0 ft. Grade: 0
Condition: Tap Factory Made
Remarks: N/A

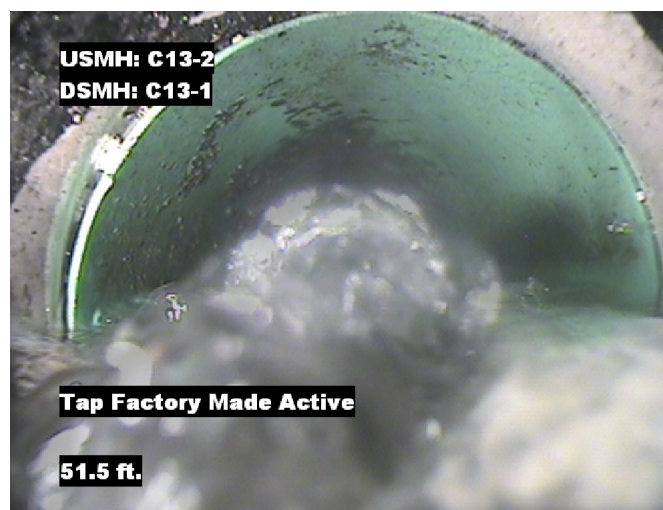
Distance: 51.5 ft. Grade: 0
Condition: Tap Factory Made Active
Remarks: N/A

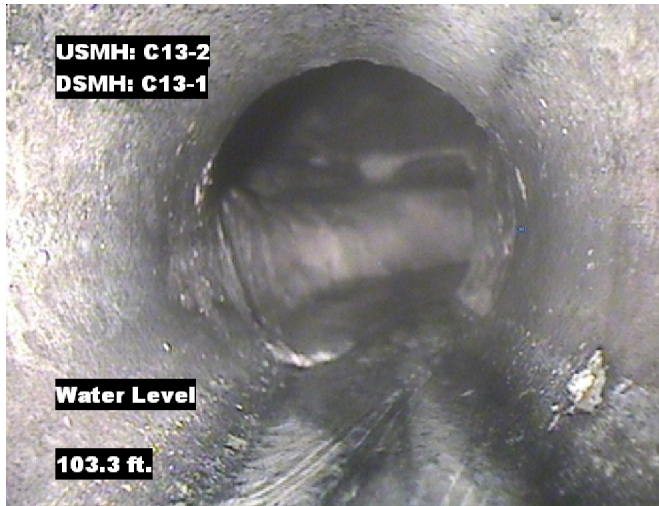
Distance: 103.3 ft. Grade: 0
Condition: Water Level
Remarks: N/A

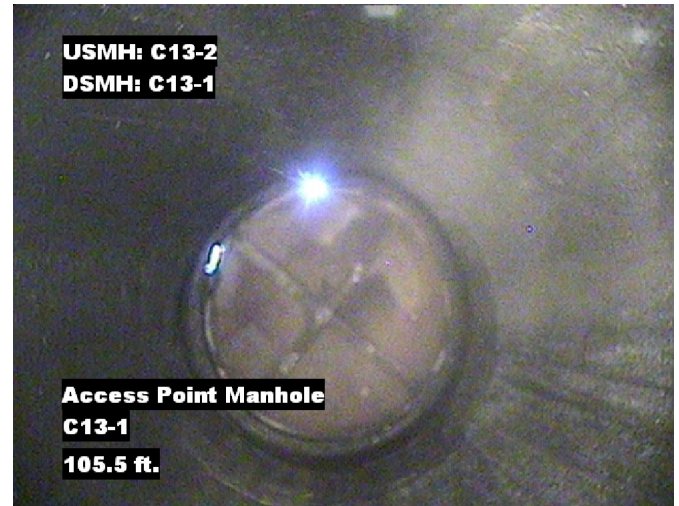
Distance: 105.5 ft. Grade: 0
Condition: Access Point Manhole
Remarks: C13-1
