Defect Listing

Pipe Segment Refere... C13-3_C13-2	City Oliver Springs	Street Browder Cir	Material Concrete Pipe (non-...	Location C... Light High...	Sewer Use Sanitary
Upstream MH C13-3	Total Length 255.5	Year Laid	Shape Circular	Location Details	
DS Manhole C13-2	Length surveyed 255.5	Year Renewed	Height 8	Width 8	Pipe Joint... 4

SPR N/A	MPR N/A	PO Number 4397-03		Customer GRW	
SPRI N/A	MPRI N/A	Work Order 4397-02		Purpose Pre-Rehabilitation Survey	
QSR N/A	QMR N/A				
OPR N/A	Surveyed By Barry Rogers	Direction Downstream	Date 20150715	Media label	
OPRI N/A	Certificate Number U-1012-16405	Pre-Cleaning Jetting	Time 09:01	Weather Damp	
Date Cleaned 20150715			End Time 09:20	Additional Info

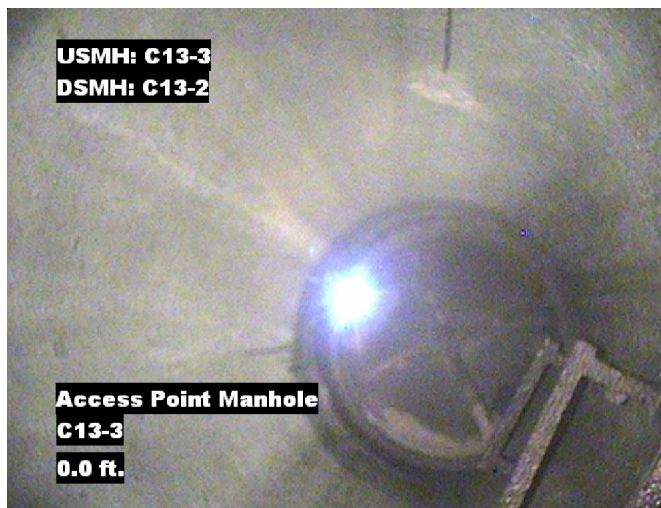
Distance: 0.0 ft. Grade: 0
Condition: Access Point Manhole
Remarks: C13-3

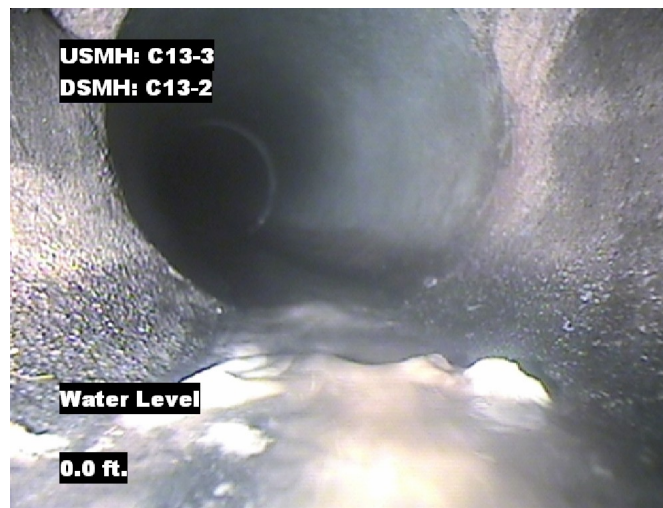
Distance: 0.0 ft. Grade: 0
Condition: Water Level
Remarks: N/A

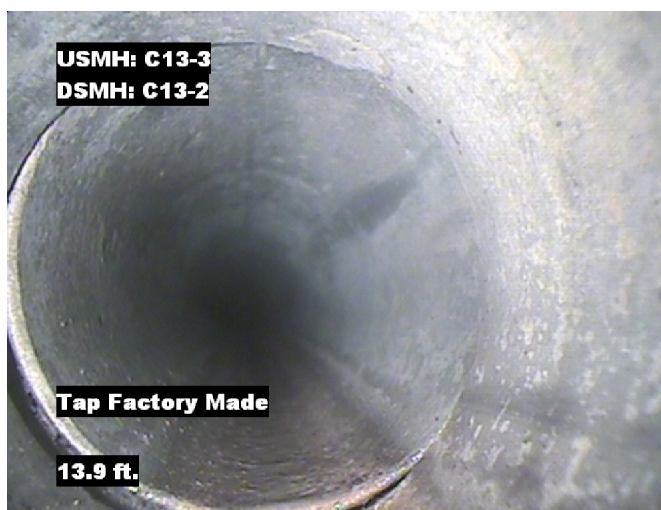
Distance: 13.9 ft. Grade: 0
Condition: Tap Factory Made
Remarks: N/A

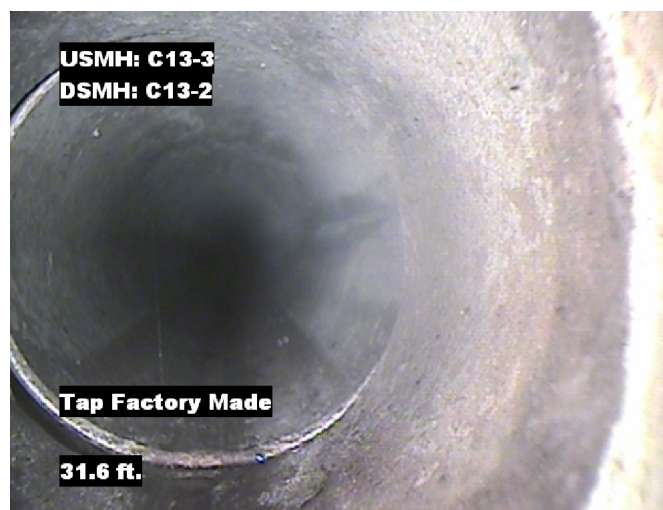
Distance: 31.6 ft. Grade: 0
Condition: Tap Factory Made
Remarks: N/A

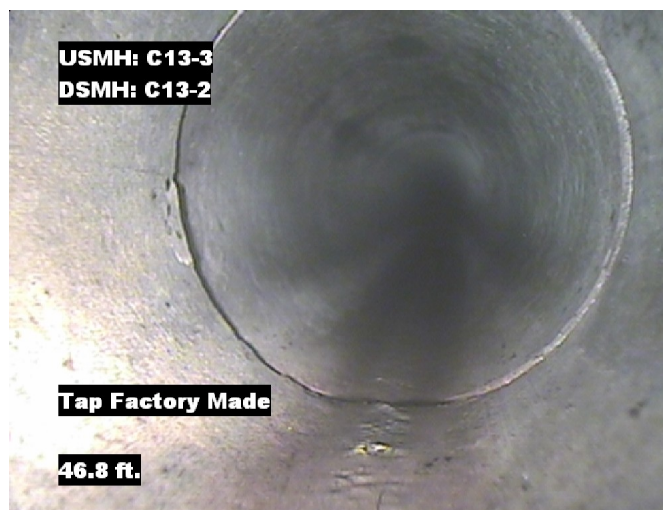
Distance: 46.8 ft. Grade: 0
Condition: Tap Factory Made
Remarks: N/A

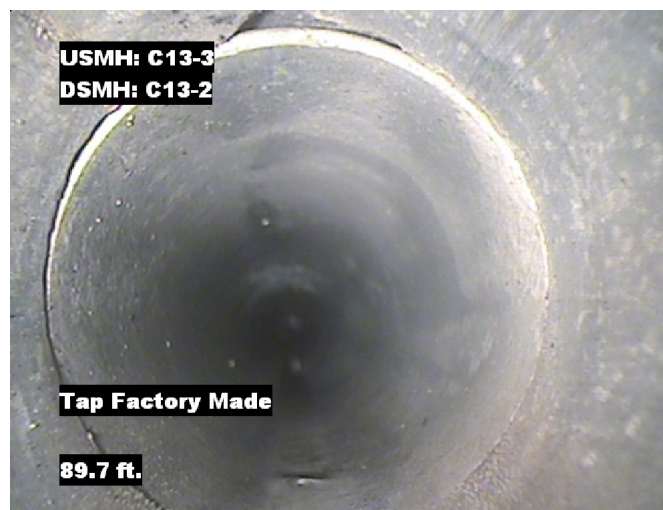
Distance: 89.7 ft. Grade: 0
Condition: Tap Factory Made
Remarks: N/A

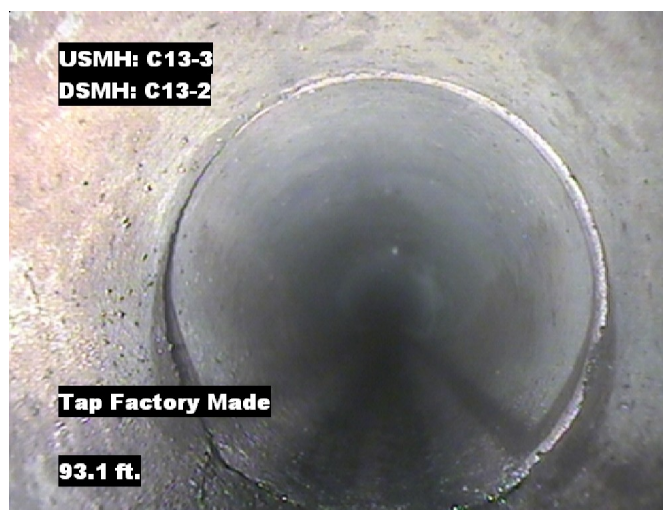
Distance: 93.1 ft. Grade: 0
Condition: Tap Factory Made
Remarks: N/A

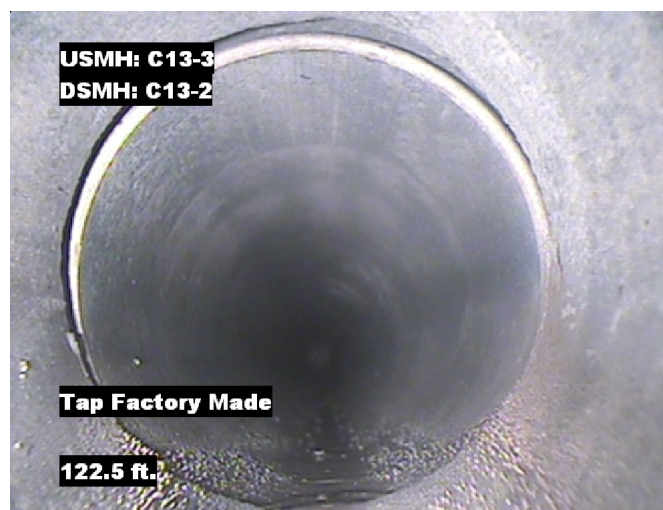
Distance: 122.5 ft. Grade: 0
Condition: Tap Factory Made
Remarks: N/A

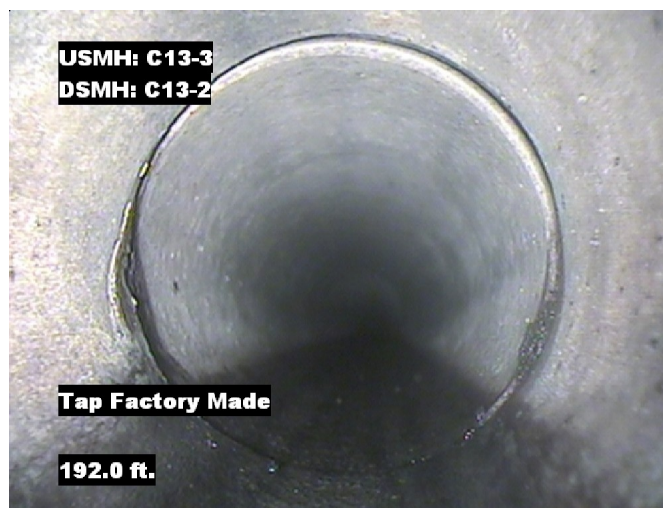
Distance: 192.0 ft. Grade: 0
Condition: Tap Factory Made
Remarks: N/A

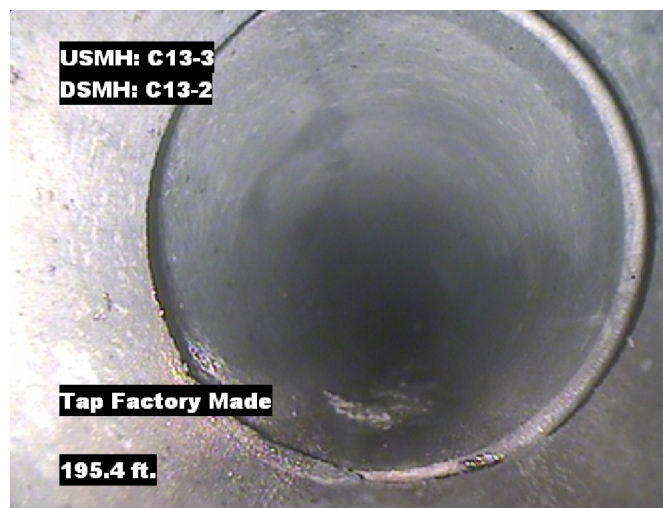
Distance: 195.4 ft. Grade: 0
Condition: Tap Factory Made
Remarks: N/A

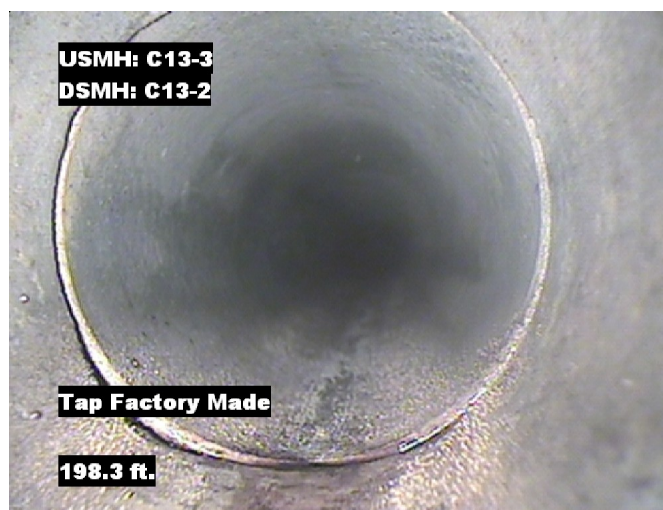
Distance: 198.3 ft. Grade: 0
Condition: Tap Factory Made
Remarks: N/A

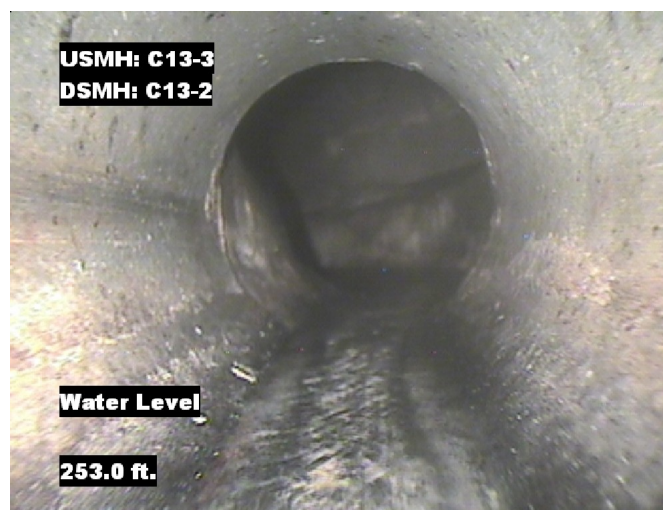
Distance: 253.0 ft. Grade: 0
Condition: Water Level
Remarks: N/A

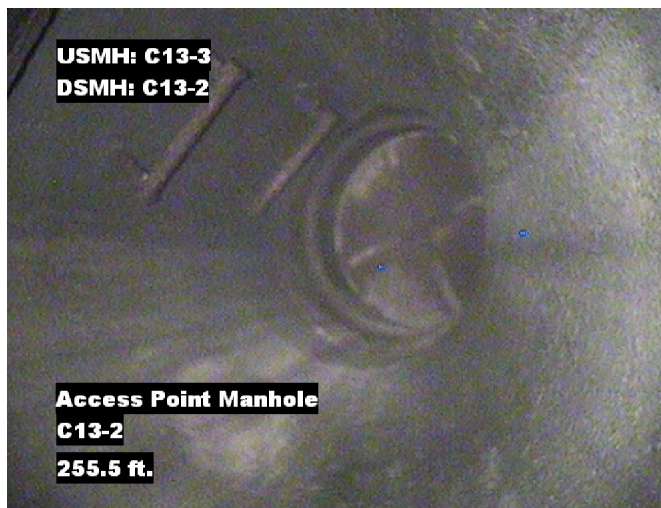
Distance: 255.5 ft. Grade: 0
Condition: Access Point Manhole
Remarks: C13-2
