Defect Listing

Pipe Segment Refere... C13-4_C13-3	City Oliver Springs	Street browder Cir	Material Concrete Pipe (non-...	Location C... Light High...	Sewer Use Sanitary
Upstream MH C13-4	Total Length 175	Year Laid	Shape Circular	Location Details	
DS Manhole C13-3	Length surveyed 175	Year Renewed	Height 8	Width 8	Pipe Joint... 4

Image Report 4/Page

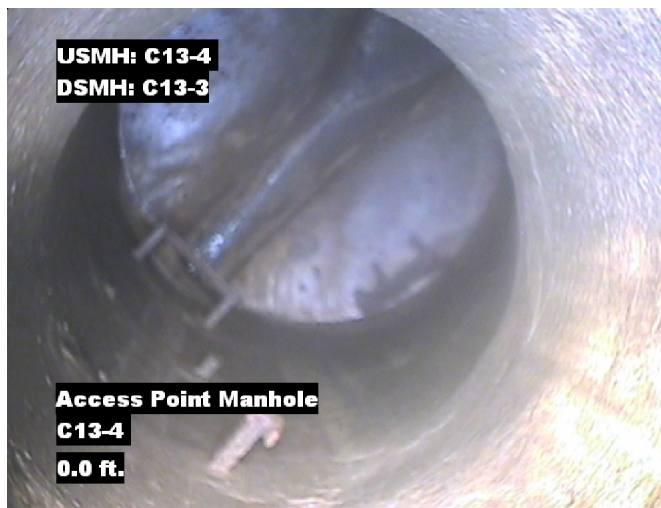
Distance: 0.0 ft. Grade: 0
Condition: Access Point Manhole
Remarks: C13-4

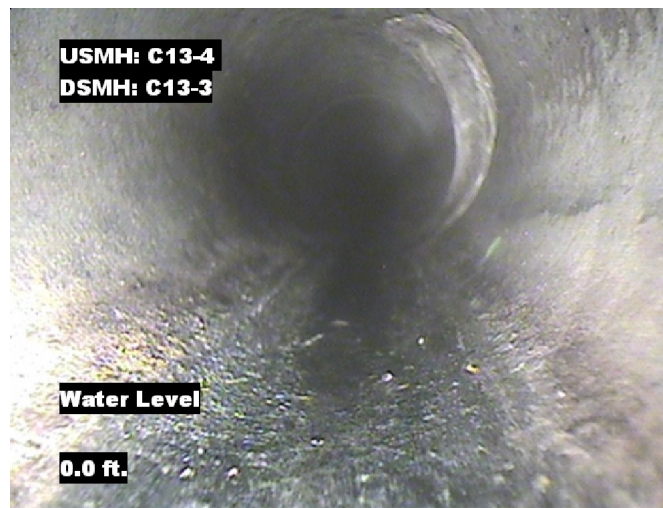
Distance: 0.0 ft. Grade: 0
Condition: Water Level
Remarks: N/A

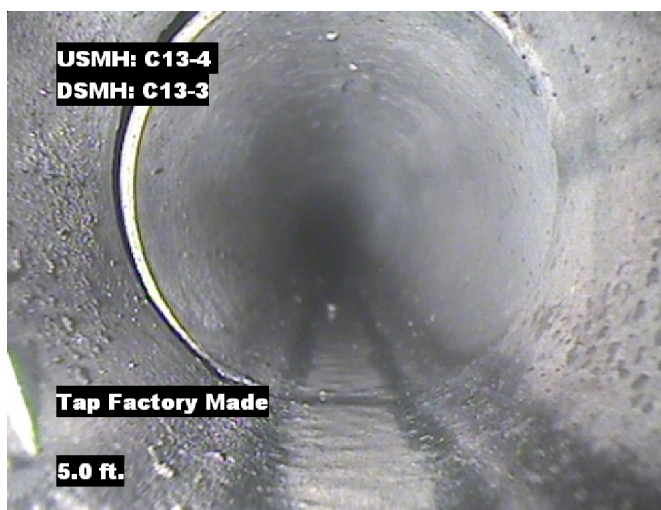
Distance: 5.0 ft. Grade: 0
Condition: Tap Factory Made
Remarks: N/A

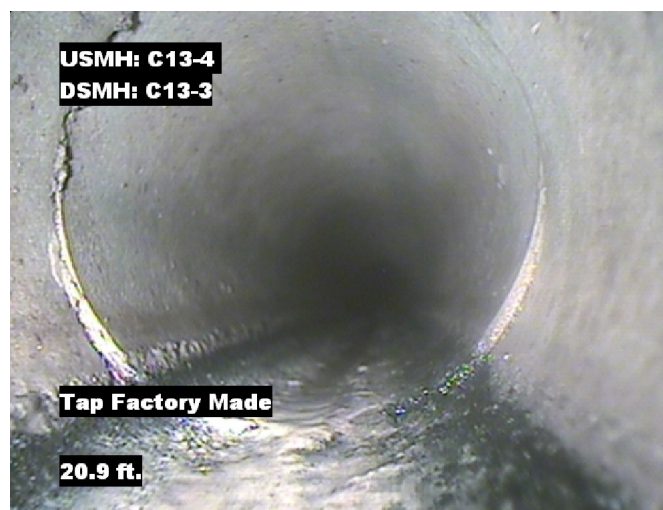
Distance: 20.9 ft. Grade: 0
Condition: Tap Factory Made
Remarks: N/A

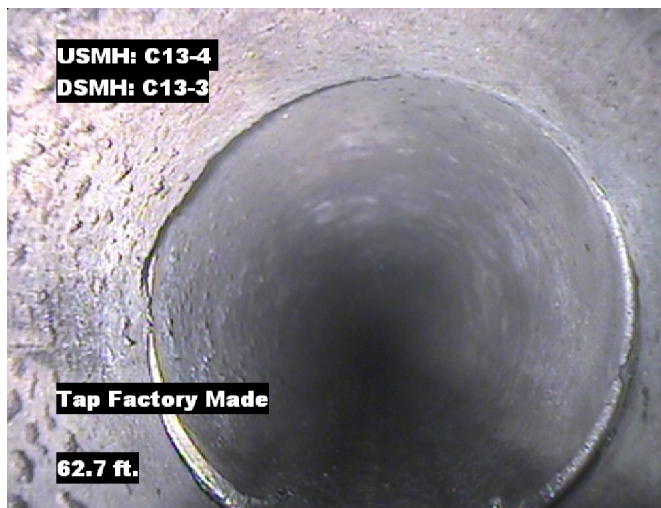
Distance: 62.7 ft. Grade: 0
Condition: Tap Factory Made
Remarks: N/A

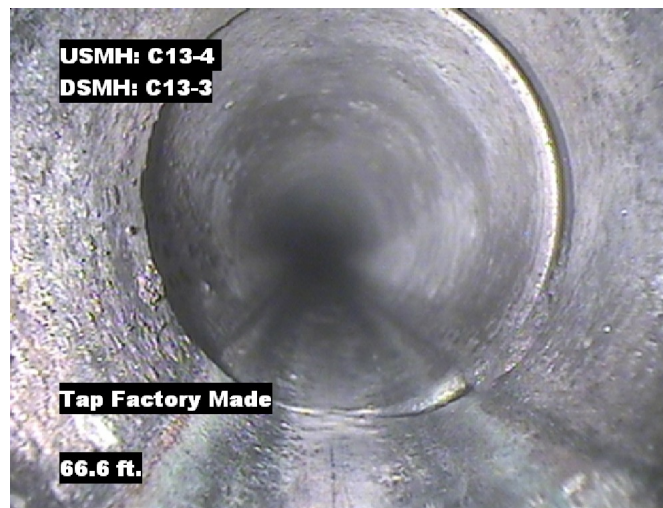
Distance: 66.6 ft. Grade: 0
Condition: Tap Factory Made
Remarks: N/A

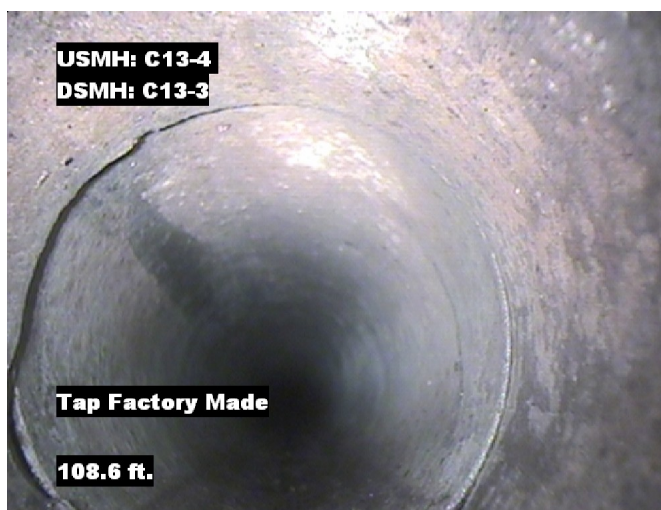
Distance: 108.6 ft. Grade: 0
Condition: Tap Factory Made
Remarks: N/A

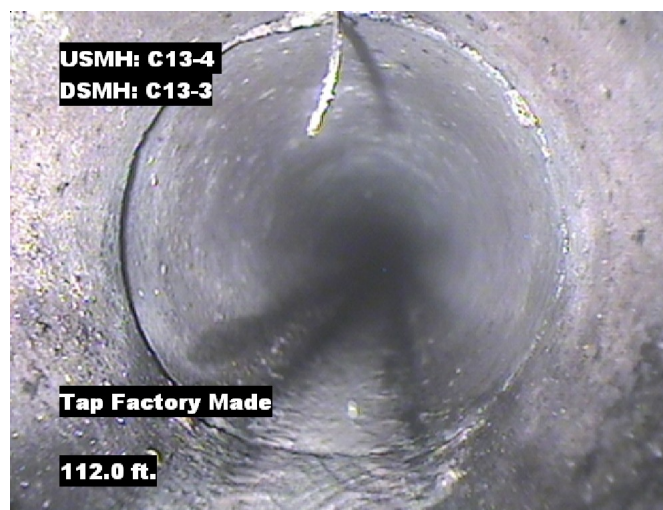
Distance: 112.0 ft. Grade: 0
Condition: Tap Factory Made
Remarks: N/A

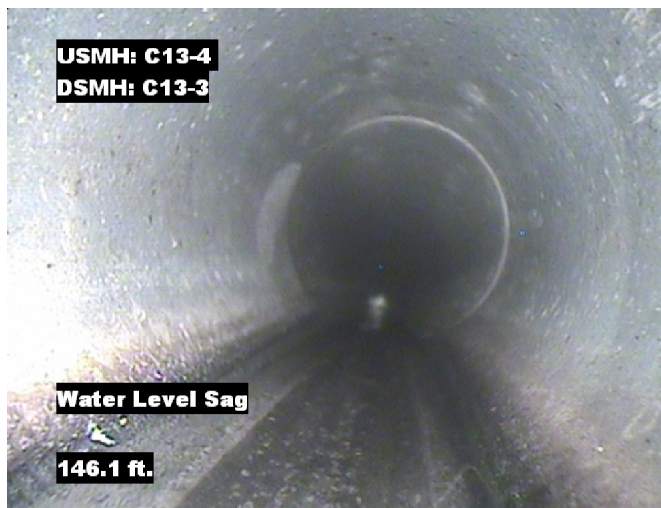
Distance: 146.1 ft. Grade: 2
Condition: Water Level Sag
Remarks: N/A

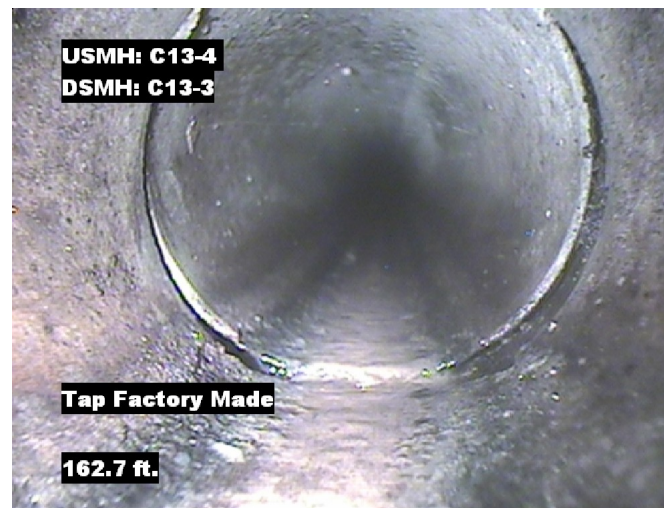
Distance: 162.7 ft. Grade: 0
Condition: Tap Factory Made
Remarks: N/A

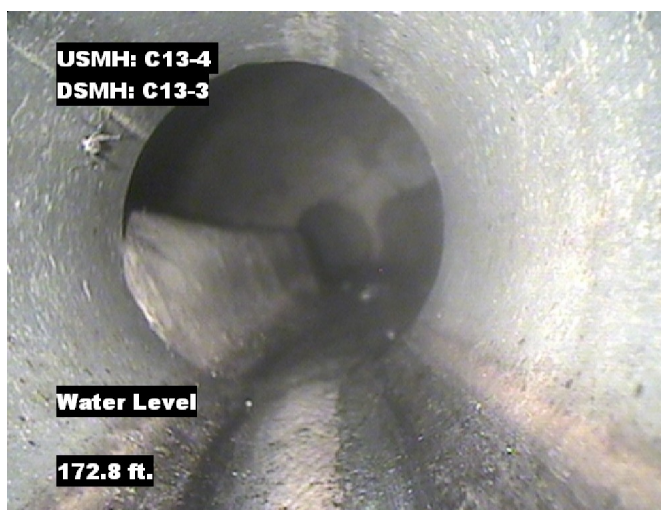
Distance: 172.8 ft. Grade: 0
Condition: Water Level
Remarks: N/A

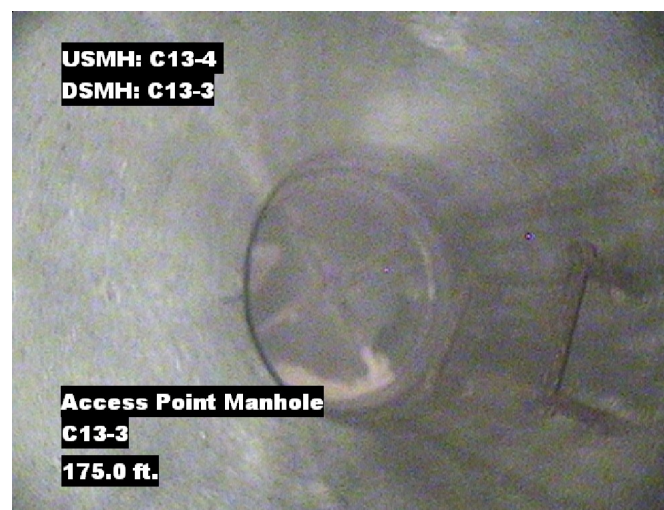
Distance: 175.0 ft. Grade: 0
Condition: Access Point Manhole
Remarks: C13-3
