Defect Listing

Pipe Segment Refere		City		Street	Mat	erial	Location C	Sewer Use	
C14-1	_C-23 Oliver Springs Edmonds Dr Fibreglass Re		ass Reinforc Yard		Sanitary				
Upstream MH		Total Length		Year Laid	Shape		Location Details		
C1	4-1	310	0.9		Circ	cular			
DS Ma	anhole	Length s	surveyed	Year Renewed	Height	Width	Pipe Joint		
C-	-23	310.9			8	8	N/A		
SPR	N/A	MPR	N/A	PO Number			Customer		
				4397-03		GRW			
SPRI	N/A	MPRI	N/A	Work Order	Work Order		Purpose		
QSR	N/A	QMR	N/A	4397-02		Pre-	Rehabilitation S	habilitation Survey	
OI	PR	Surve	/ed By	Direction	Da	ate	Media	alabel	
N.	/A	Barry_	Rogers	Downstream	2015	0714			
OF	PRI	Certificate Number		Pre-Cleaning	Time		Weather		
N.	N/A U-1012-16405		-16405	Jetting 1		11:26			
Date Cleaned 20150714						End Time		Additional Info	
					11	:46

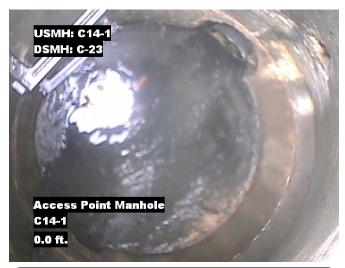
Distance: 0.0 ft. Grade: 0

Condition: Access Point Manhole

Remarks: C14-1

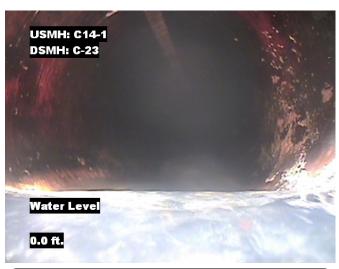
Distance: 0.0 ft. Grade: 0

Condition: Water Level

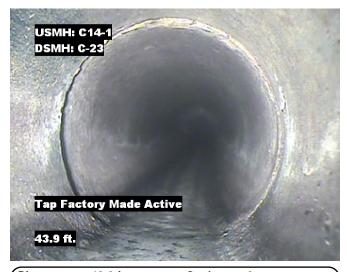
Distance: 43.9 ft. **Grade**: 0 **Condition**: Tap Factory Made Active

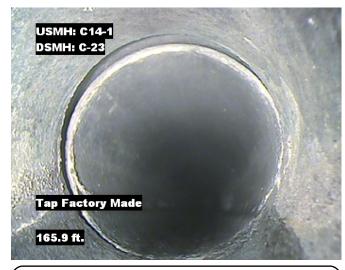
Distance: 165.9 ft. Grade: 0

Condition: Tap Factory Made

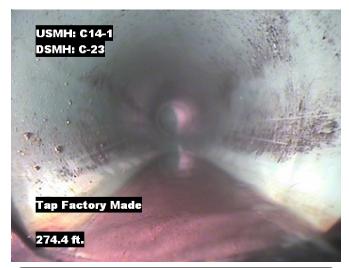
Distance: 274.4 ft. Grade:

Condition: Tap Factory Made

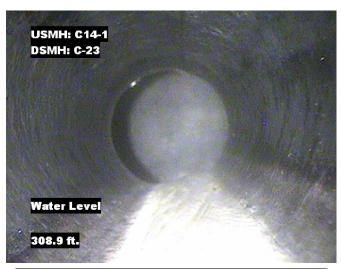
Distance: 308.8 ft. Grade: 0

Condition: Water Level
